A地区イオン分析結果一覧

B地区イオン分析結果

断面線設定位置図
大字田畑

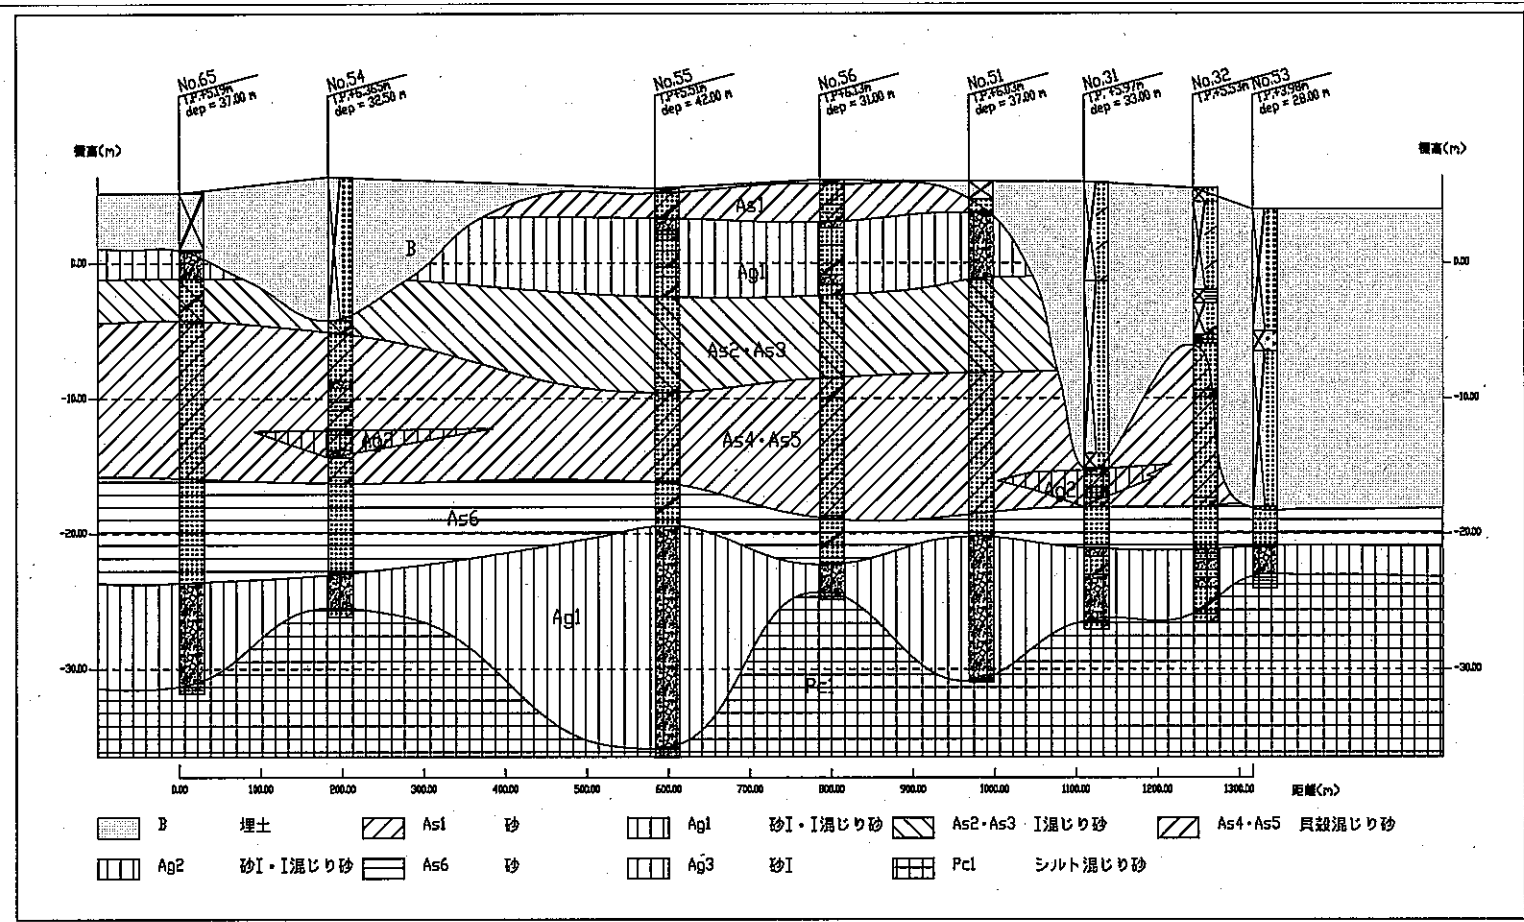
○設置済み観測孔
