Management Plan for Antarctic Specially Protected Area No. 162

MAWSON'S HUTS, CAPE DENISON, COMMONWEALTH BAY, GEORGE V LAND, EAST ANTARCTICA

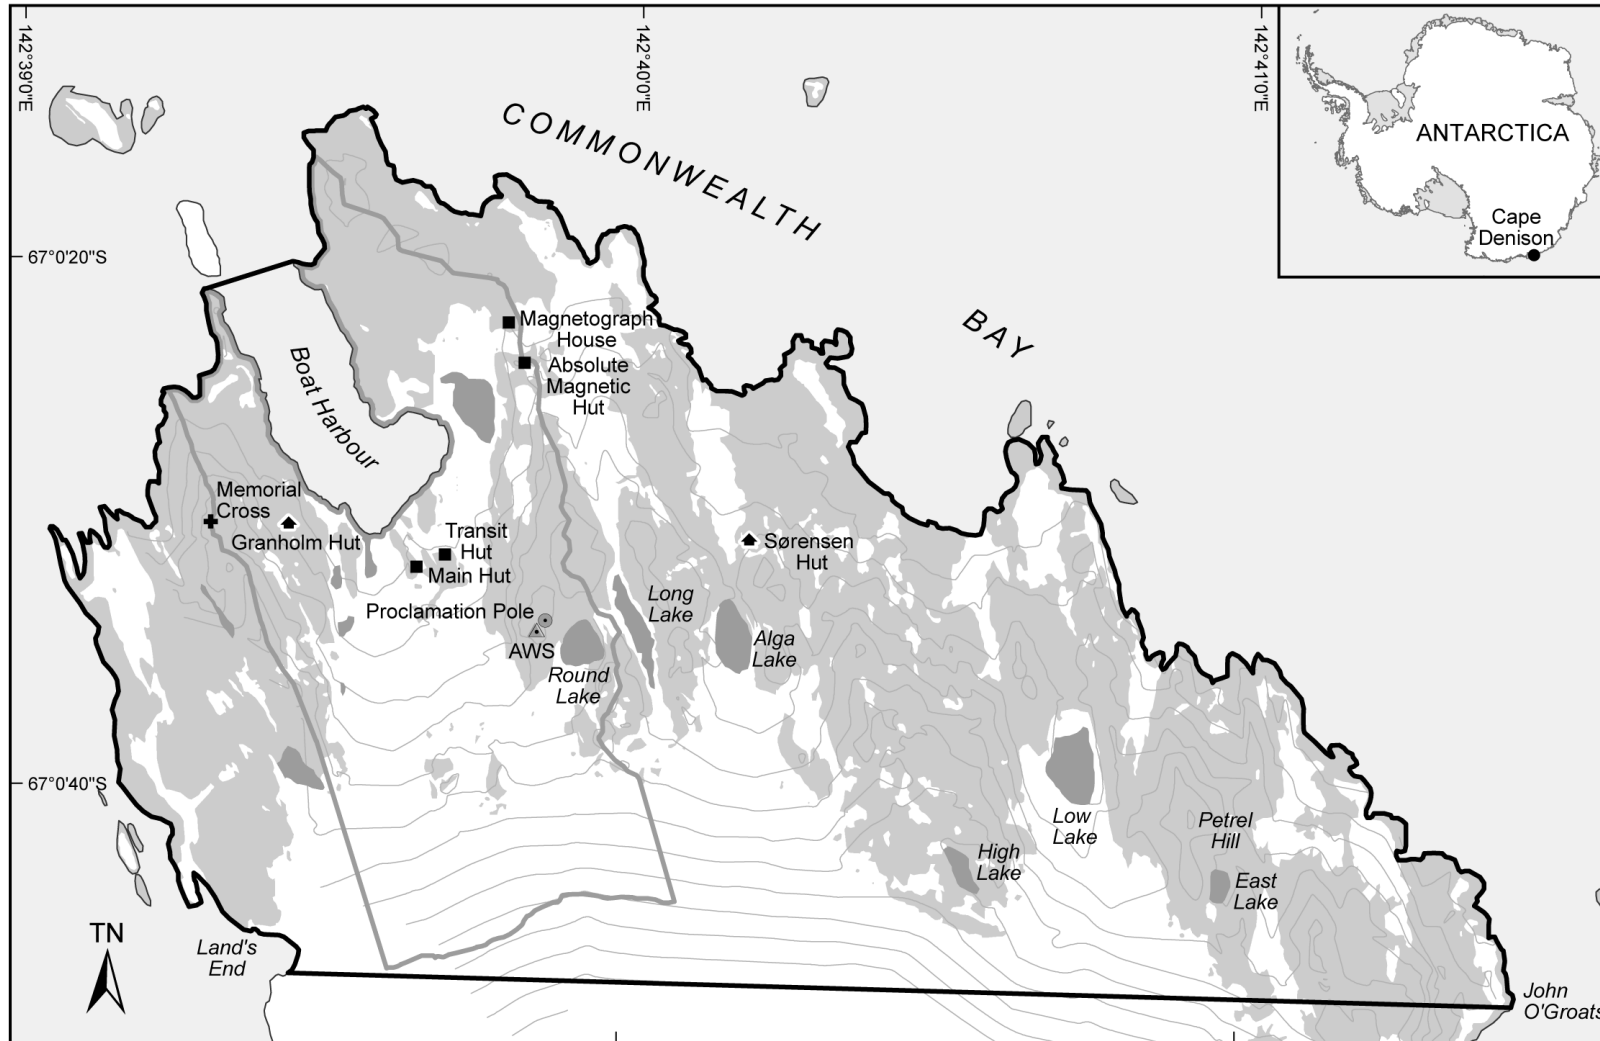
Map A Mawson's Huts, Cape Denison

The map shows the boundaries of the ASPA, the Historic Site, the Visual Protection Zone, and significant topographic features of the Area. The inset map indicates the location in relation to the Antarctic continent.

Map A: Mawson's Huts, Cape Denison.

The designated ASPA (Map A) extends from Land's End (67° 00' 47" S, 142° 39' 28" E) in the west, along the coastline to the northern tip of the western shore of Boat Harbour (67° 00' 21" S, 142° 39' 28" E), across the mouth of Boat Harbour (in a straight north-easterly diagonal) to the eastern shore of Boat Harbour (67° 00' 21" S, 142° 39' 27" E), south-west of Penguin Knob, and then along the coastline in a south-easterly direction down to John O'Groats (67° 00' 47" S, 142° 41' 27" E). The southern boundary extends in a straight line from Land's End to John O'Groats along

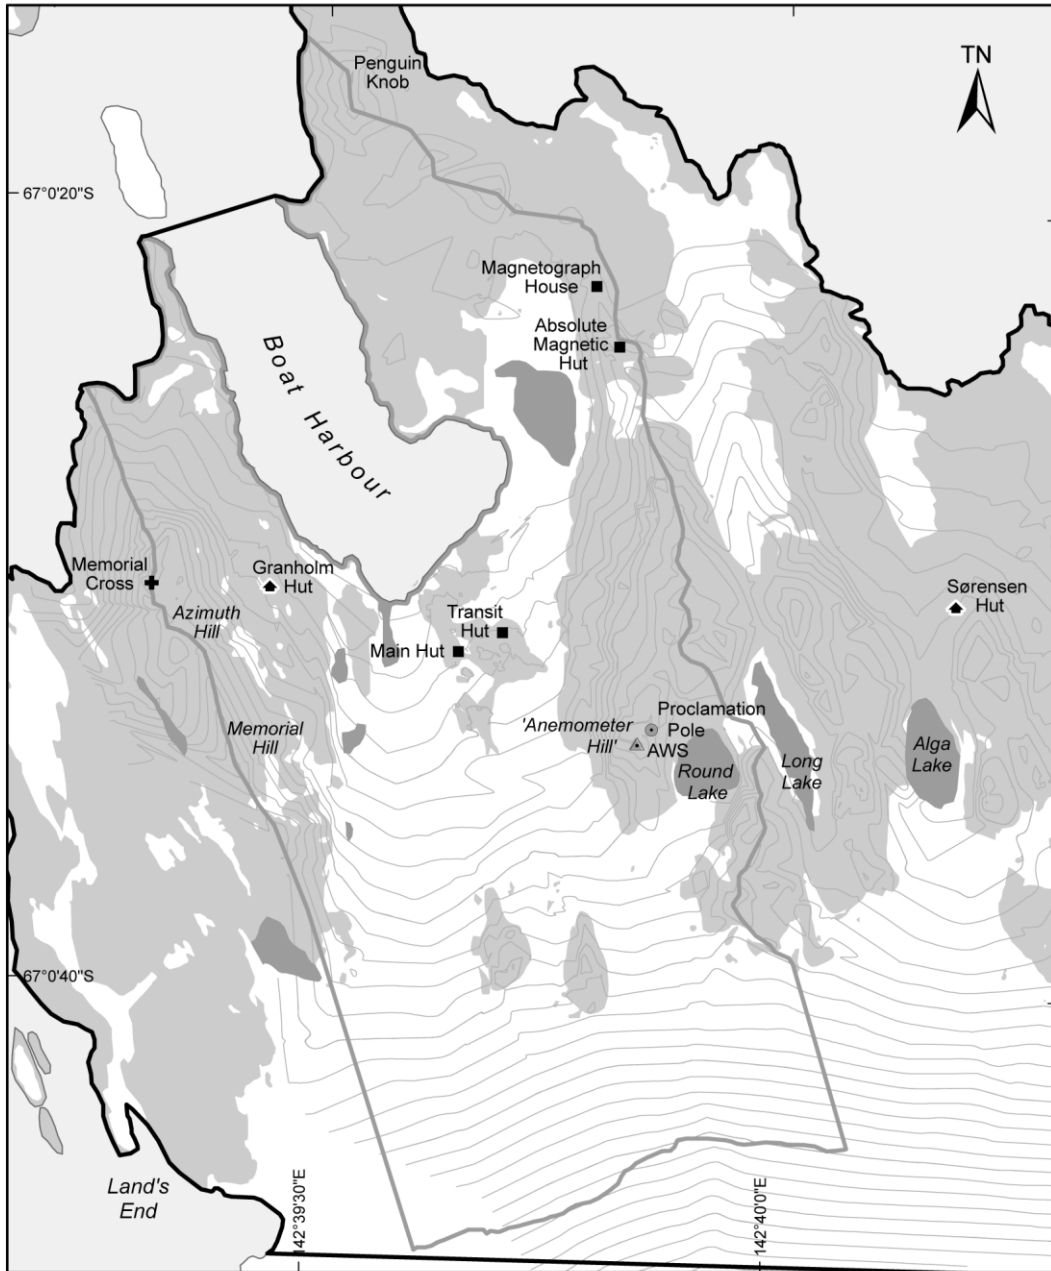
The map shows the boundaries of the Visual Protection Zone and indicates the position of significant historic artefacts, including the four Australasian Antarctic Expedition huts, the Memorial Cross, and Anemometer Hill, the site of the BANZARE Proclamation Pole.

Map B: Cape Denison Visual Protection Zone.

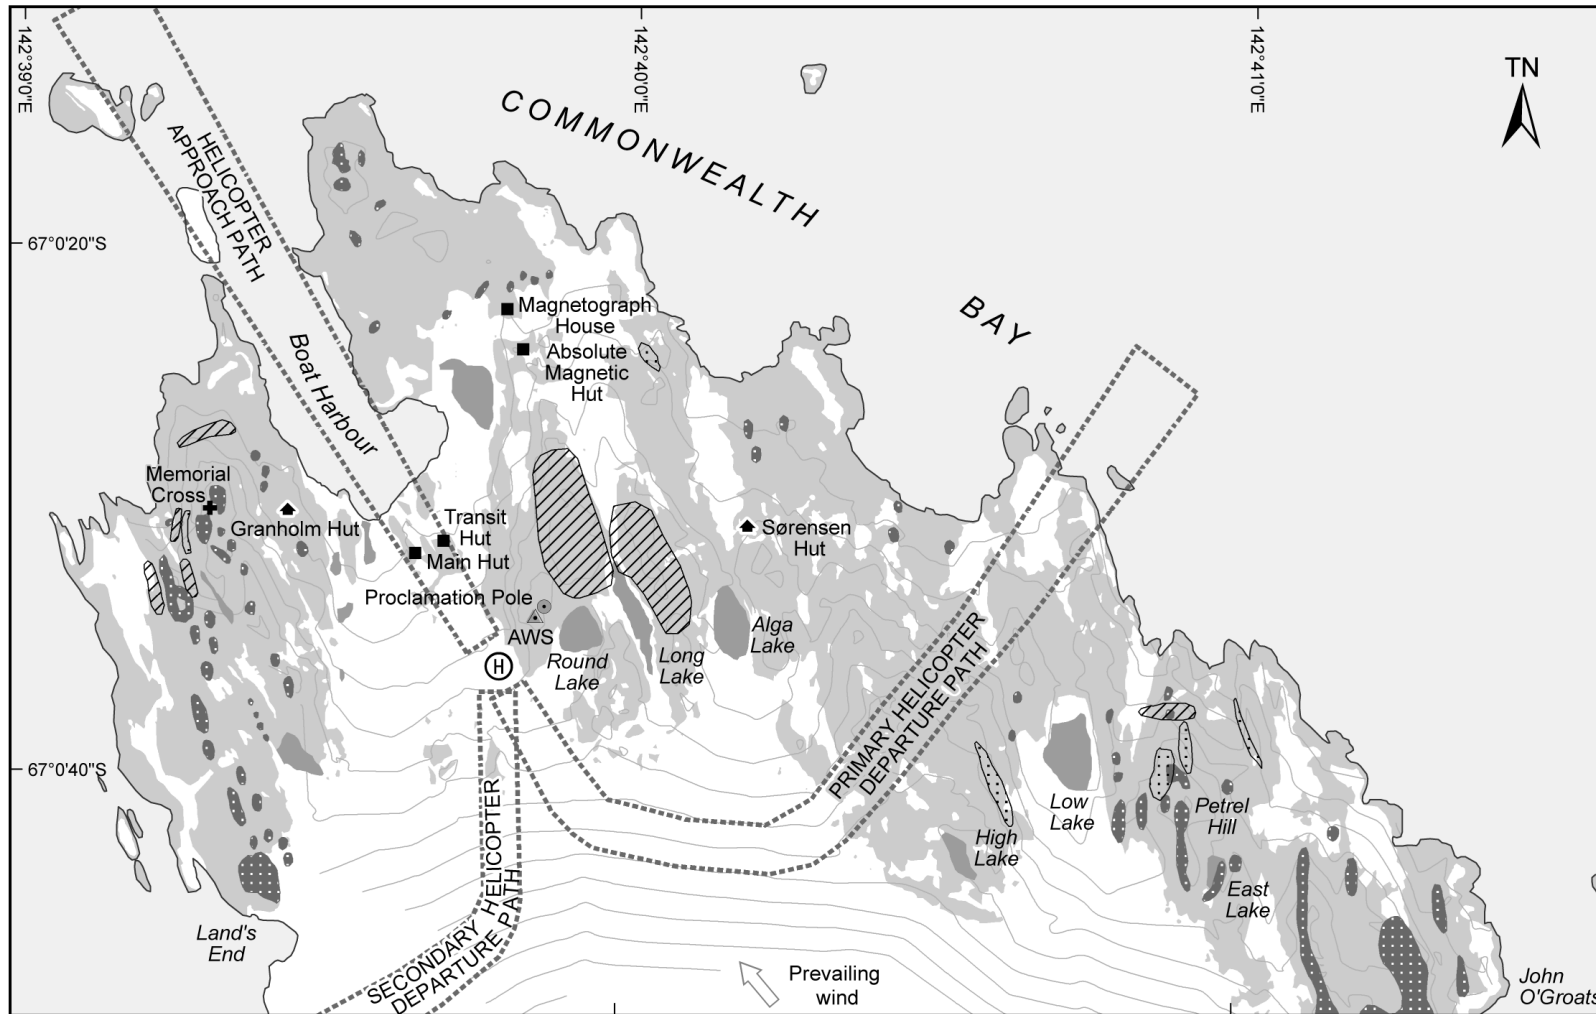
Map C Cape Denison Flight Paths and Bird Colonies

The map indicates the approaches, departures and landing site for helicopters, as well as the location of bird colonies in the vicinity.

Map C: Cape Denison Flight Paths and Bird Colonies.

Sea, land and air access to Mawson's Huts is difficult due to the rugged topography and climate of the area. Sea ice extent and uncharted bathymetry may constrain ship access up to 10nm or more from the coastline. Access can be gained either by small watercraft or by helicopter, although attempts to land are frequently hampered by heavy seas and prevailing north-westerly or katabatic winds. Boat landings can be made at Boat Harbour and due north of Sørensen Hut. The helicopter landing site (67°0'30"S, 142°39'19"E) and approach and departure flight paths are indicated on Map

C.
