### Damage due to the Great East Japan Earthquake

Fukushima Daiichi Nuclear Power Station (NPS) Accident

## **Accident at the Nuclear Power Station**

# Factors of the Accident: (Estimated) Influence of the Earthquake and Tsunami

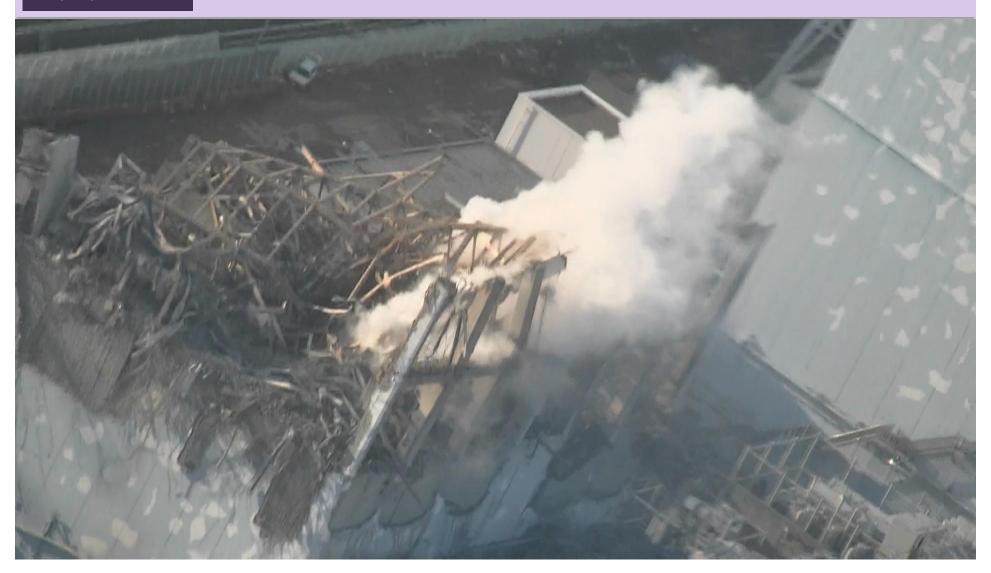
Tokyo Electric Power Company (TEPCO)'s Fukushima Daiichi NPS Unit 3 (shot from the air)

(Shot on March 16, 2011; Provided by TEPCO)

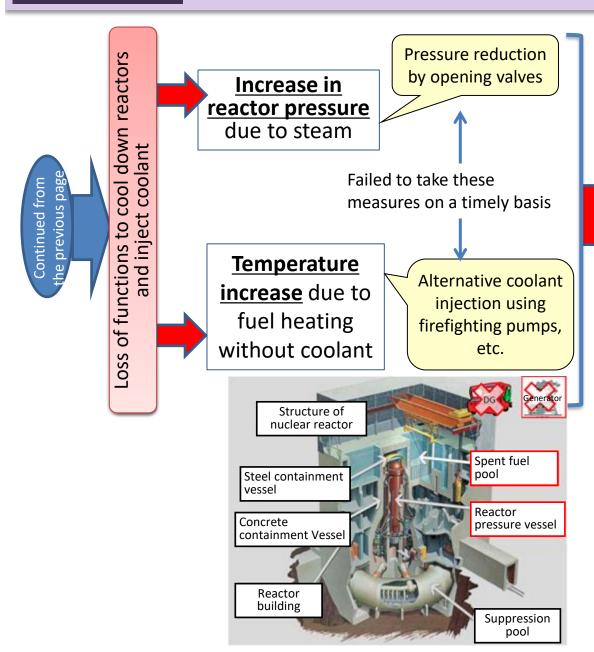
## Factors of the Accident: (Estimated) Status within the Reactor

#### **Events that occurred**

- Generation of hydrogen due to waterzirconium reaction
  - → Hydrogen explosion
- **≻**Overheat of core fuel
  - →Core melt
- Deterioration of air tightness at the pressure vessel penetrator
  - →Part of the melted fuel flowed down from the pressure vessel to the containment vessel.
- Deterioration of the containment vessel
  - →Outflow of high-level radioactivecontaminated water
  - → Discharge of radioactive materials into the air

### Almost avoided

- **♦** Steam explosion
- Recriticality
- ◆ Fuel damage due to evaporation of coolant in the spent fuel pool
