Workshop 2010 of the Asian Network for Prevention  
of Illegal Transboundary Movement of HW  
Siem Reap, Cambodia, 30<sup>th</sup> Nov. – 2<sup>nd</sup> Dec.

# **Lesson learned of taking back the illegal dumping HW in Cambodia**

By: SINA Chea  
Pollution Control Department  
Ministry of Environment

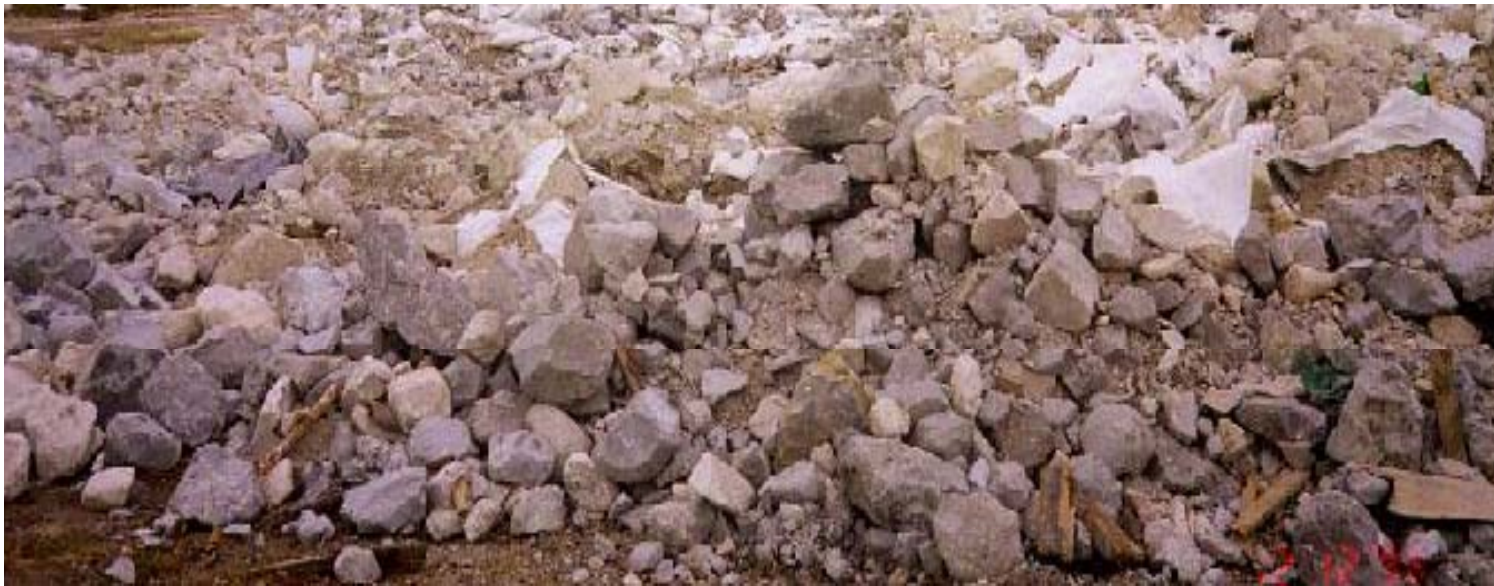
- Hg waste was solidified by  $\text{Na}_2\text{S}$  &  $\text{CaCl}_2$  to transform Hg into stable and insoluble  $\text{HgS}$  which was mixed with white cement to become a cement block

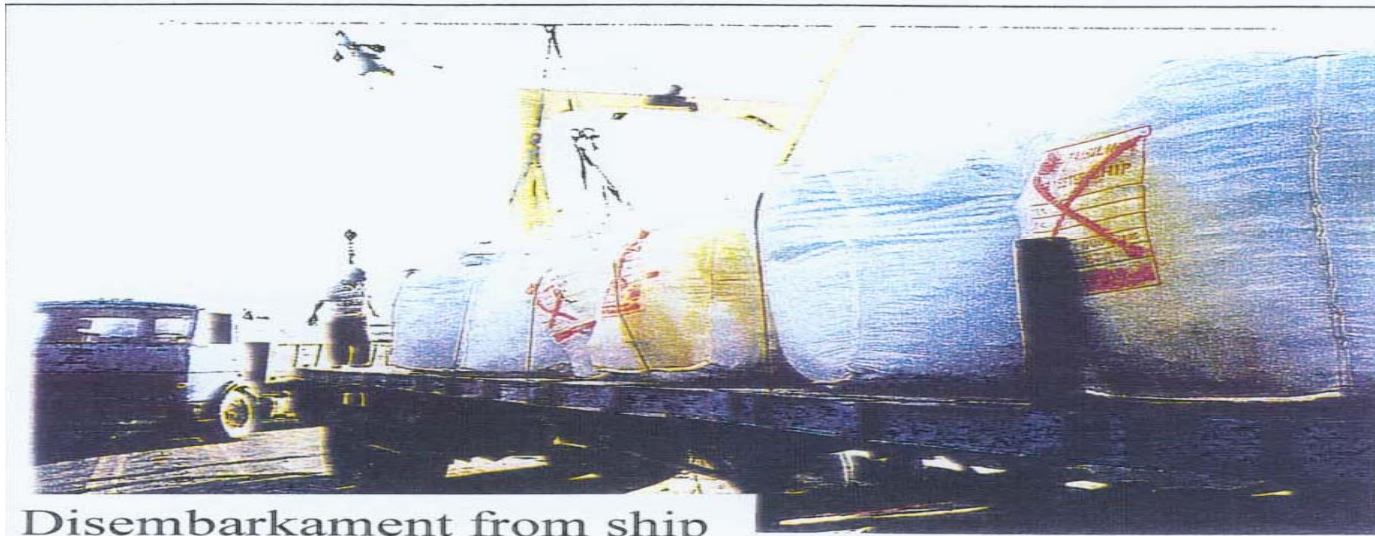
# Unloading Hg Waste at Sihanoukville Port

Disembarkament from ship

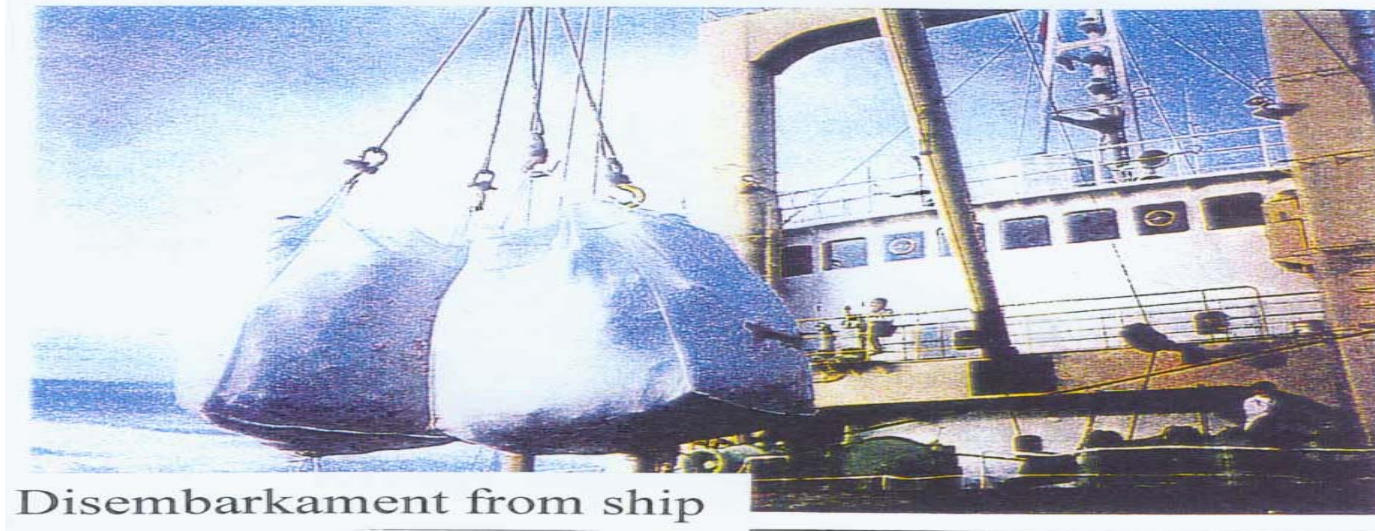
Disembarkament from ship

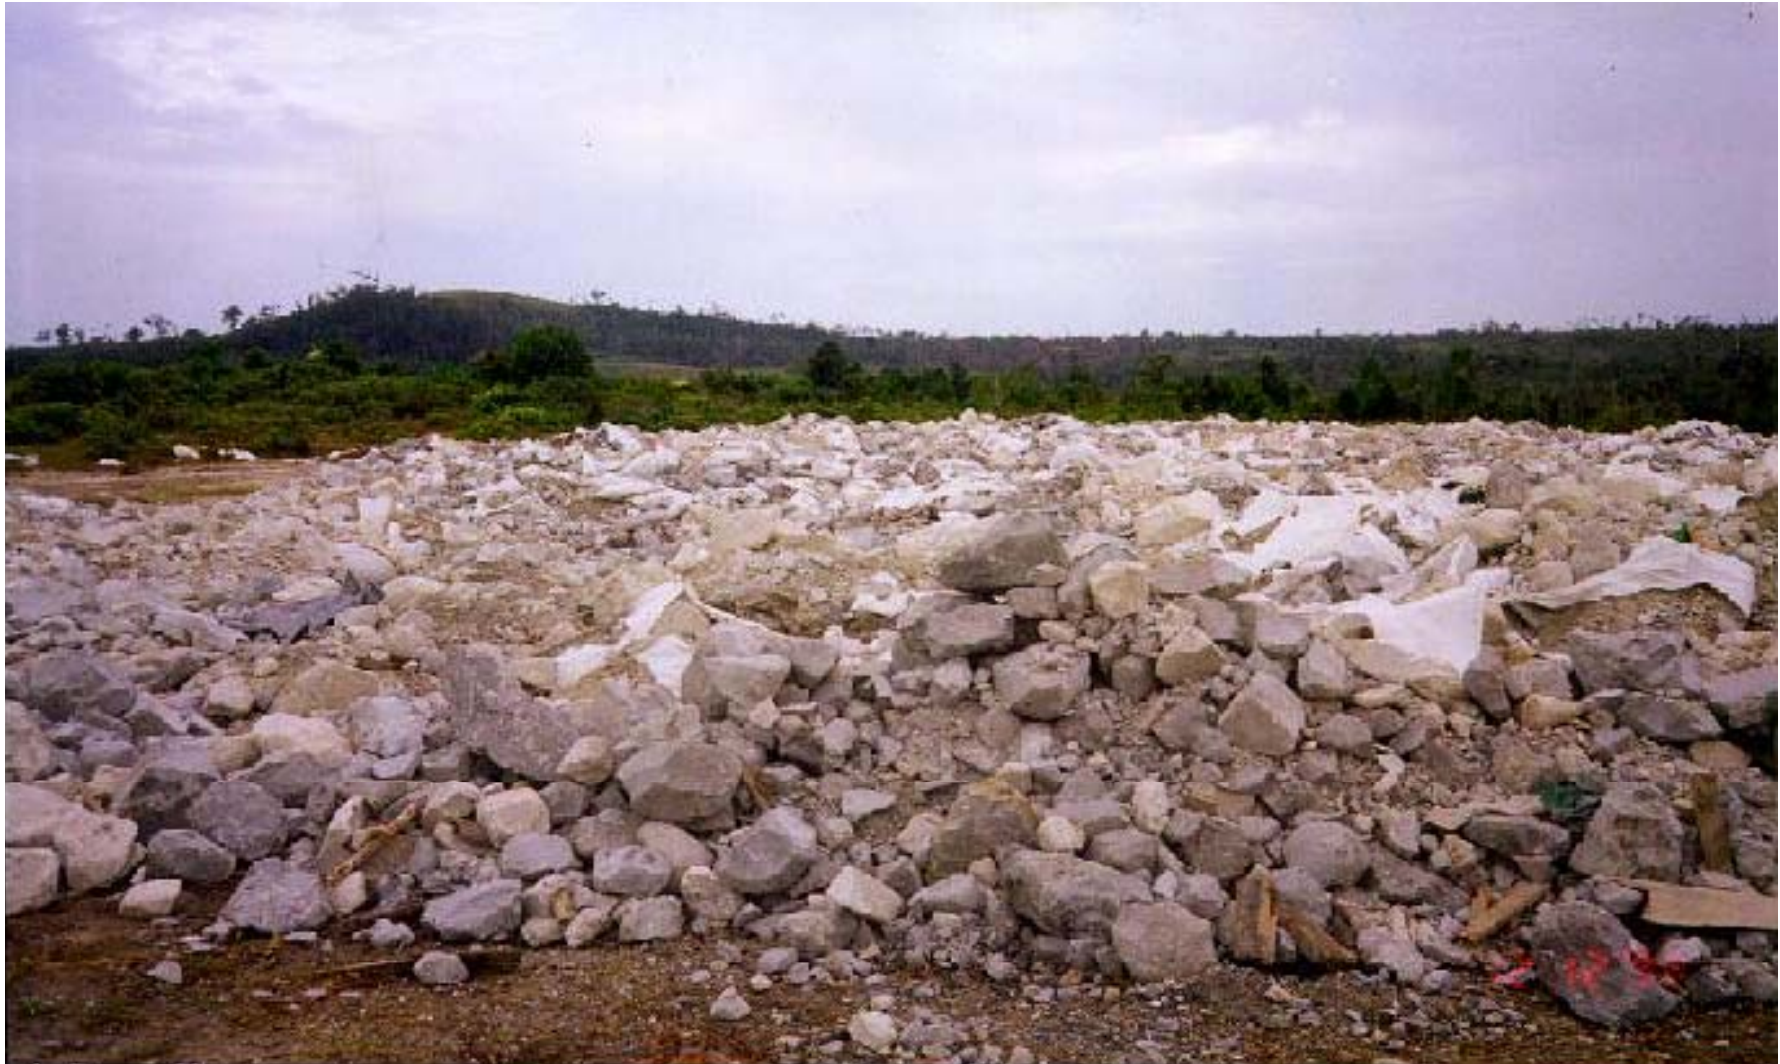
# Hg Waste Dumping at Open Site

- November 28<sup>th</sup>, 1998, 2,799 MT of Hg waste under the fake name, cement cakes, was shipped into Cambodian International Port at Sihanoukville
- Imported products, Hg waste, was packed in plastic bag
- December 4<sup>th</sup>, imported products was unloaded and transported to dump at an open site (10,000 m<sup>2</sup>), about 5 Km far from the central
