Disaster Mitigation Functions of Coral Reef around an Island

Eizo NAKAZA
University of the Ryukyus

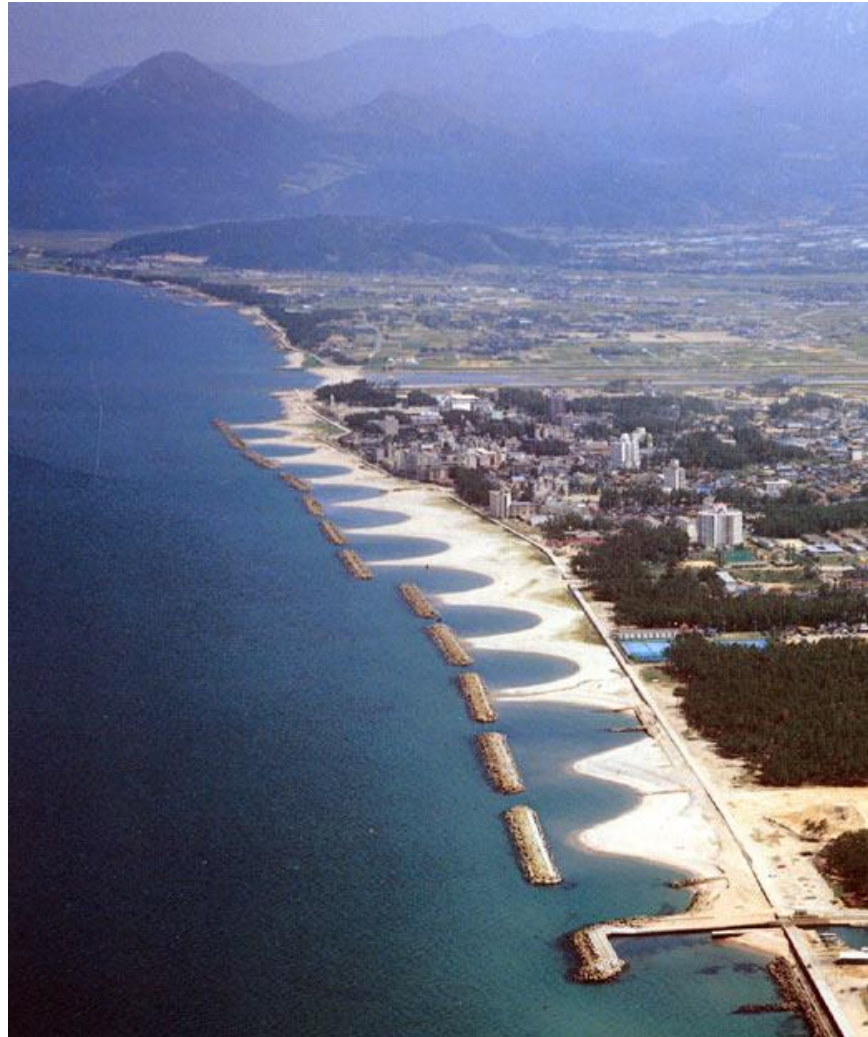
We think this is an example of the successes of coastal protection work in Japan

りがんてい
離岸堤による侵食対策
(トンボロの形成, 皆生海岸)

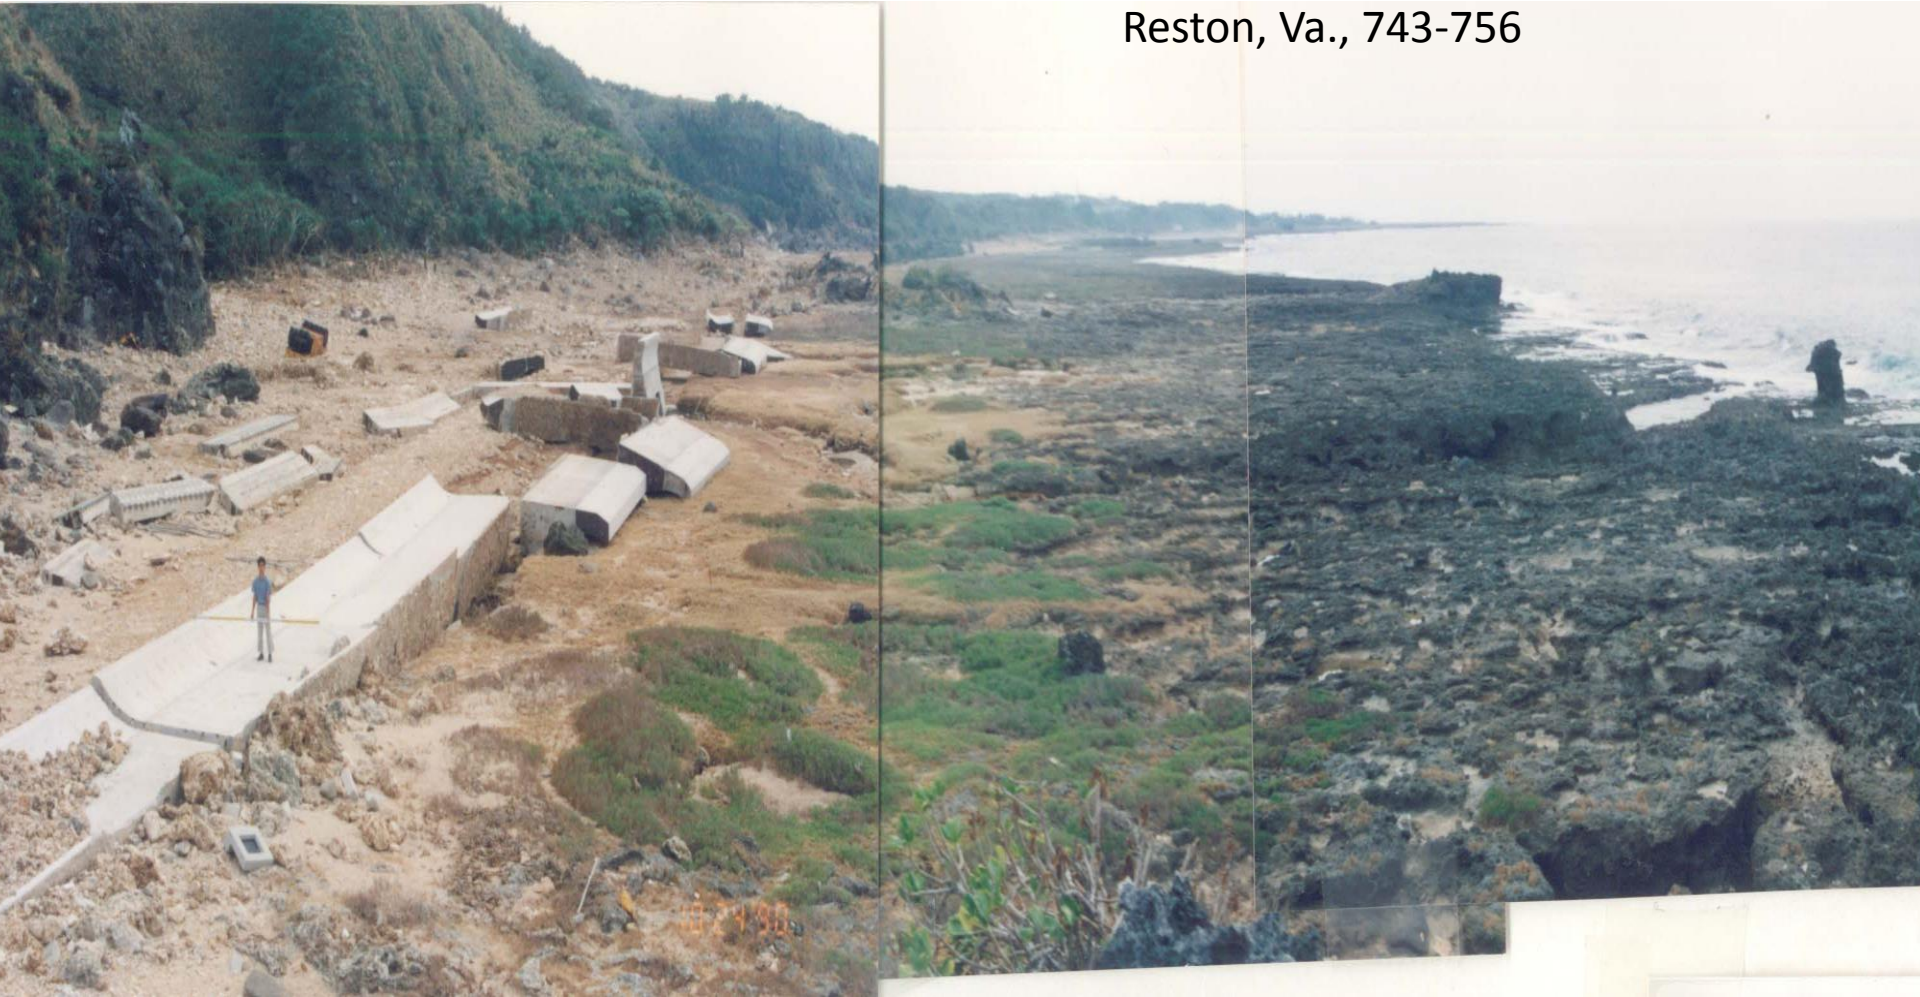
**Damage caused by typhoon waves on
a typical coral reef coast.**

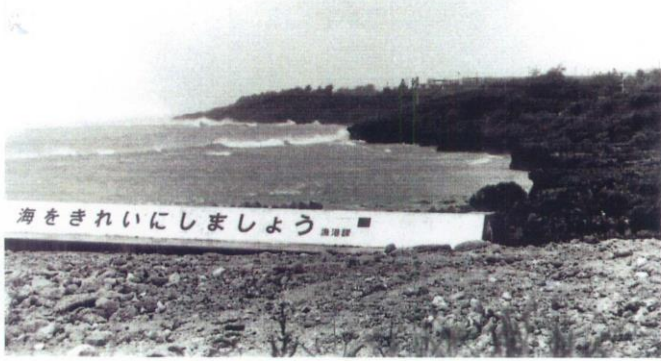
Tsunami-like Surf Beat Wave Caused by Typhoon No.24, Minatogawa Coast, 1988

Characteristic wave
phenomena, surf beat waves
were discovered by
E. Nakaza in 1986.

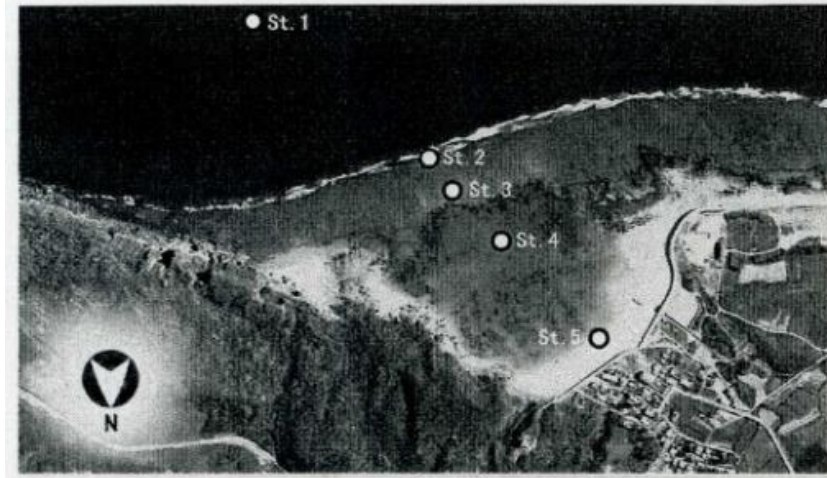
Hikawa Coast at Yonaguni Island of Okinawa, Japan

Locations of the wave detection sensors, St.1-5.

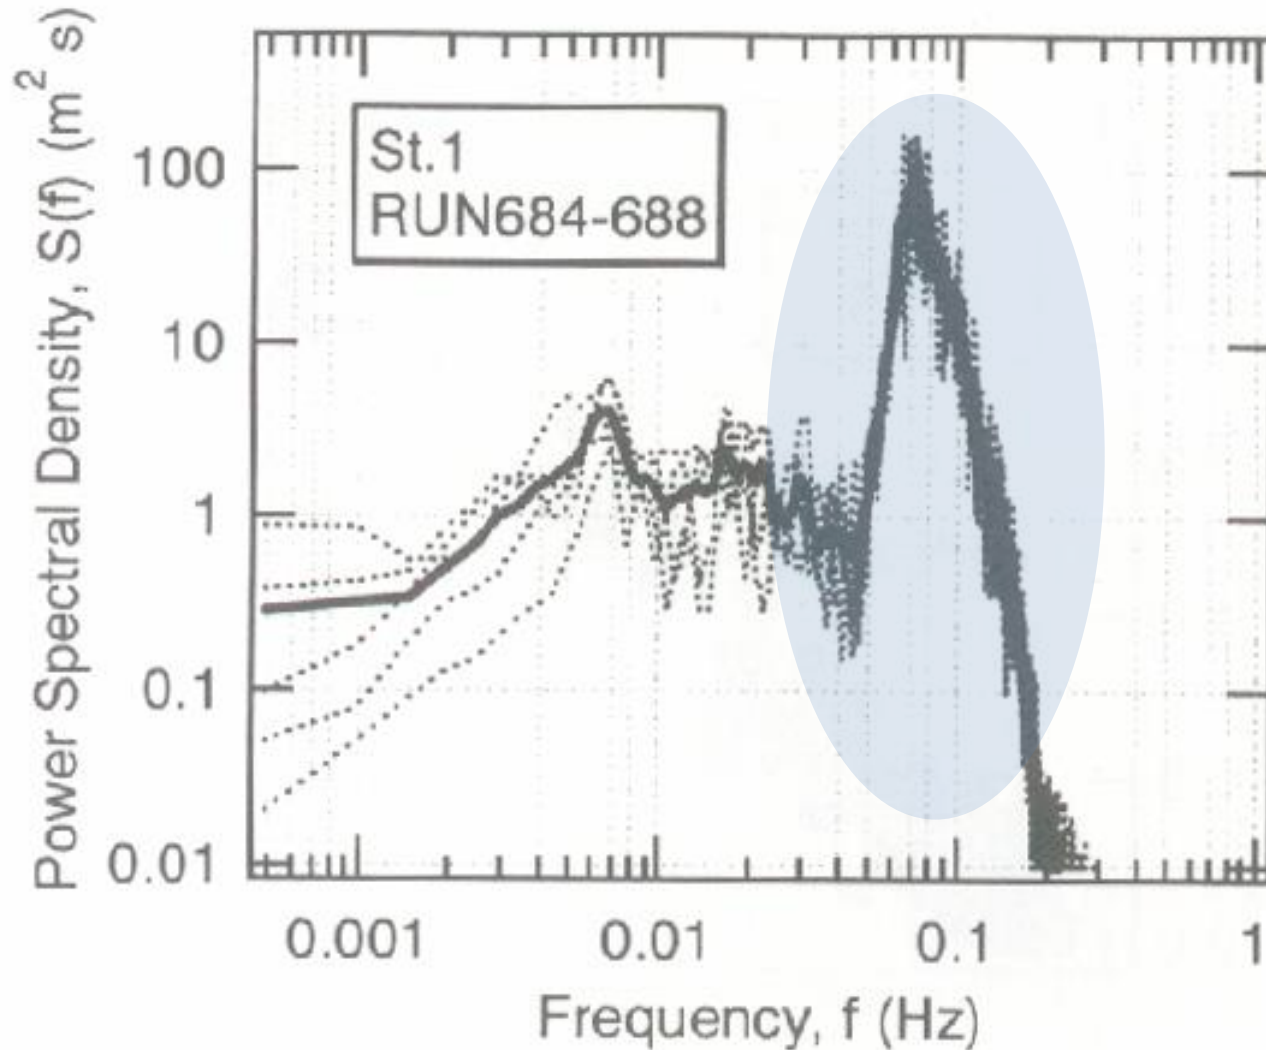
Energy strength of offshore waves

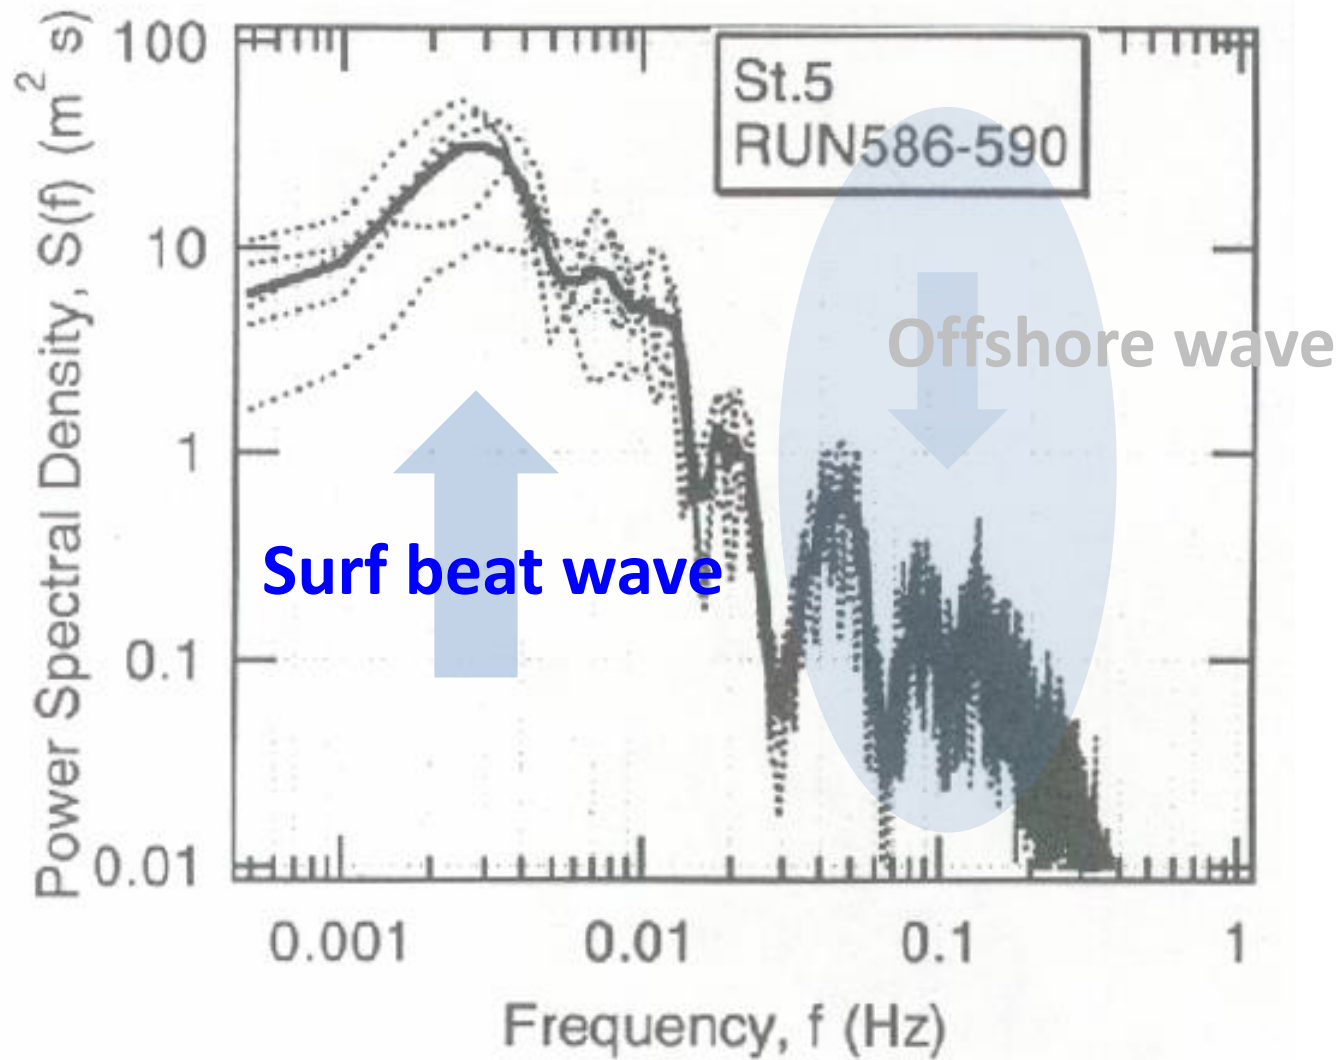
Energy strength of waves on reef flat

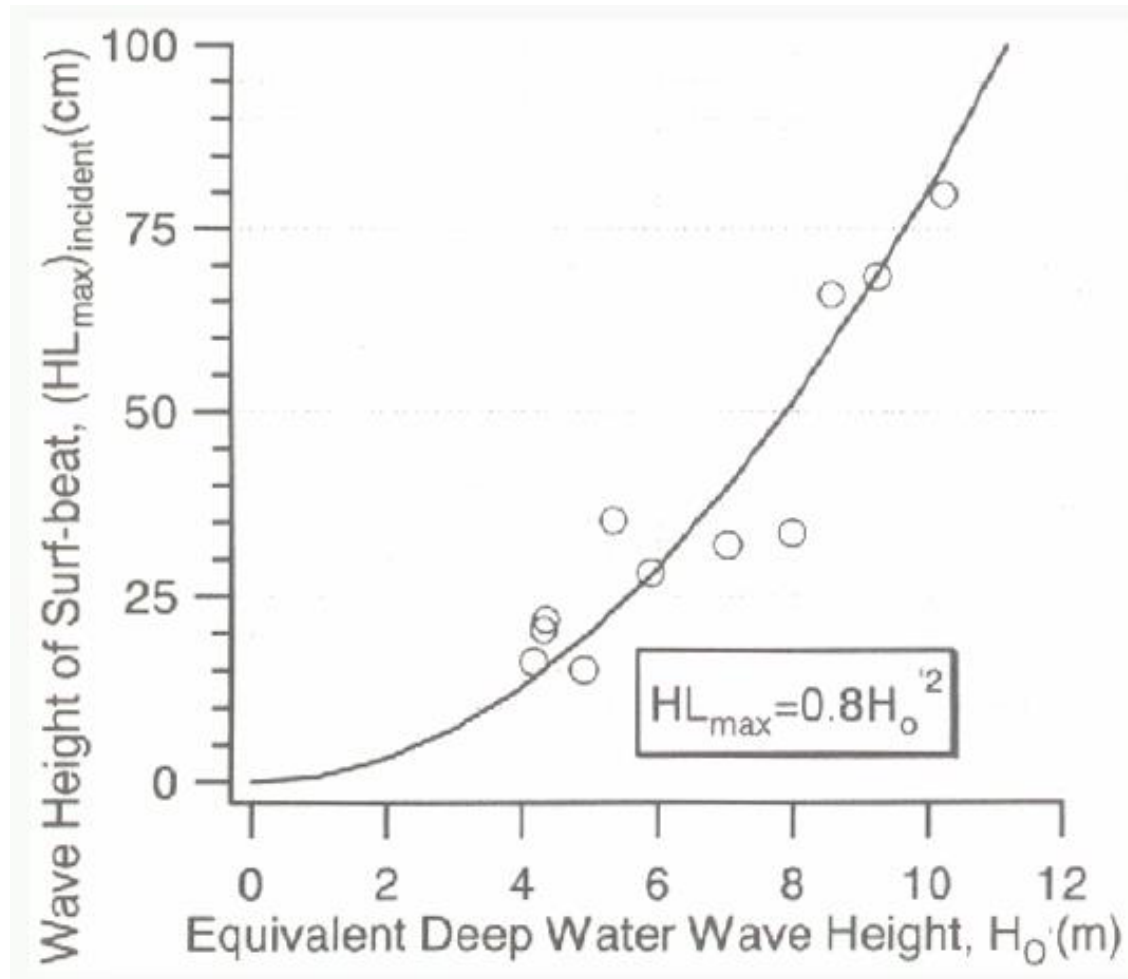
Relationship between Surf Beat wave height and incident wave height

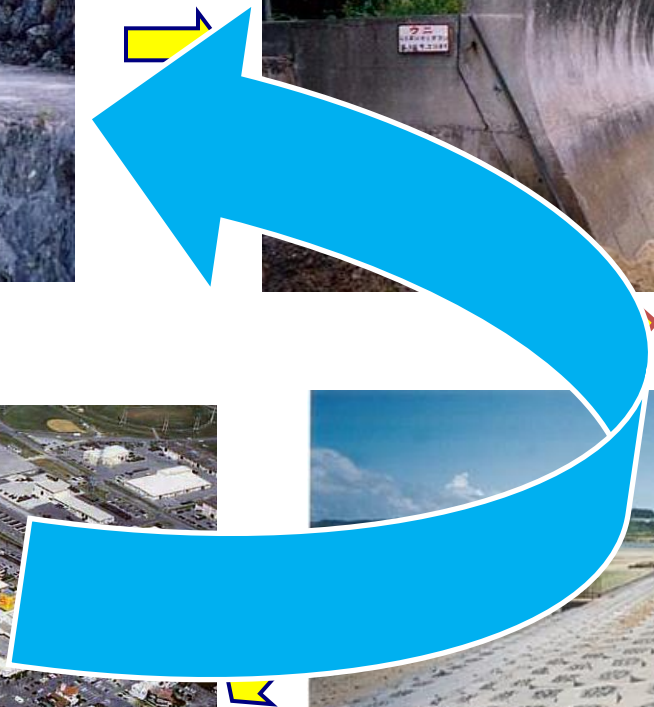
*Huge tsunami boulders, Higashi-Henna Cape,
Miyako-Jima City, Okinawa, Japan*

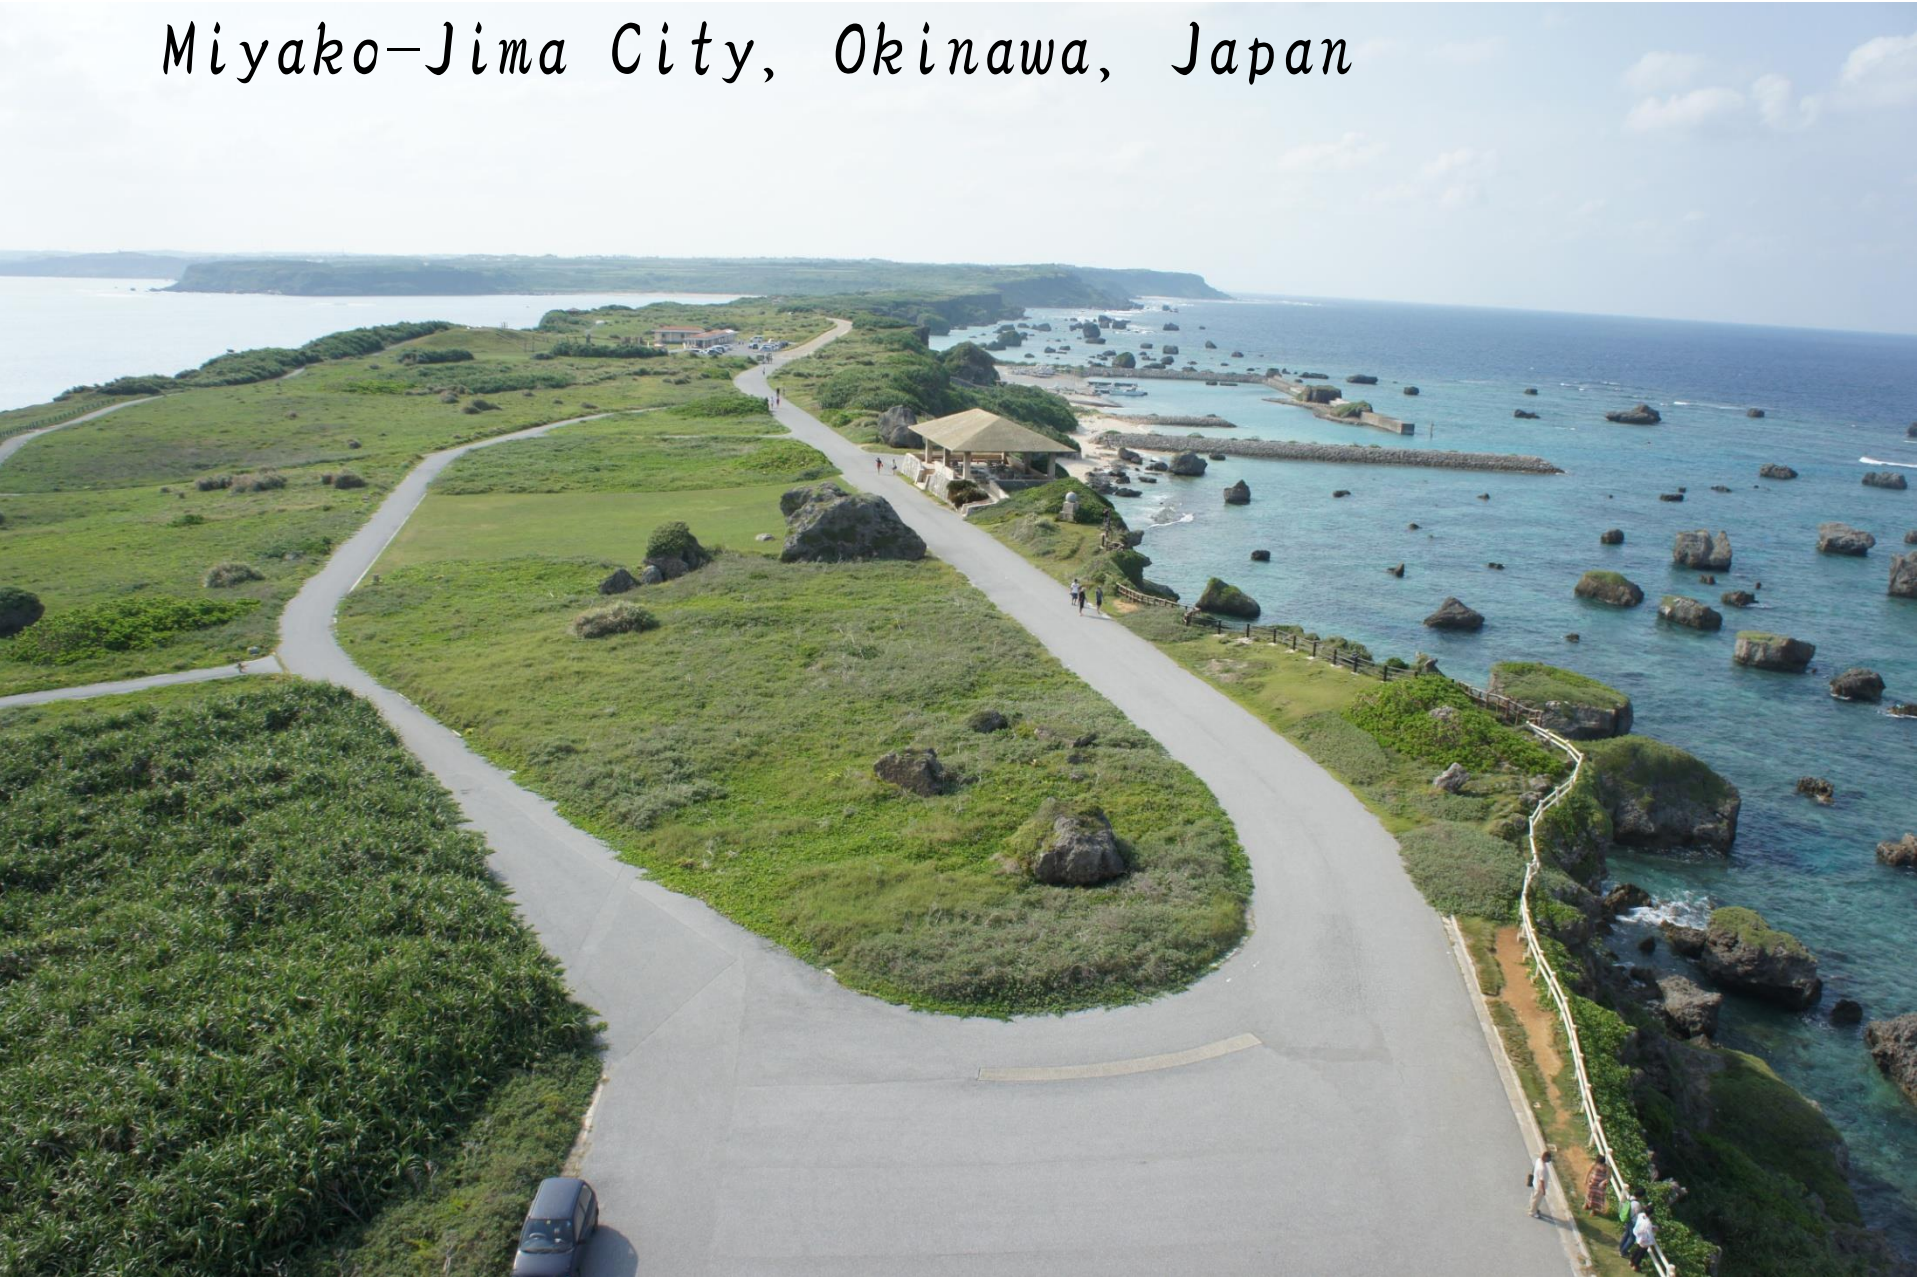
表島間珊瑚礁分布図

The coral surrounding the Islands have been acting as a natural breakwater against tsunami.
