# 英国Brixhamにおける水道水を原因とした クリプトスポリジウム集団感染事故と対応の概要

国立保健医療科学院 生活環境研究部

# クリプトスポリジウム集団感染事故の概要

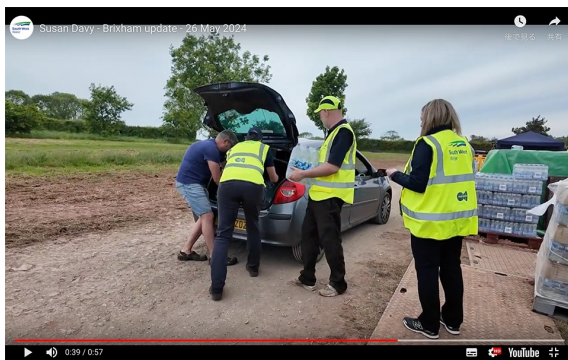
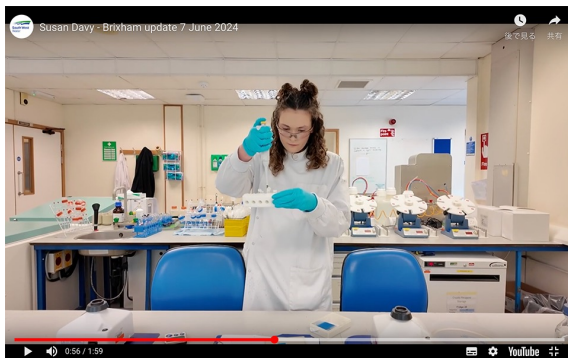
## 汚染された給水区域での対応・対策

- ボトル水の配布
- 採水とクリプトスポリジウム検査
- 34 kmに渡る配水管をフラッシングにより27回洗浄
- 送水管と配水管をアイスピグやスワブで洗浄（17フェーズ）
- UV照射装置とMF膜処理を配水管網に設置（家庭に給水されるまでに2～3回処理）
- 1.2 kmの新しい管を敷設

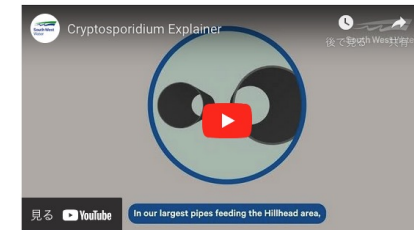
A video to explain the process followed to remove Cryptosporidium - 5 June 2024

フラッシングやアイス  
ピグによる洗浄をア  
ニメーションで解説

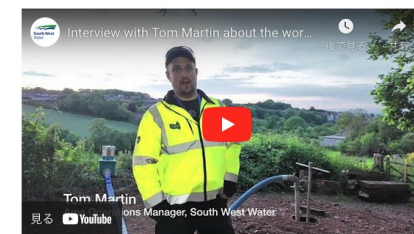
Interview with Tom Martin about the works carried out at Hillhead reservoir - 4 June 2024

フラッシングによる洗  
浄作業を紹介

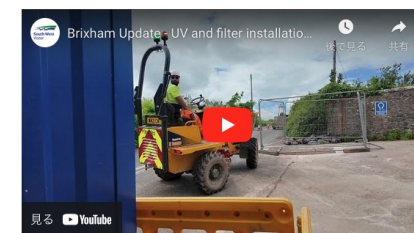
Brixham Update - UV and filter installation in Hillhead - 2 June 2024

可搬型UV照射装置や  
膜処理装置を紹介
