南東90m周辺地質断面図

南東90m汚染状況図

南東90m掘削部土壤汚染状況図

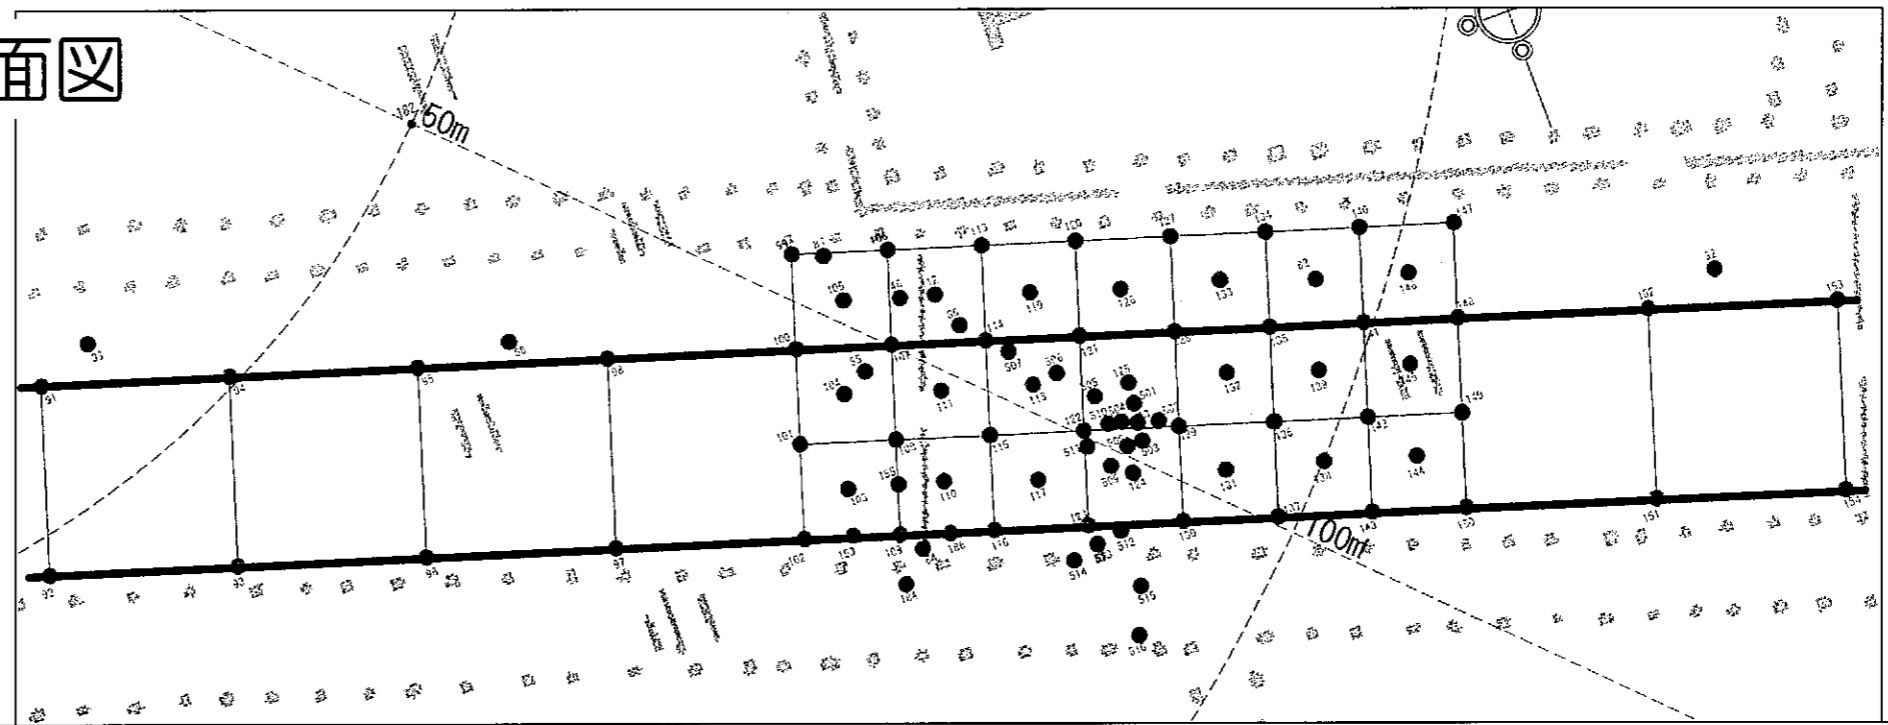
A南東90m (91~153ライン) (S=1:400)

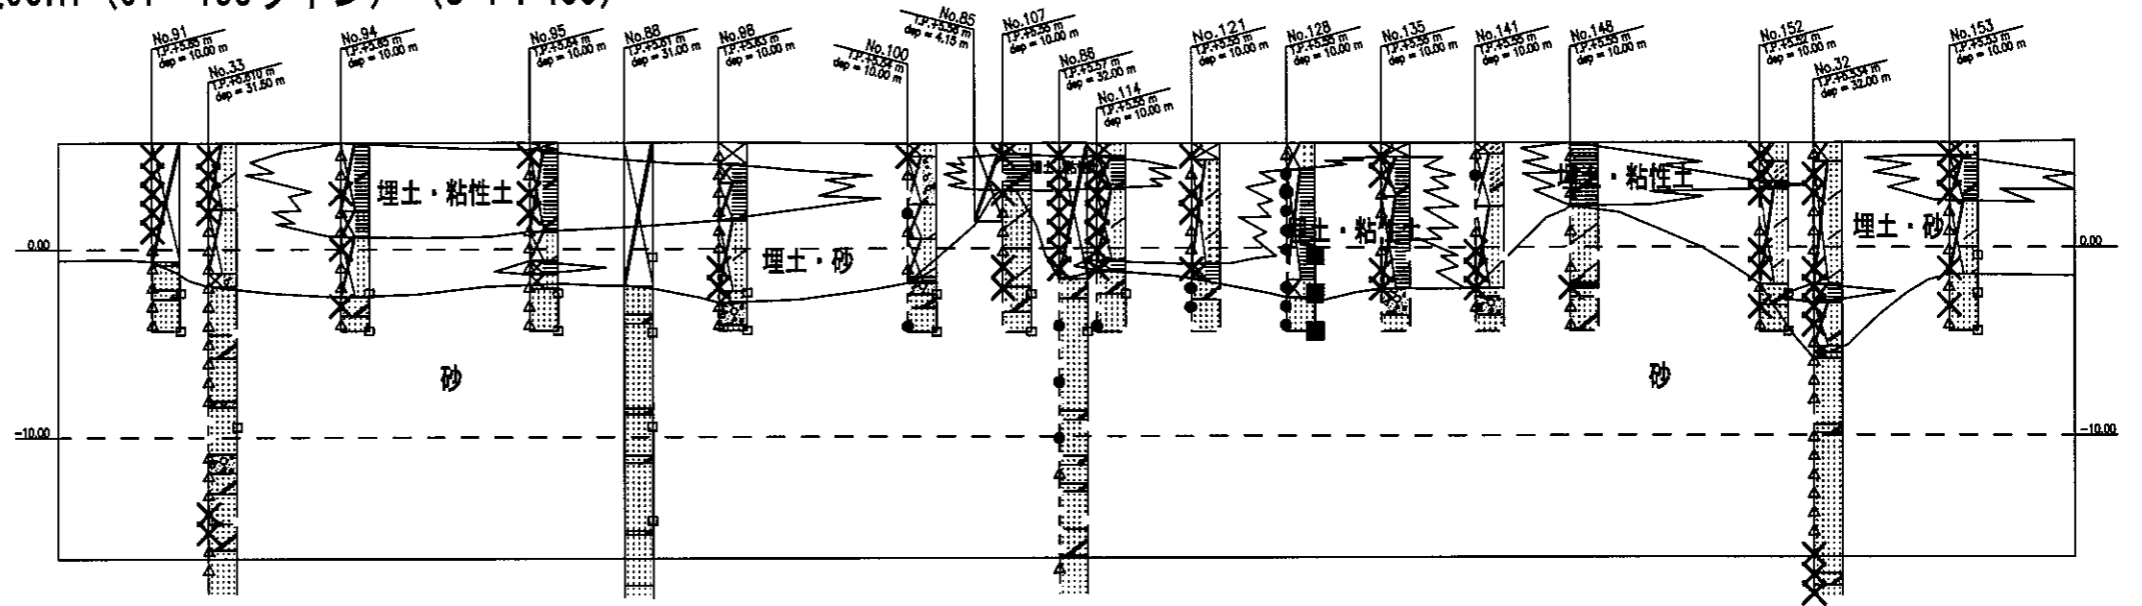
A南東90m (92~154ライン) (S=1:400)

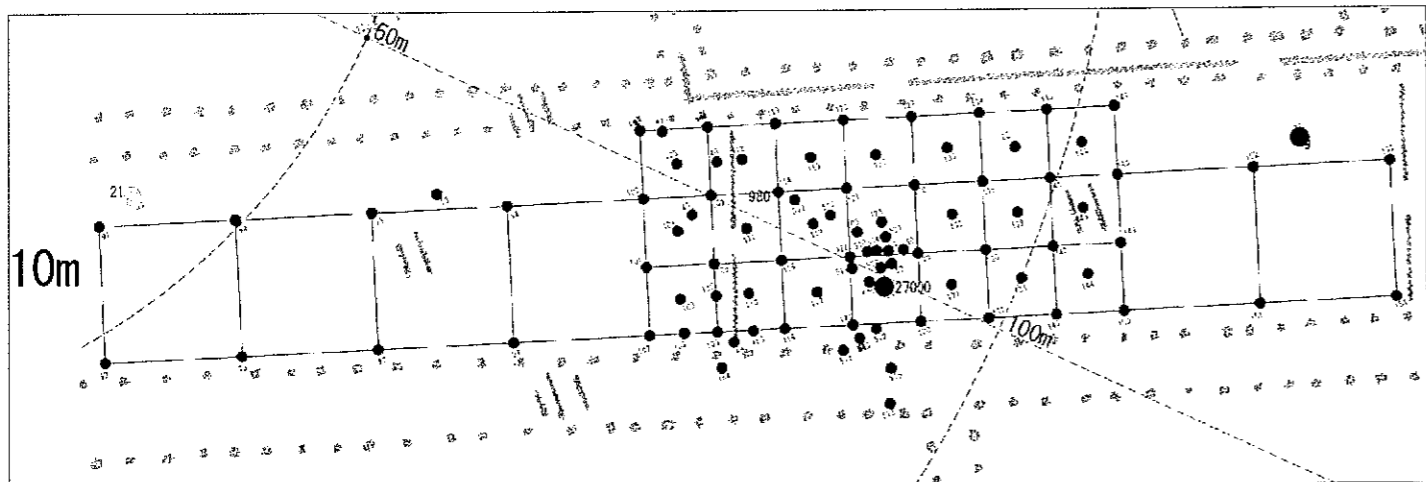
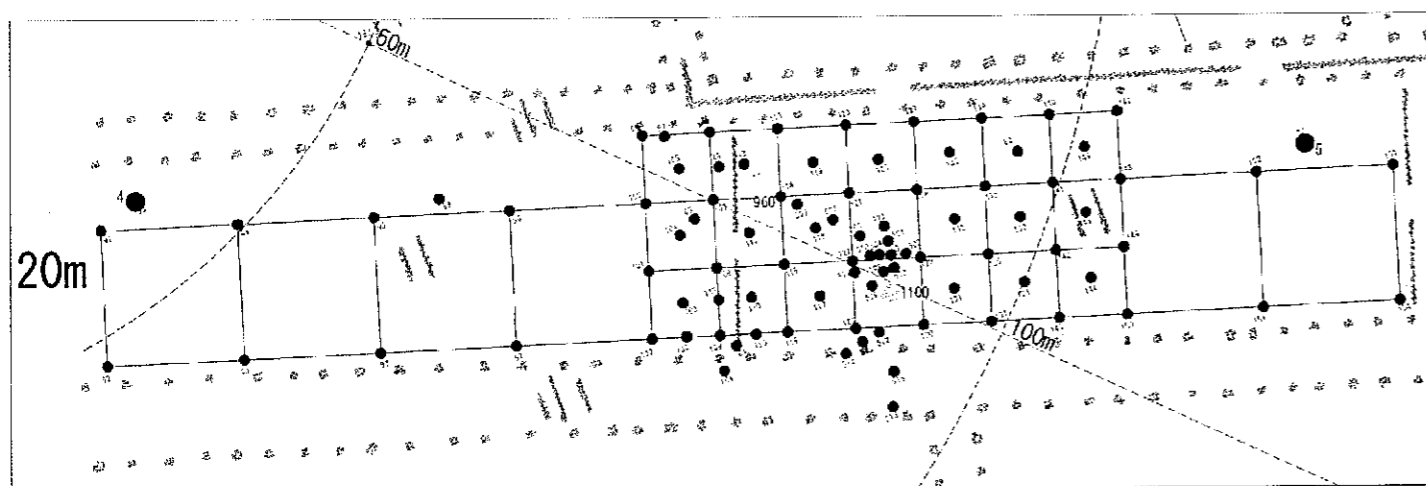
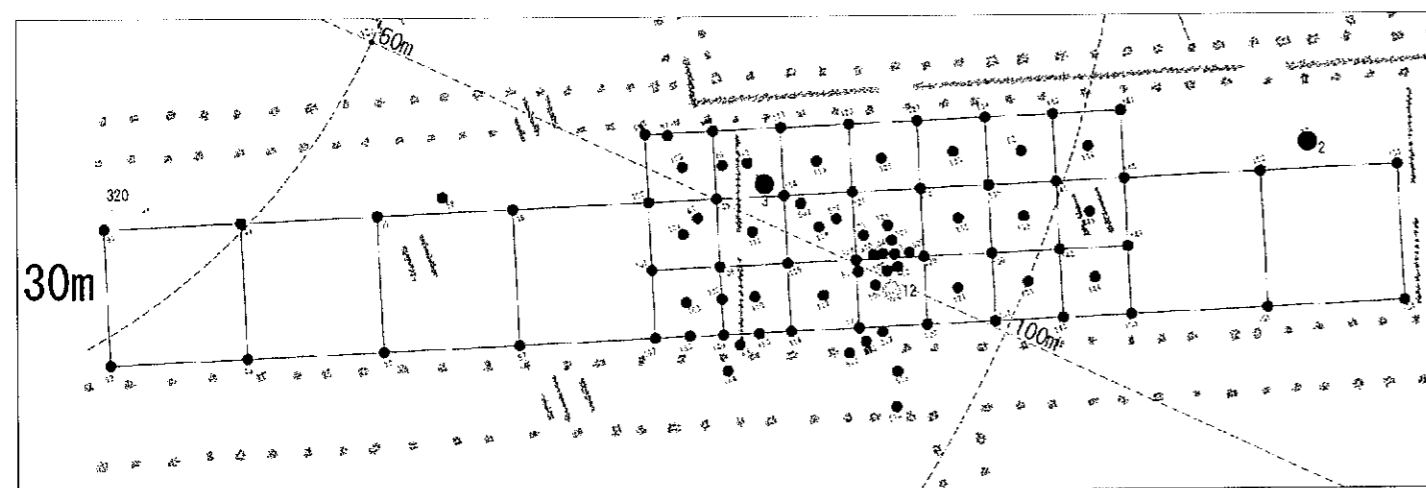
<土壌>

DPAA濃度 (ppb)	
×	不検出
●	1~
○	10~
◎	100~
⊙	1000~
⦿	10000~
⦿	100000~

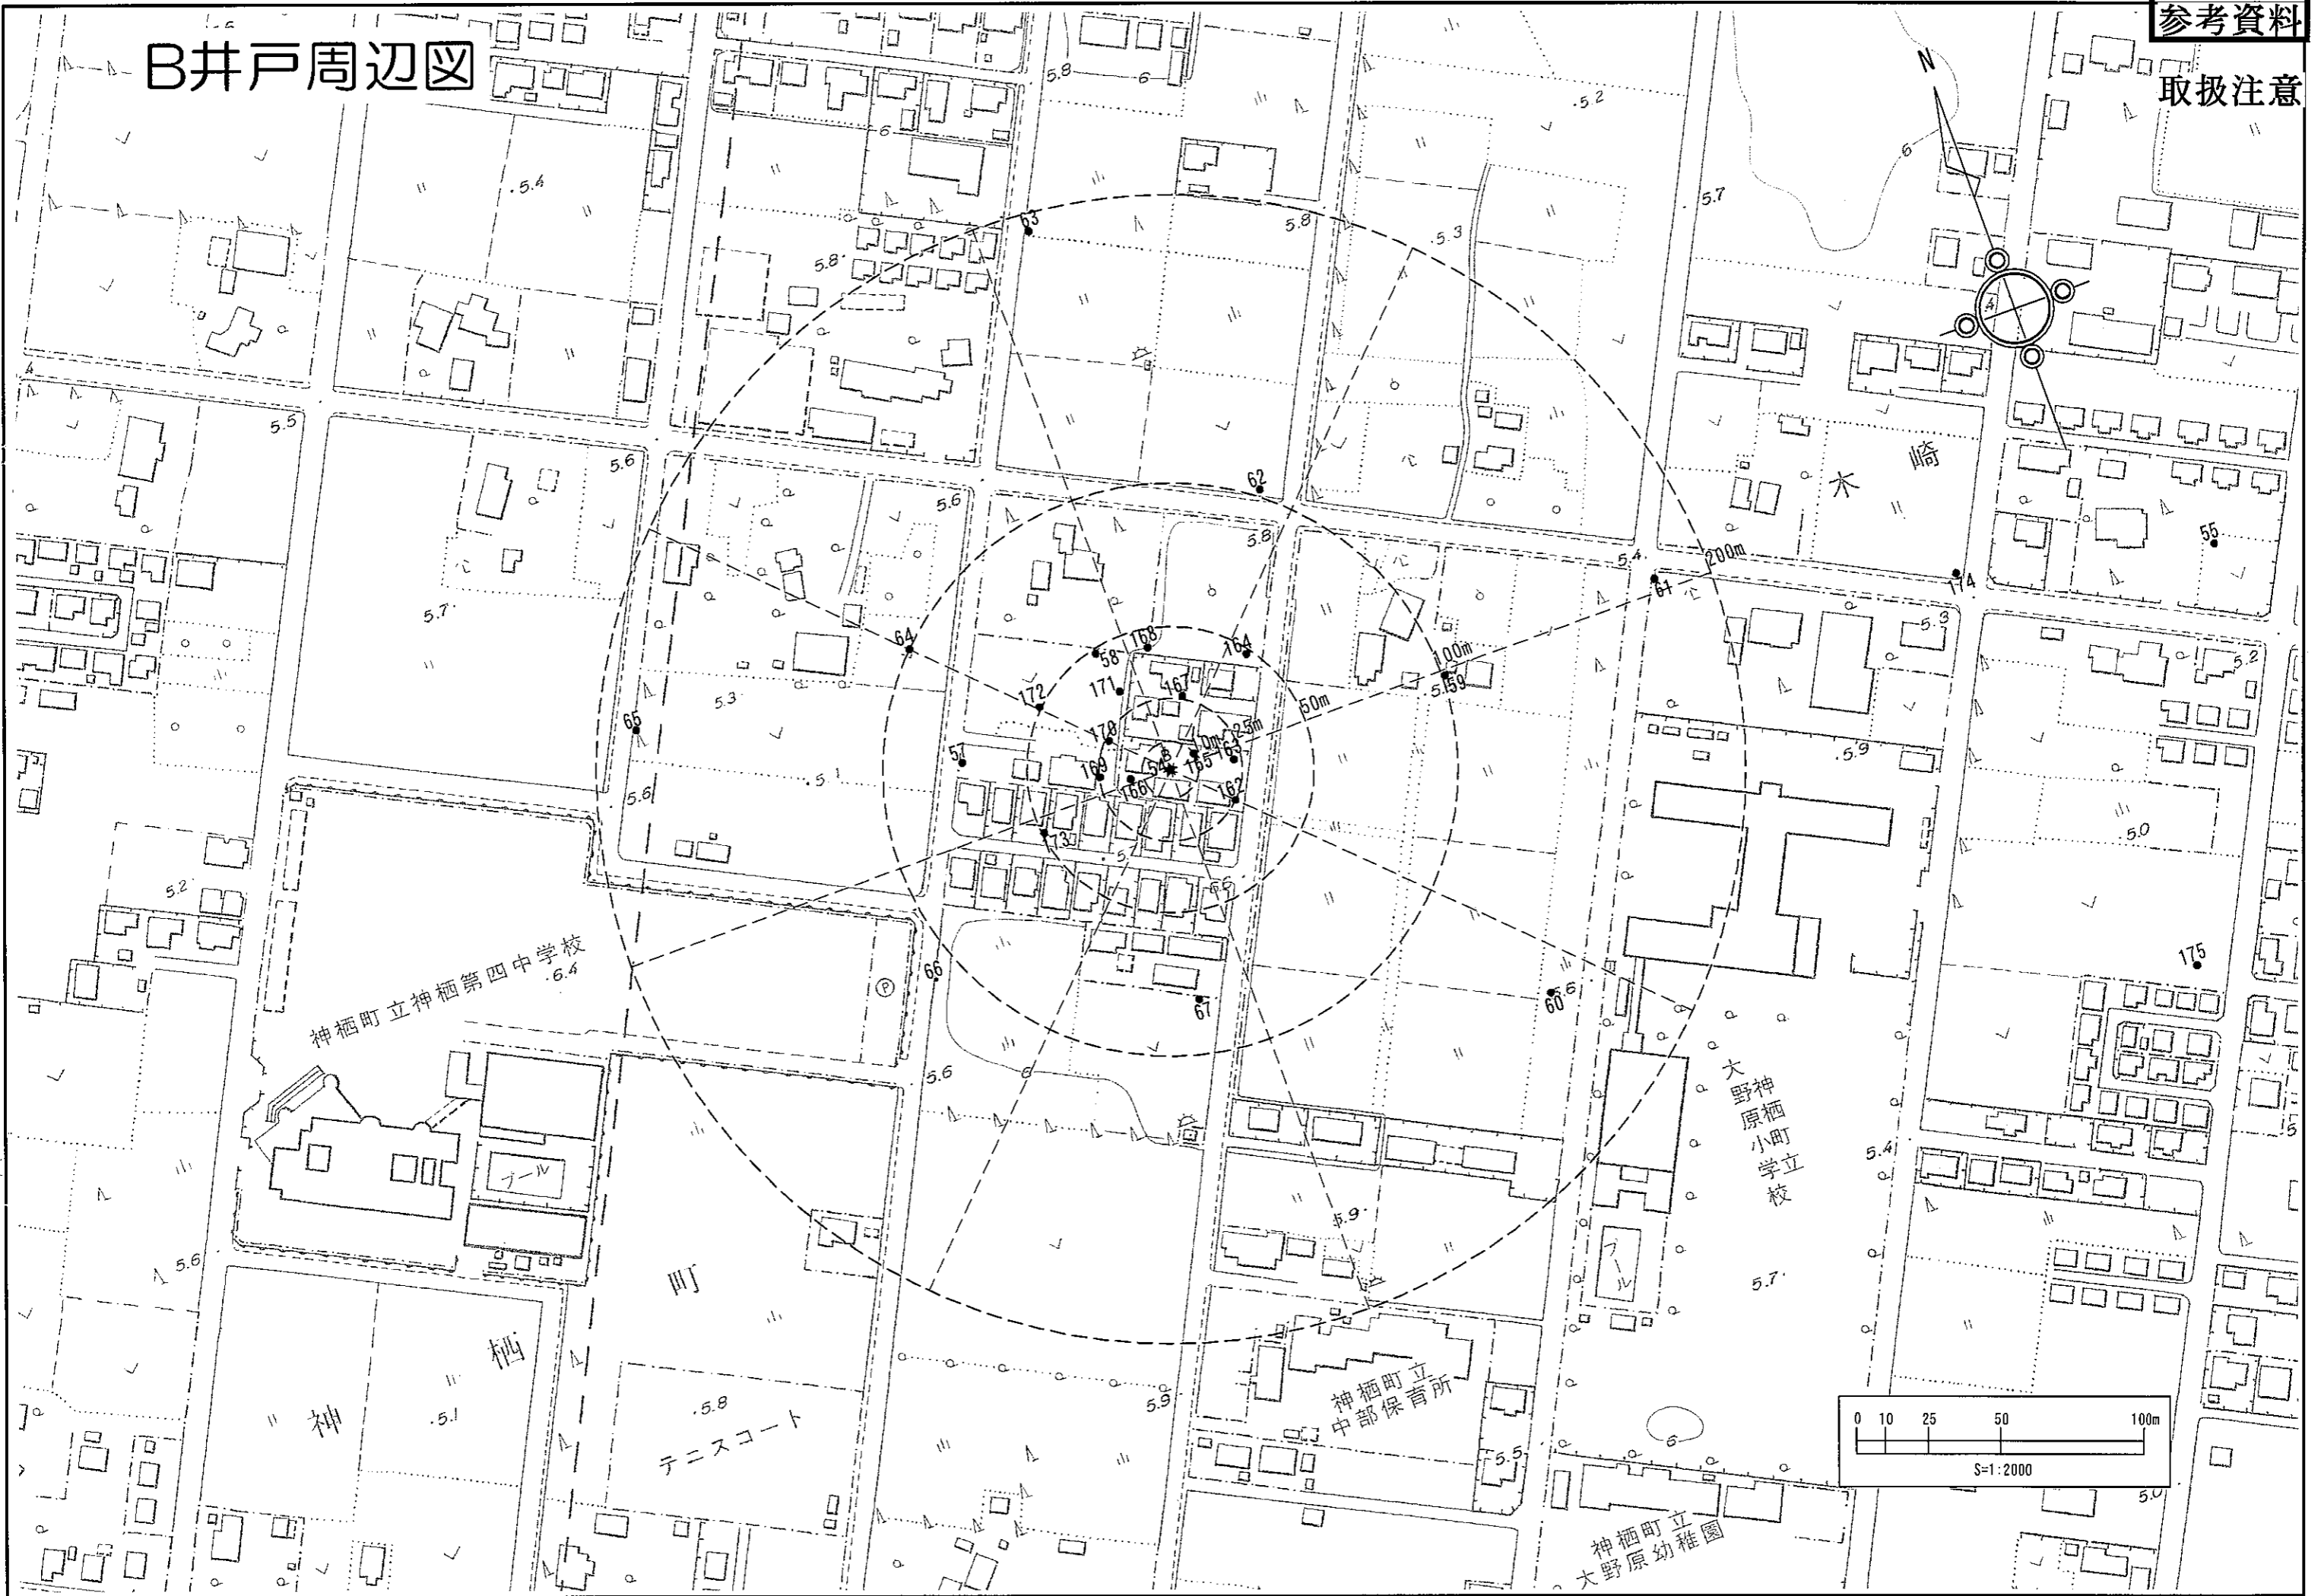
B井戸周辺図
