Fukushima Daiichi
Nuclear Power Station
(NPS) Accident

Accident at the Nuclear Power Station

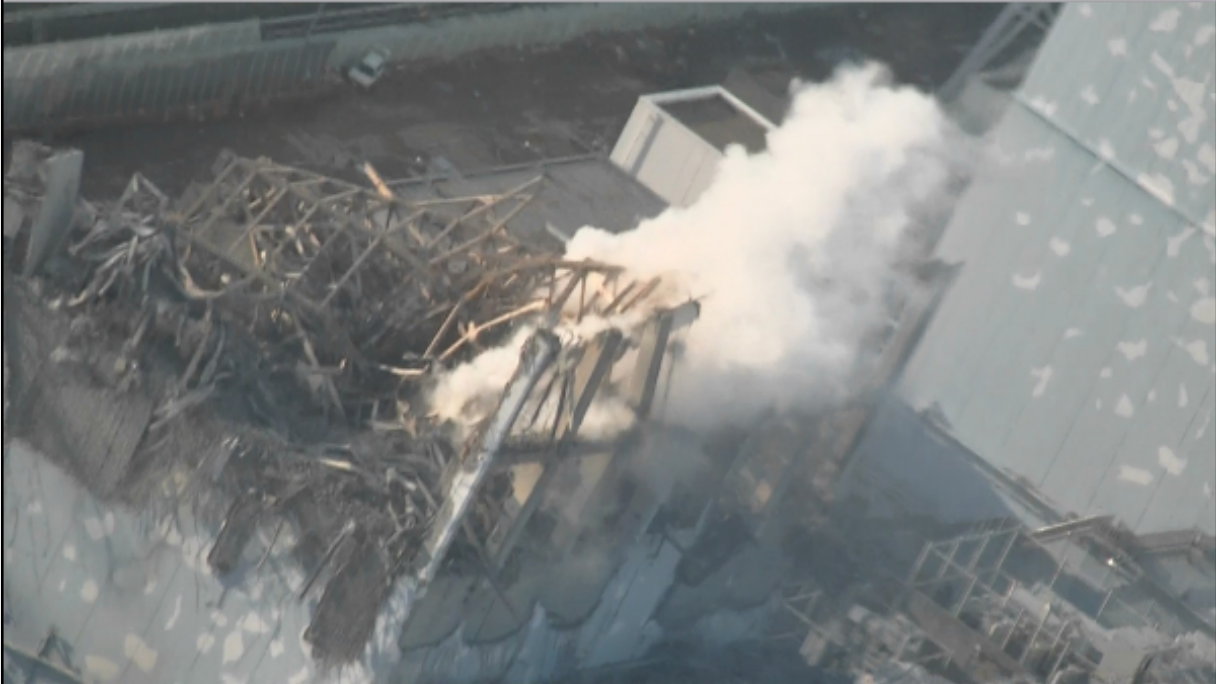
**Tokyo Electric Power Company (TEPCO)'s Fukushima Daiichi NPS
Unit 3 (shot from the air)**

(Shot on March 16, 2011; Provided by TEPCO)

Tokyo Electric Power Company (TEPCO)'s Fukushima Daiichi NPS Unit 1, 2 and 3, which were in operation at the time of the earthquake, lost all AC power due to the earthquake and subsequent tsunami. This led to the stop of the cooling system and loss of means to cool down nuclear fuels, eventually resulting in the melt of nuclear fuel. In the process of the melt, hydrogen gas was generated, and hydrogen gas accumulated in reactor buildings caused an explosion at Unit 1 on March 12 and at Unit 3 on March 14. Additionally, at Unit 4 adjacent to Unit 3, a hydrogen explosion occurred due to hydrogen gas that is considered to have flowed into it from Unit 3.
