Included in this reference material on March 31, 2013 Updated on March 31, 2024 Fukushima Daiichi Nuclear Power Station (NPS) Accident

Accident at the Nuclear Power Station

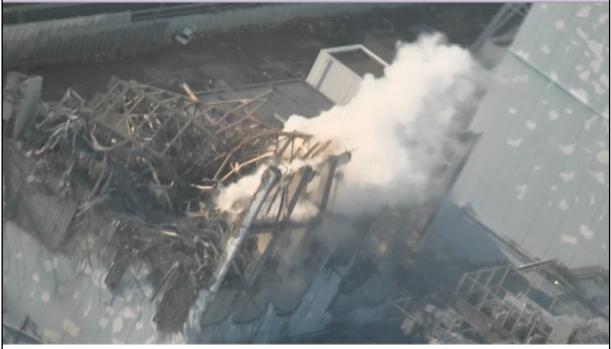
Tokyo Electric Power Company (TEPCO)'s Fukushima Daiichi NPS Unit 3 (shot from the air) (Shot on March 16, 2011; Provided by TEPCO)

Tokyo Electric Power Company (TEPCO)'s Fukushima Daiichi NPS Unit 1, 2 and 3, which were in operation at the time of the earthquake, lost all AC power due to the earthquake and subsequent tsunami. This led to the stop of the cooling system and loss of means to cool down nuclear fuels, eventually resulting in the melt of nuclear fuel. In the process of the melt, hydrogen gas was generated, and hydrogen gas accumulated in reactor buildings caused an explosion at Unit 1 on March 12 and at Unit 3 on March 14. Additionally, at Unit 4 adjacent to Unit 3, a hydrogen explosion occurred due to hydrogen gas that is considered to have flowed into it from Unit 3.

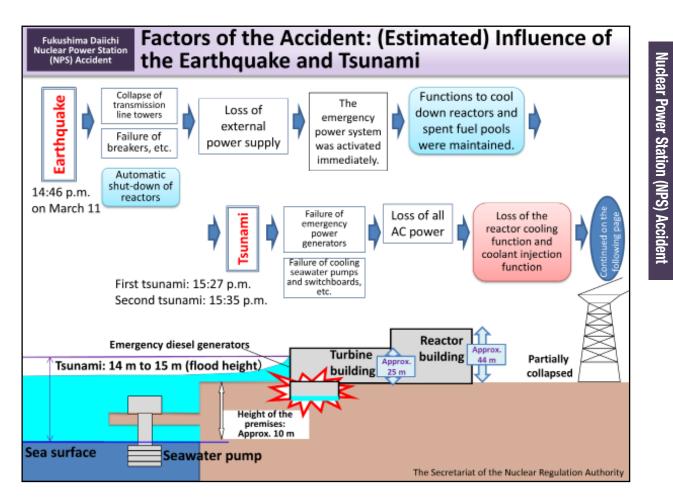
Fukushima Daiich

Immediately after the earthquake, at Units 1, 2 and 3 at Tokyo Electric Power Company (TEPCO)'s Fukushima Daiichi NPS, which were in operation, all reactors were shut down automatically.

Even after reactors are shut down, it is necessary to remove the decay heat of core fuel. At the NPS, after external electrical power supply was lost due to the collapse of transmission line towers, etc., emergency diesel generators were automatically activated and procedures for normal cold shutdown were commenced.

However, the subsequent tsunamis hit the NPS and flooded those emergency diesel generators, switchboards and other equipment. All Units except for Unit 6 lost all AC power and cooling seawater pumps stopped functioning. Unit 1 thus lost all functions to cool down the reactor. While Units 2 and 3 continued cooling reactors for some time using the Reactor Core Isolation Cooling System (RCIC) and the High Pressure Coolant Injection System (HPCI), respectively, which can work without AC power, these systems also stopped soon and both Units eventually lost the means to remove the decay heat of core fuel.

Under such circumstances, NPS staff worked to activate alternative coolant injection routes using fire pumps or other equipment at Units 1, 2 and 3, but partly due to the possibility of another tsunami hitting, until those alternative measures were commenced, reactor cores were left uncooled. Coolant injection is considered to have been suspended for around 14 hours at Unit 1 and for around 6.5 hours at Units 2 and 3. Additionally, many hidden bypasses in the alternative coolant injection system made it difficult to supply injected water effectively to the reactor cores for cooling, and the reactors went into meltdown.

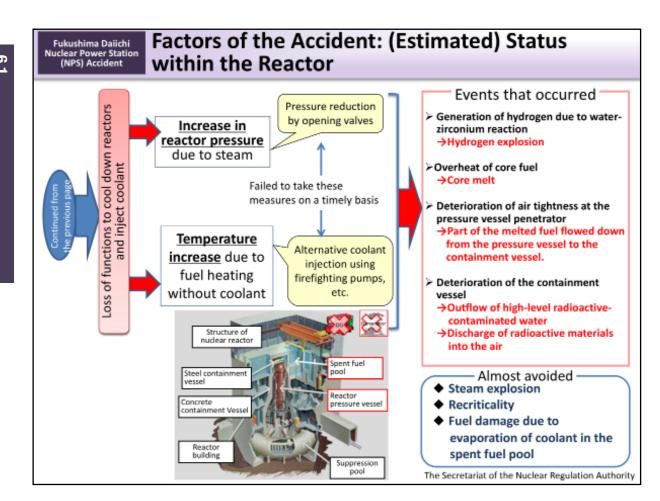
As coolant injection to the reactor core was suspended, the water level in the reactor declined and the fuel was exposed. This caused overheating of core fuel, triggered core melt and damaged a part of the pressure vessel. Melted fuel leaked from the pressure vessel into the inside of the containment vessel, and at the same time, cesium and other radioactive materials discharged from the fuel assembly was discharged within the containment vessel. Additionally, under high temperature due to core damage, steam and zirconium of the fuel cladding reacted to generate hydrogen, which was discharged within the containment vessel from the damaged part of the pressure vessel together with steam.

In the meantime, core damage increased the temperature and pressure in the containment vessel and deteriorated its confinement function, causing gaps in such parts as the penetrator that extends to the outside of the containment vessel. Radioactive materials discharged from such gaps to the outside of the containment vessel and diffused into the environment. Hydrogen generated due to the reaction of the steam and metal of the fuel cladding leaked through the gaps into the reactor building and accumulated there, and led to a hydrogen explosion.

Coolant injected into the reactor leaked from the pressure vessel and containment vessel and high-level radioactive-contaminated water accumulated underground below the reactor building and turbine building and partially flowed out into the ocean.

The damage to the pressure vessel and deterioration of the confinement function of the containment vessel caused a leak of steam containing radioactive materials. In addition, radioactive materials were also discharged into the air due to containment vessel vent operations, etc.

In this manner, radioactive materials were discharged into the environment in the forms of outflow of high-level contaminated water into the ocean and discharge of radioactive materials into the air.
