Damage due to the Great East Japan Earthquake

Accident at the Nuclear Power Station

Factors of the Accident: (Estimated) Influence of the Earthquake and Tsunami

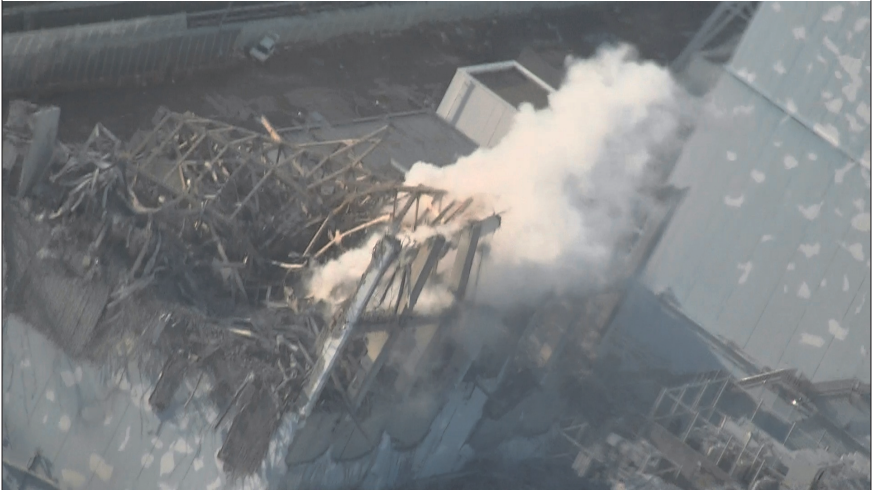
Tokyo Electric Power Company (TEPCO)'s Fukushima Daiichi NPS Unit 3 (shot from the air)

(Shot on March 16, 2011; Provided by TEPCO)

Tokyo Electric Power Company (TEPCO)'s Fukushima Daiichi NPS Unit 1, Unit 2 and Unit 3, which were in operation at the time of the earthquake, lost all AC power due to the earthquake and subsequent tsunami. This led to the stop of the cooling system and loss of means to cool down nuclear fuels, eventually resulting in the melt of nuclear fuel. In the process of the melt, a large amount of hydrogen gas was generated and hydrogen gas accumulated in reactor buildings caused an explosion at Unit 1 on March 12 and at Unit 3 on March 14. Additionally, at Unit 4 adjacent to Unit 3, a hydrogen explosion occurred due to hydrogen gas that is considered to have flowed into it from Unit 3.
