Damage due to the Great East Japan Earthquake

Accident at the Nuclear Power Station

Factors of the Accident: (Estimated) Status within the Reactor

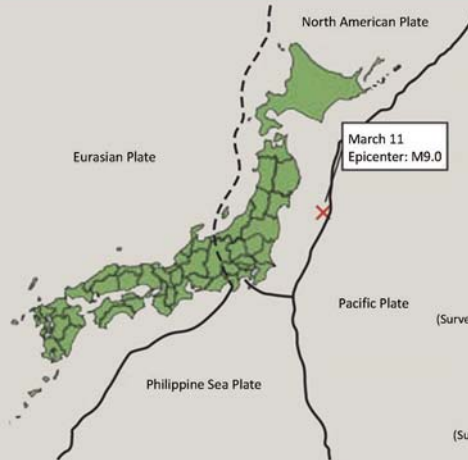
- A 9.0-magnitude earthquake occurred off the coast of Sanriku at 14:46 p.m. on Friday, March 11, 2011. The Earthquake and subsequent tsunami caused severe damage mainly to the Tohoku region.
- The earthquake was the largest ever recorded in Japan and the fourth biggest in the world since 1900.

A big earthquake centered off the coast of Sanriku occurred, at 14:46 p.m. on Friday, March 11, 2011. The seismic intensity of 7 on the Japanese earthquake scale was measured in Kurihara City, Miyagi Prefecture. This 9.0-magnitude earthquake was the biggest recorded in Japan since 1923 and the highest level in the world, equivalent to the 2010 Chili Earthquake (M8.8).

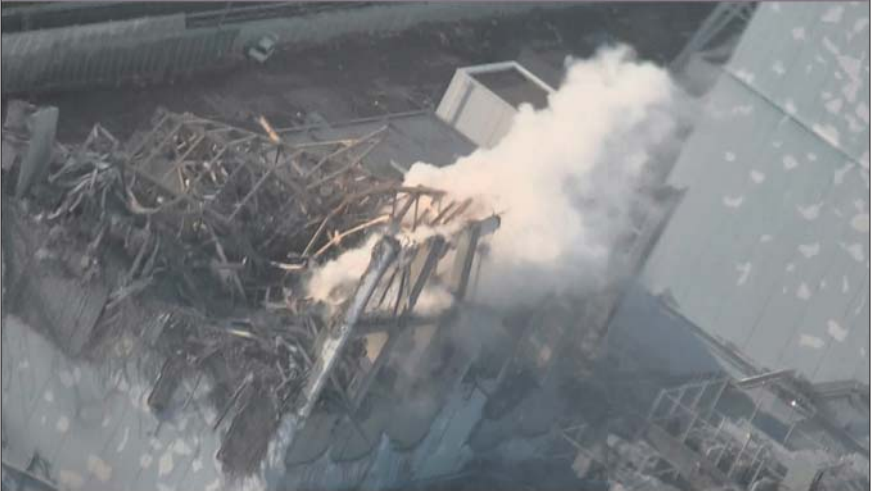
Tokyo Electric Power Company (TEPCO)'s Fukushima Daiichi NPS Unit 3 (shot from the air)

Tokyo Electric Power Company (TEPCO)'s Fukushima Daiichi NPS Unit 1, 2 and 3, which were in operation at the time of the earthquake, lost all AC power due to the earthquake and subsequent tsunami. This led to the stop of the cooling system and loss of means to cool down nuclear fuels, eventually resulting in the melt of nuclear fuel. In the process of the melt, a large amount of hydrogen gas was generated, and hydrogen gas accumulated in reactor buildings caused an explosion at Unit 1 on March 12 and at Unit 3 on March 14. Additionally, at Unit 4 adjacent to Unit 3, a hydrogen explosion occurred due to hydrogen gas that is considered to have flowed into it from Unit 3.

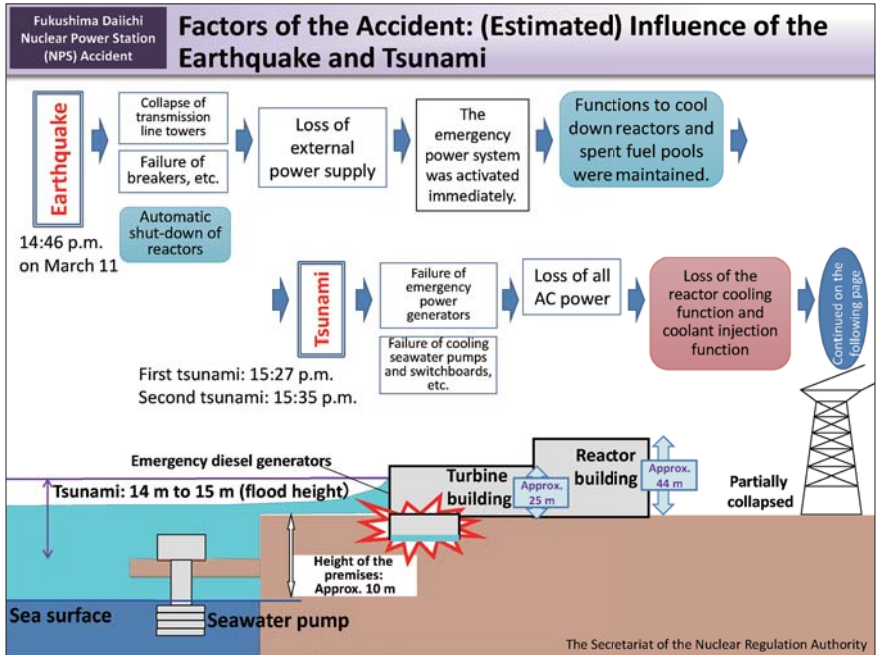
Immediately after the earthquake, at Units 1, 2 and 3 at Tokyo Electric Power Company (TEPCO)'s Fukushima Daiichi NPS, which were in operation, all reactors were shut down automatically.

Even after reactors are shut down, it is necessary to remove the decay heat of core fuel. At the NPS, after external electrical power supply was lost due to the collapse of transmission line towers, etc., emergency diesel generators were automatically activated and procedures for normal cold shutdown were commenced.

However, the subsequent tsunamis hit the NPS and flooded those emergency diesel generators, switchboards and other equipment. All Units except for Unit 6 lost all AC power and cooling seawater pumps stopped functioning. Unit 1 thus lost all functions to cool down the reactor. While Units 2 and 3 continued cooling reactors for some time using the Reactor Core Isolation Cooling System (RCIC) and the High Pressure Coolant Injection System (HPCI), respectively, which can work without AC power, these systems also stopped soon and both Units eventually lost the means to remove the decay heat of core fuel.

Under such circumstances, NPS staff worked to activate alternative coolant injection routes using fire pumps or other equipment at Units 1, 2 and 3, but partly due to the possibility of another tsunami hitting, until those alternative measures were commenced, reactor cores were left uncooled. Coolant injection is considered to have been suspended for around 14 hours at Unit 1 and for around 6.5 hours at Units 2 and 3. Additionally, many hidden bypasses in the alternative coolant injection system made it difficult to supply injected water effectively to the reactor cores for cooling, and the reactors went into meltdown.

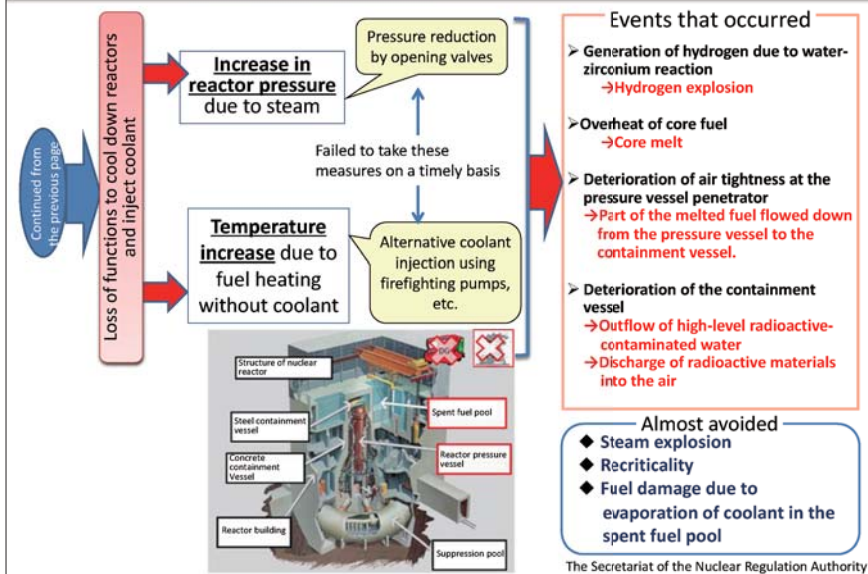
As coolant injection to the reactor core was suspended, the water level in the reactor declined and the fuel was exposed. This caused overheating of core fuel, triggered core melt and damaged a part of the pressure vessel. Melted fuel leaked from the pressure vessel into the inside of the containment vessel, and at the same time, cesium and other radioactive materials discharged from the fuel assembly was discharged within the containment vessel. Additionally, under high temperature due to core damage, steam and zirconium of the fuel cladding reacted to generate hydrogen, which was discharged within the containment vessel from the damaged part of the pressure vessel together with steam.

In the meantime, core damage increased the temperature and pressure in the containment vessel and deteriorated its confinement function, causing gaps in such parts as the penetrator that extends to the outside of the containment vessel. Radioactive materials discharged from such gaps to the outside of the containment vessel and diffused into the environment. Hydrogen generated due to the reaction of the steam and metal of the fuel cladding leaked through the gaps into the reactor building and accumulated there, and led to a hydrogen explosion.

Coolant injected into the reactor leaked from the pressure vessel and containment vessel and a large amount of high-level radioactive-contaminated water accumulated underground below the reactor building and turbine building and partially flowed out into the ocean.

The damage to the pressure vessel and deterioration of the confinement function of the containment vessel caused a leak of steam containing radioactive materials. In addition, radioactive materials were also discharged into the air due to containment vessel vent operations, etc.

In this manner, radioactive materials were discharged into the environment in the forms of outflow of high-level contaminated water into the ocean and discharge of radioactive materials into the air.
