# Responses Immediately after the Accident

# Ambient Dose Rates during Two Months after the Accident (Within and around of the premises of TEPCO's Fukushima Daiichi NPS)

Report of Japanese Government to the IAEA Ministerial Conference on Nuclear Safety, June 2011  
 Nuclear Emergency Response Headquarters, Attachment V-9

# Ambient Dose Rates during Two Weeks after the Accident (Within and around of the premises of TEPCO's Fukushima Daiichi NPS)

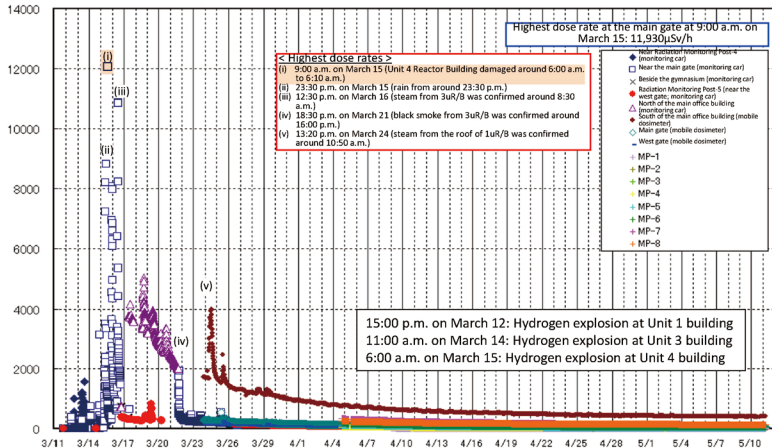
Hydrogen explosions occurred at buildings, etc. at Unit 1 to Unit 4 and the highest dose rates were measured in the morning of March 15.

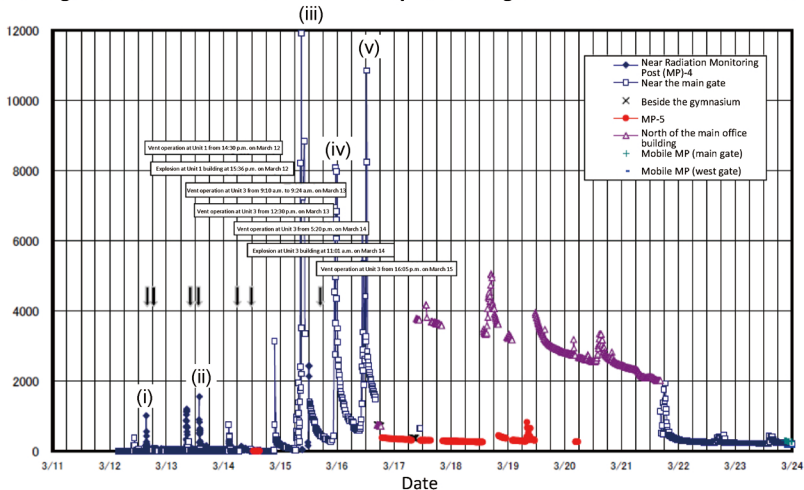
## Changes in ambient dose rates measured by monitoring cars within and around the NPS
