Fukushima Daiichi
Nuclear Power Station
(NPS) Accident

Accident at the Nuclear Power Station

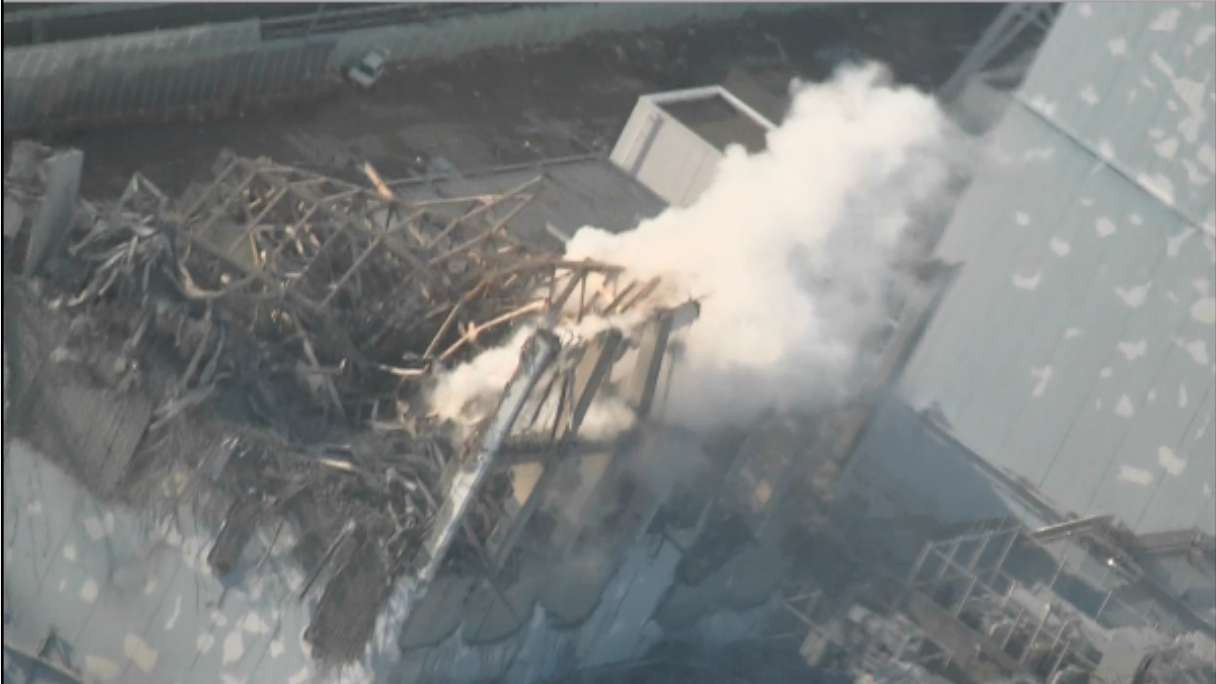
**Tokyo Electric Power Company (TEPCO)'s Fukushima Daiichi NPS
Unit 3 (shot from the air)**

(Shot on March 16, 2011; Provided by TEPCO)

Tokyo Electric Power Company (TEPCO)'s Fukushima Daiichi NPS Unit 1, 2 and 3, which were in operation at the time of the earthquake, lost all AC power due to the earthquake and subsequent tsunami. This led to the stop of the cooling system and loss of means to cool down nuclear fuels, eventually resulting in the melt of nuclear fuel. In the process of the melt, hydrogen gas was generated, and hydrogen gas accumulated in reactor buildings caused an explosion at Unit 1 on March 12 and at Unit 3 on March 14. Additionally, at Unit 4 adjacent to Unit 3, a hydrogen explosion occurred due to hydrogen gas that is considered to have flowed into it from Unit 3.

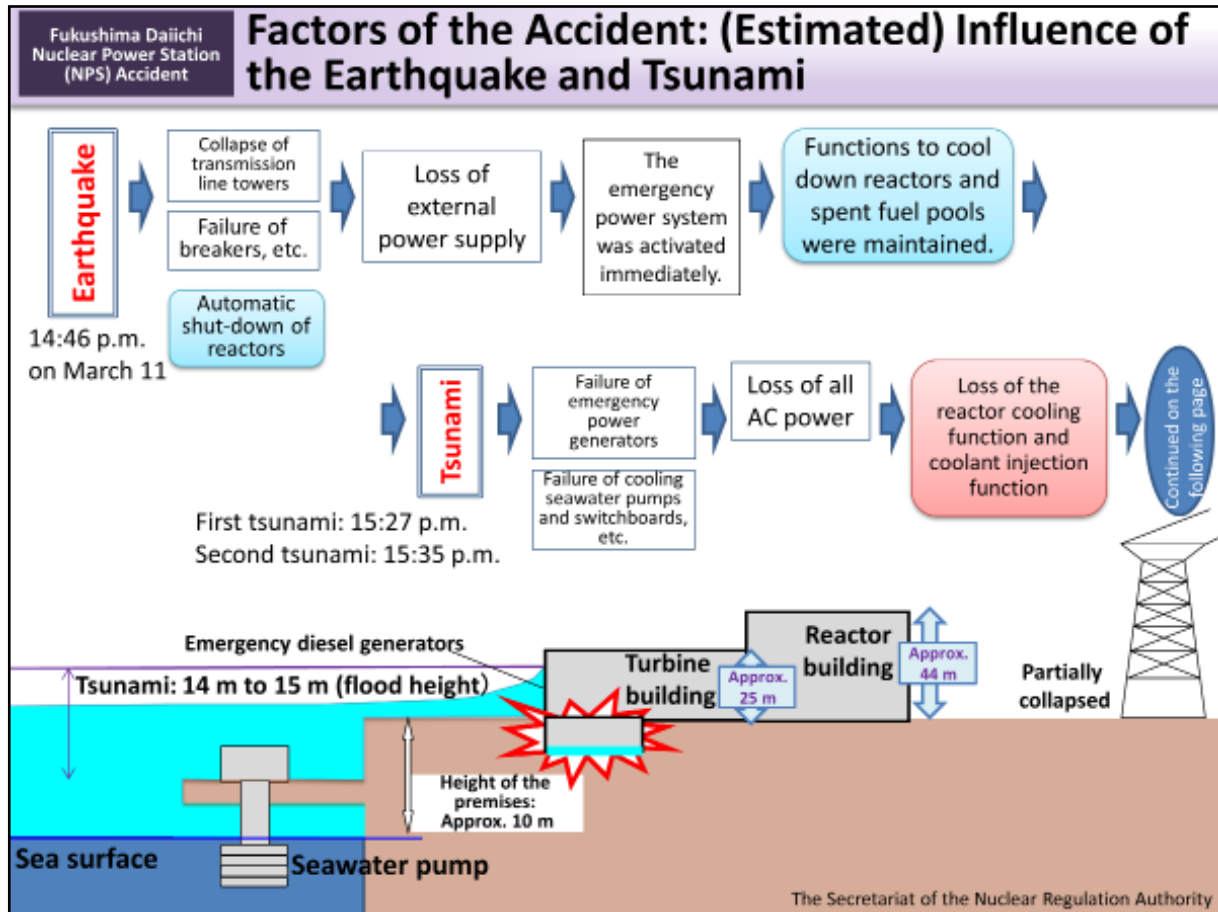
Immediately after the earthquake, at Units 1, 2 and 3 at Tokyo Electric Power Company (TEPCO)'s Fukushima Daiichi NPS, which were in operation, all reactors were shut down automatically.

Even after reactors are shut down, it is necessary to remove the decay heat of core fuel. At the NPS, after external electrical power supply was lost due to the collapse of transmission line towers, etc., emergency diesel generators were automatically activated and procedures for normal cold shutdown were commenced.

However, the subsequent tsunamis hit the NPS and flooded those emergency diesel generators, switchboards and other equipment. All Units except for Unit 6 lost all AC power and cooling seawater pumps stopped functioning. Unit 1 thus lost all functions to cool down the reactor. While Units 2 and 3 continued cooling reactors for some time using the Reactor Core Isolation Cooling System (RCIC) and the High Pressure Coolant Injection System (HPCI), respectively, which can work without AC power, these systems also stopped soon and both Units eventually lost the means to remove the decay heat of core fuel.

Under such circumstances, NPS staff worked to activate alternative coolant injection routes using fire pumps or other equipment at Units 1, 2 and 3, but partly due to the possibility of another tsunami hitting, until those alternative measures were commenced, reactor cores were left uncooled. Coolant injection is considered to have been suspended for around 14 hours at Unit 1 and for around 6.5 hours at Units 2 and 3. Additionally, many hidden bypasses in the alternative coolant injection system made it difficult to supply injected water effectively to the reactor cores for cooling, and the reactors went into meltdown.

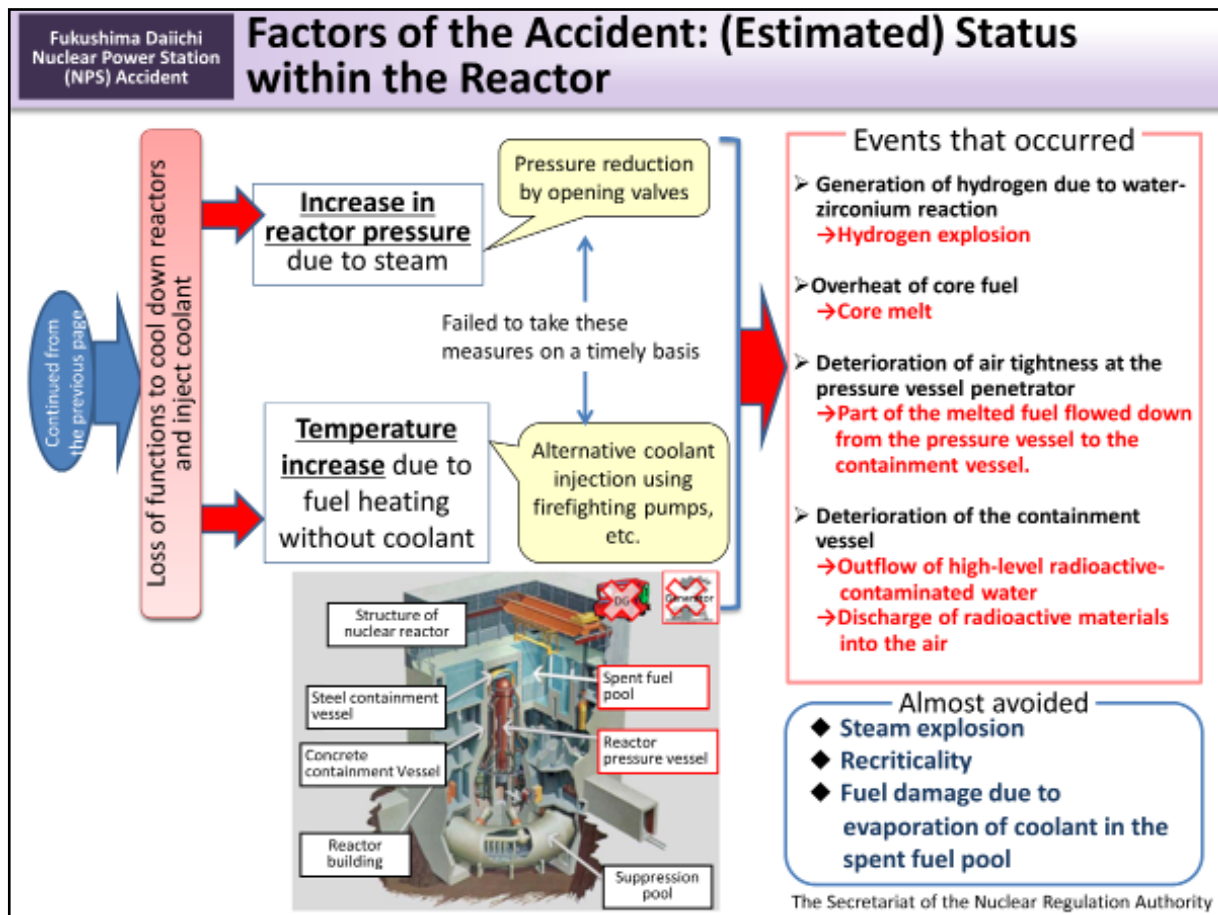
As coolant injection to the reactor core was suspended, the water level in the reactor declined and the fuel was exposed. This caused overheating of core fuel, triggered core melt and damaged a part of the pressure vessel. Melted fuel leaked from the pressure vessel into the inside of the containment vessel, and at the same time, cesium and other radioactive materials discharged from the fuel assembly was discharged within the containment vessel. Additionally, under high temperature due to core damage, steam and zirconium of the fuel cladding reacted to generate hydrogen, which was discharged within the containment vessel from the damaged part of the pressure vessel together with steam.

In the meantime, core damage increased the temperature and pressure in the containment vessel and deteriorated its confinement function, causing gaps in such parts as the penetrator that extends to the outside of the containment vessel. Radioactive materials discharged from such gaps to the outside of the containment vessel and diffused into the environment. Hydrogen generated due to the reaction of the steam and metal of the fuel cladding leaked through the gaps into the reactor building and accumulated there, and led to a hydrogen explosion.

Coolant injected into the reactor leaked from the pressure vessel and containment vessel and high-level radioactive-contaminated water accumulated underground below the reactor building and turbine building and partially flowed out into the ocean.

The damage to the pressure vessel and deterioration of the confinement function of the containment vessel caused a leak of steam containing radioactive materials. In addition, radioactive materials were also discharged into the air due to containment vessel vent operations, etc.

In this manner, radioactive materials were discharged into the environment in the forms of outflow of high-level contaminated water into the ocean and discharge of radioactive materials into the air.
