Tatsukushi

Preserve and restore the underwater view and marine ecosystems, primarily consisting of coral communities that have notably diminished in recent years

Designation:
Ashizuri-Uwakai National Park
Location:
Tosashimizu, Kochi Prefecture
Year Initiated: 2003

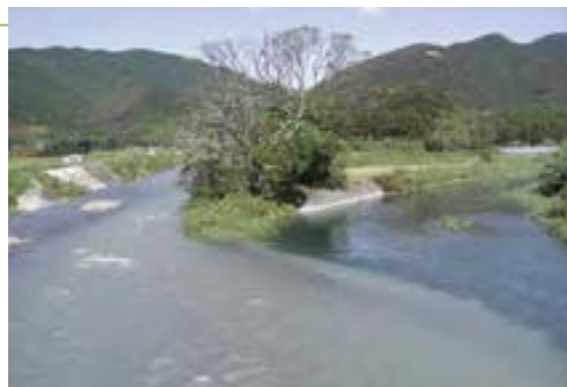
High turbid water from the Nishino-kawa River (left) after rainfall, at the confluence to the Misaki River (right).

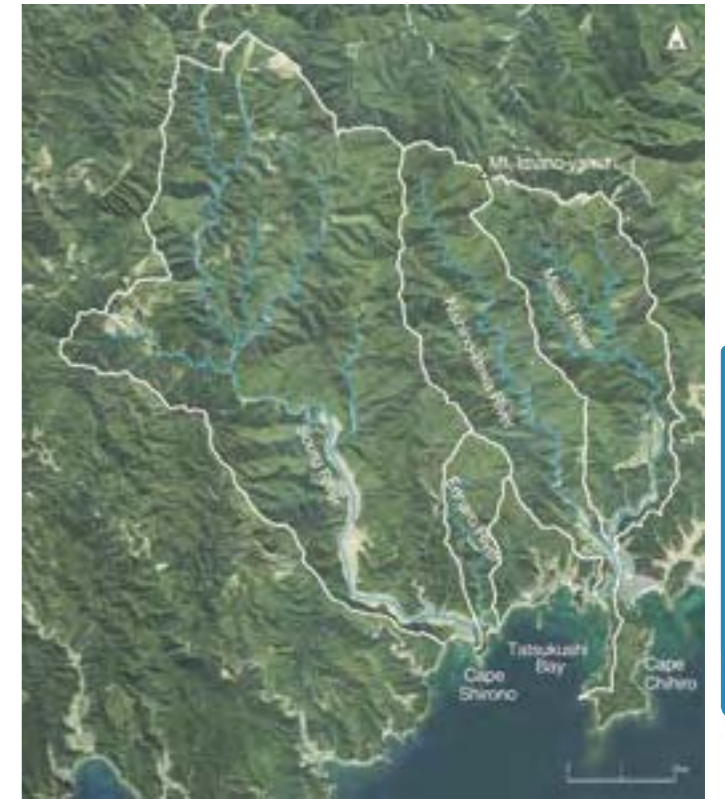
Watersheds draining to the Tatsukushi Bay.

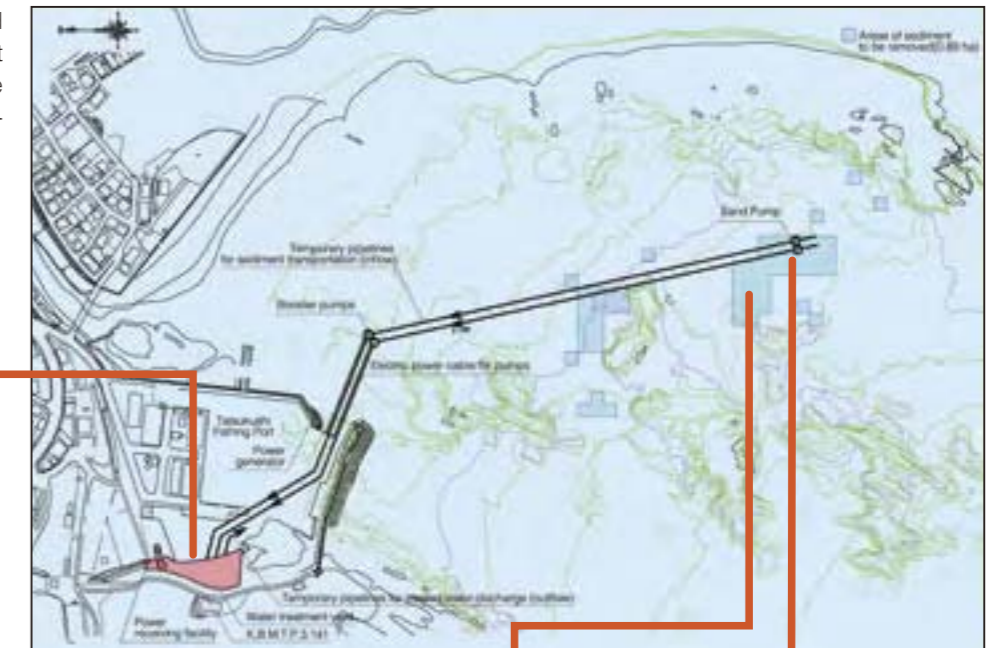
In areas of severe sedimentation, deposited mud sediments will be vacuumed using an underwater pump and discharged up to the treatment plant through a temporary bottom pipeline system. The sediments will be dewatered and properly disposed.

A design for sediment removal system

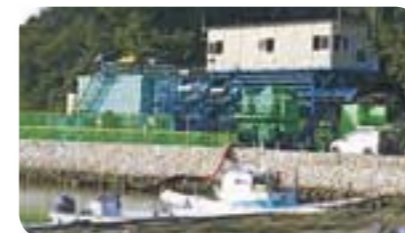
Water treatment plant

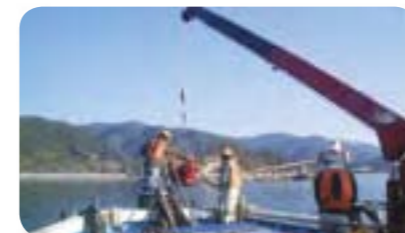
A small-sized crane and dredge pump

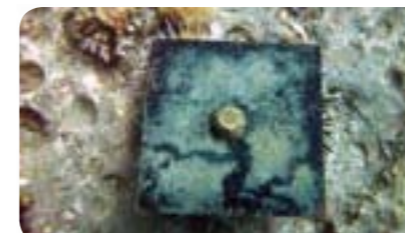
Estimating the amount of suspended silt using a flat plate, in monitoring before and after the sediment removal

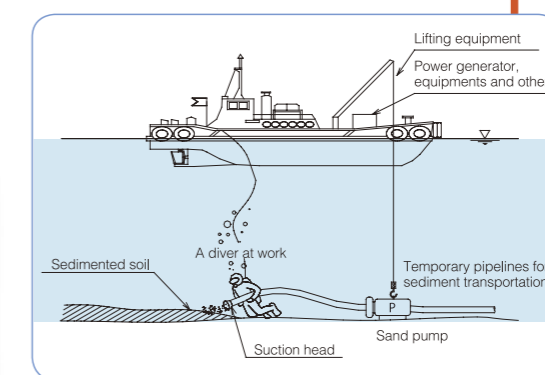
Workboat operation

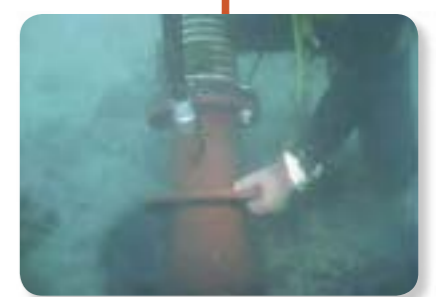
Vacuuming mud sediments
