Lake Biwa

Goal Restore the native reed and lagoon habitats that existed in the 1950s

Council for Native Reed Colonies Restoration at Lake Biwa Northern Region

Hayazaki Lagoon Restoration Planning Committee

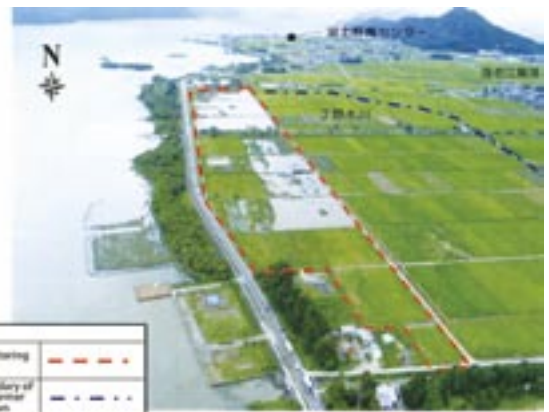
Hayazaki reclamation project in August 2003

To test the feasibility of the Lagoon restoration, 17 ha of the drained land has been experimentally flooded since November 2001, and the recovery of lagoon ecosystems has been monitored. Currently, the site shows a recovery of healthy habitats for plants and animals such as the whistling swan (*Cygnus columbianus*).

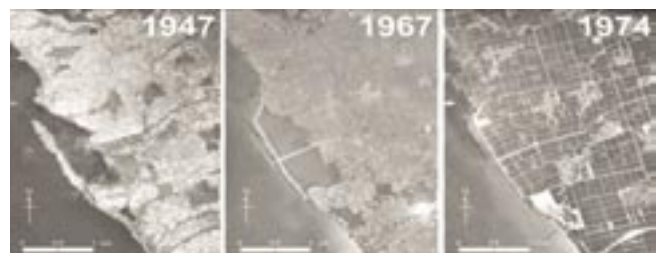
Transformation of the Hayazaki Lagoon. Land reclamation occurred between 1963 and 1970
