Tsunami Damage and Recovery of the Sanriku Coastal Area

November 15, 2013

Junichi HIROTA
Iwate University

1. TSUNAMI DAMAGE

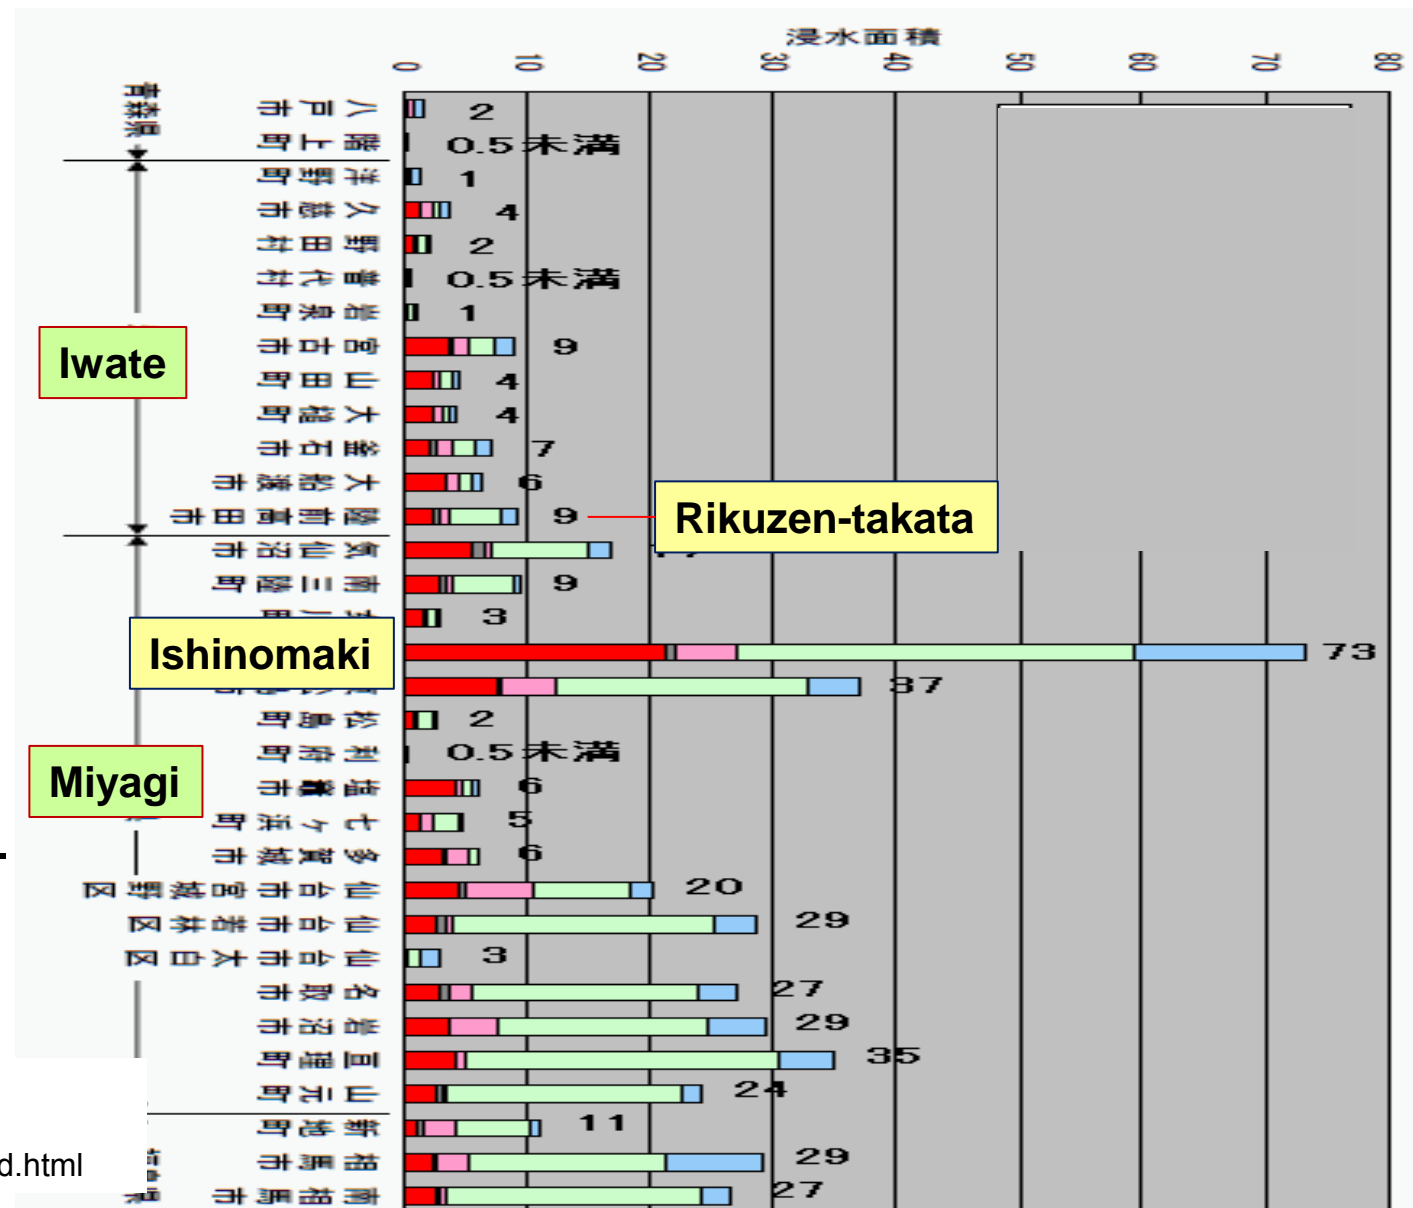
Area Flooded by Tsunami (by City, Town and Village)

In Iwate, Flooded area was smaller, but the rate of buildings(red) flooded was higher.

In Miyagi, Flooded area was larger, and most of the flooded area was agricultural land(green),..

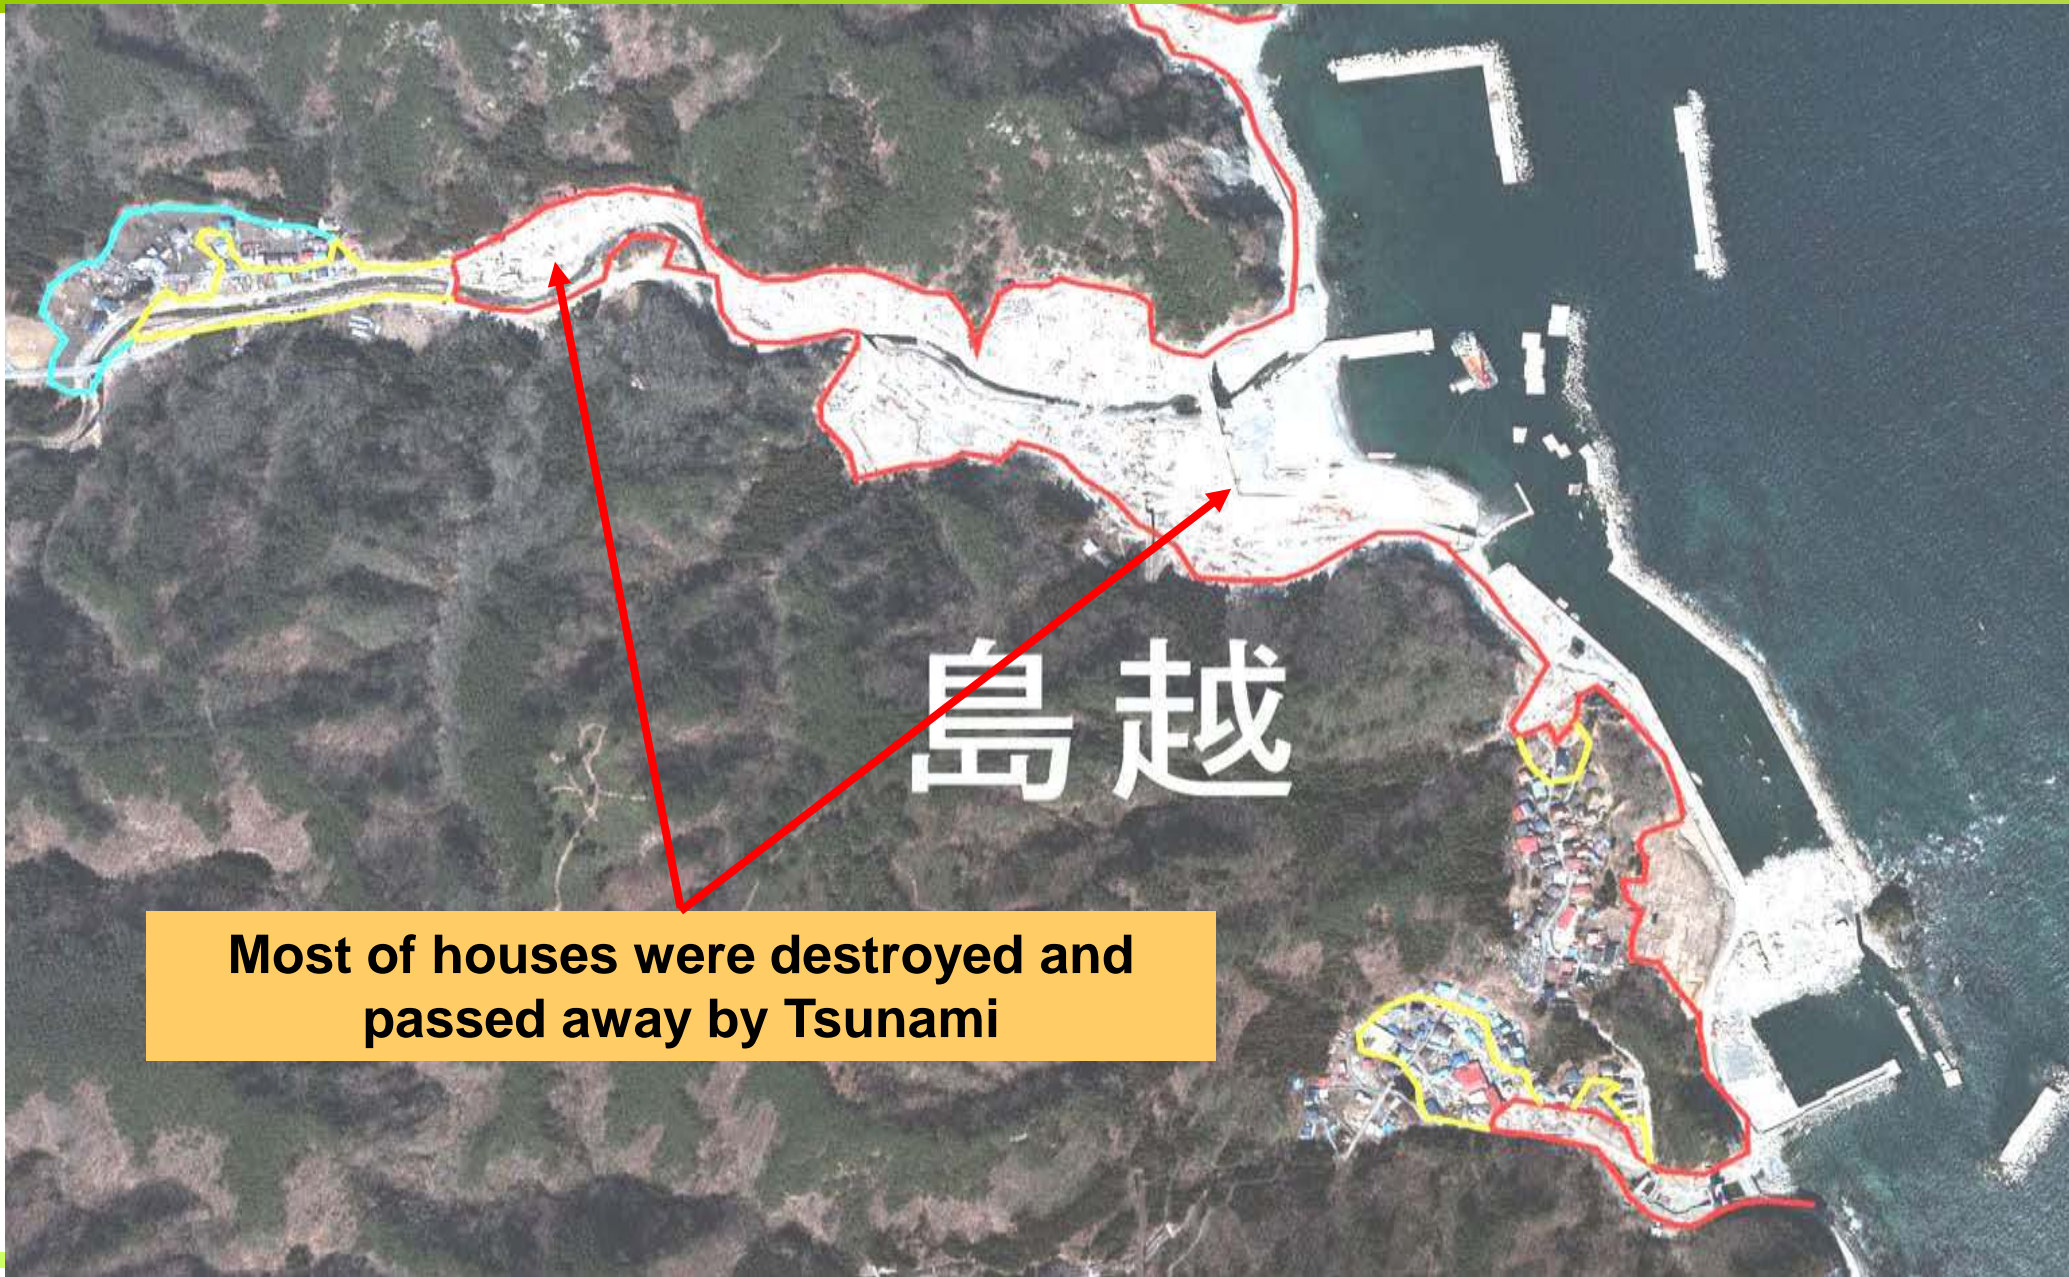
Shimakoshi of Tanohata-mura in Northern Sanriku

Many buildings were flooded

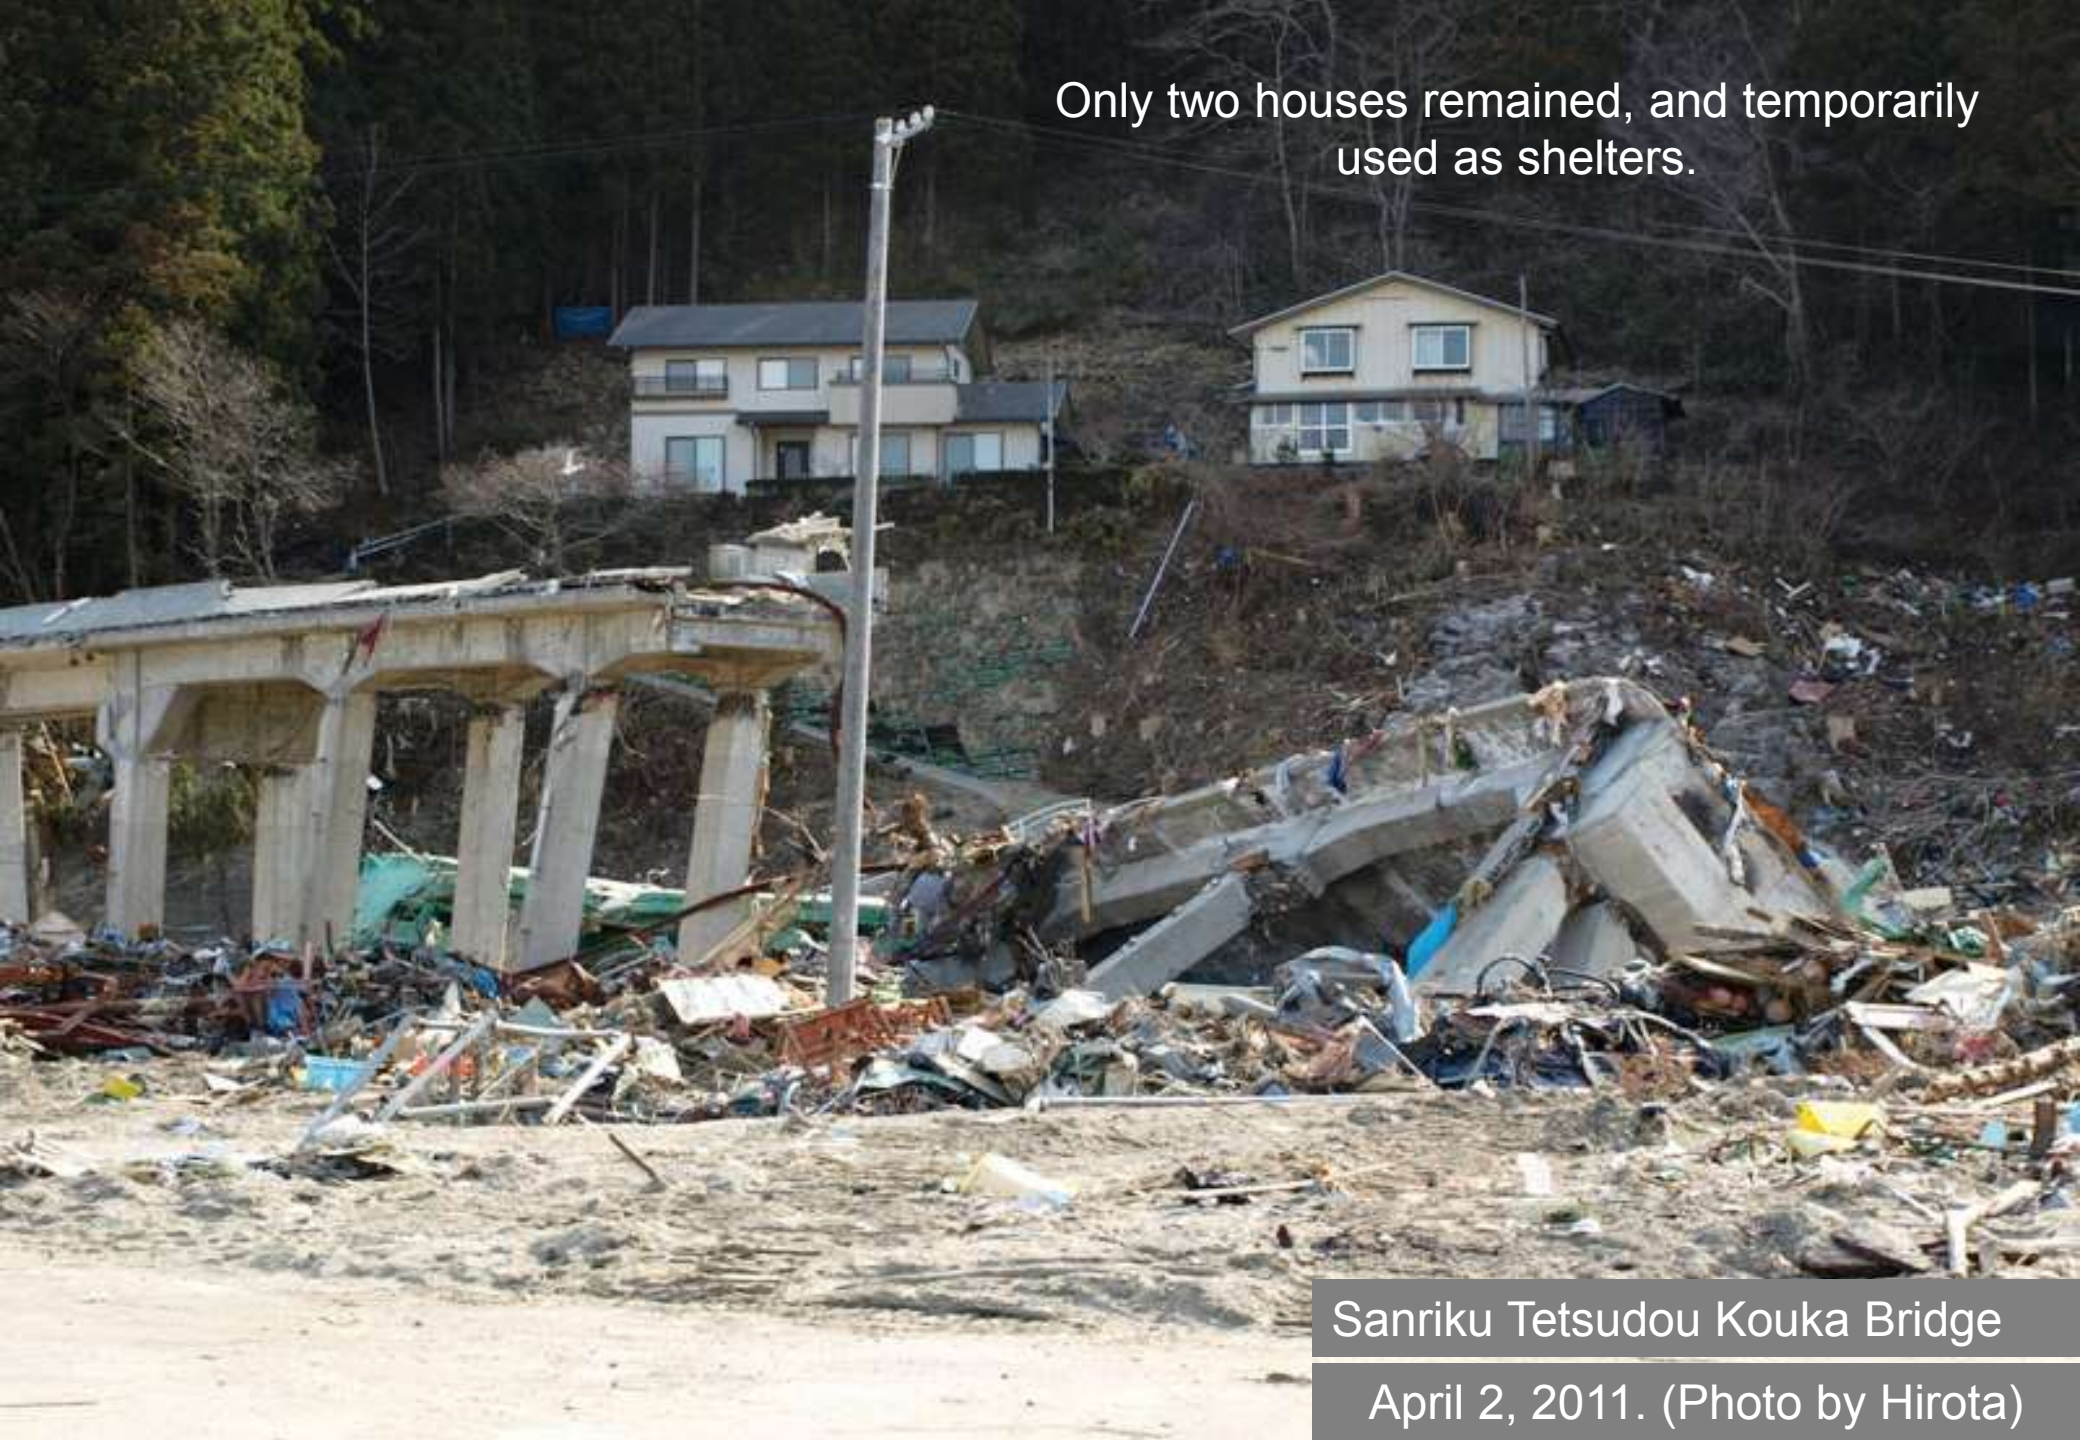
Sanriku Tetsudou Kouka Bridge

Most of houses were destroyed and passed away by Tsunami

Only two houses remained, and temporarily
used as shelters.

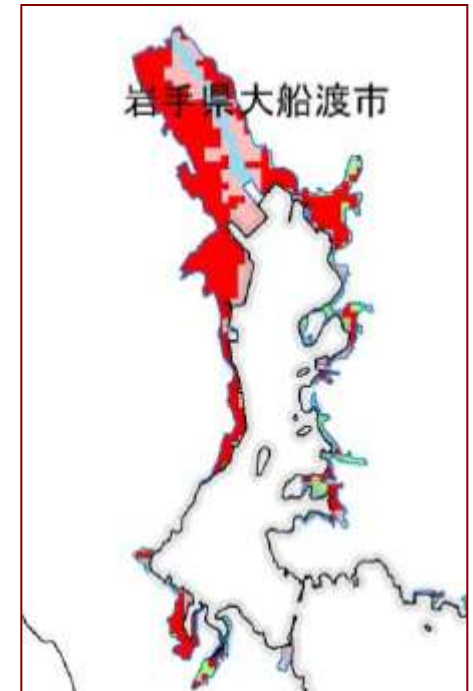
Flooded areas of Southern Sanriku Area

Much of Flooded area was land with buildings.

In Rikuzentakata, many paddy fields were also flooded.

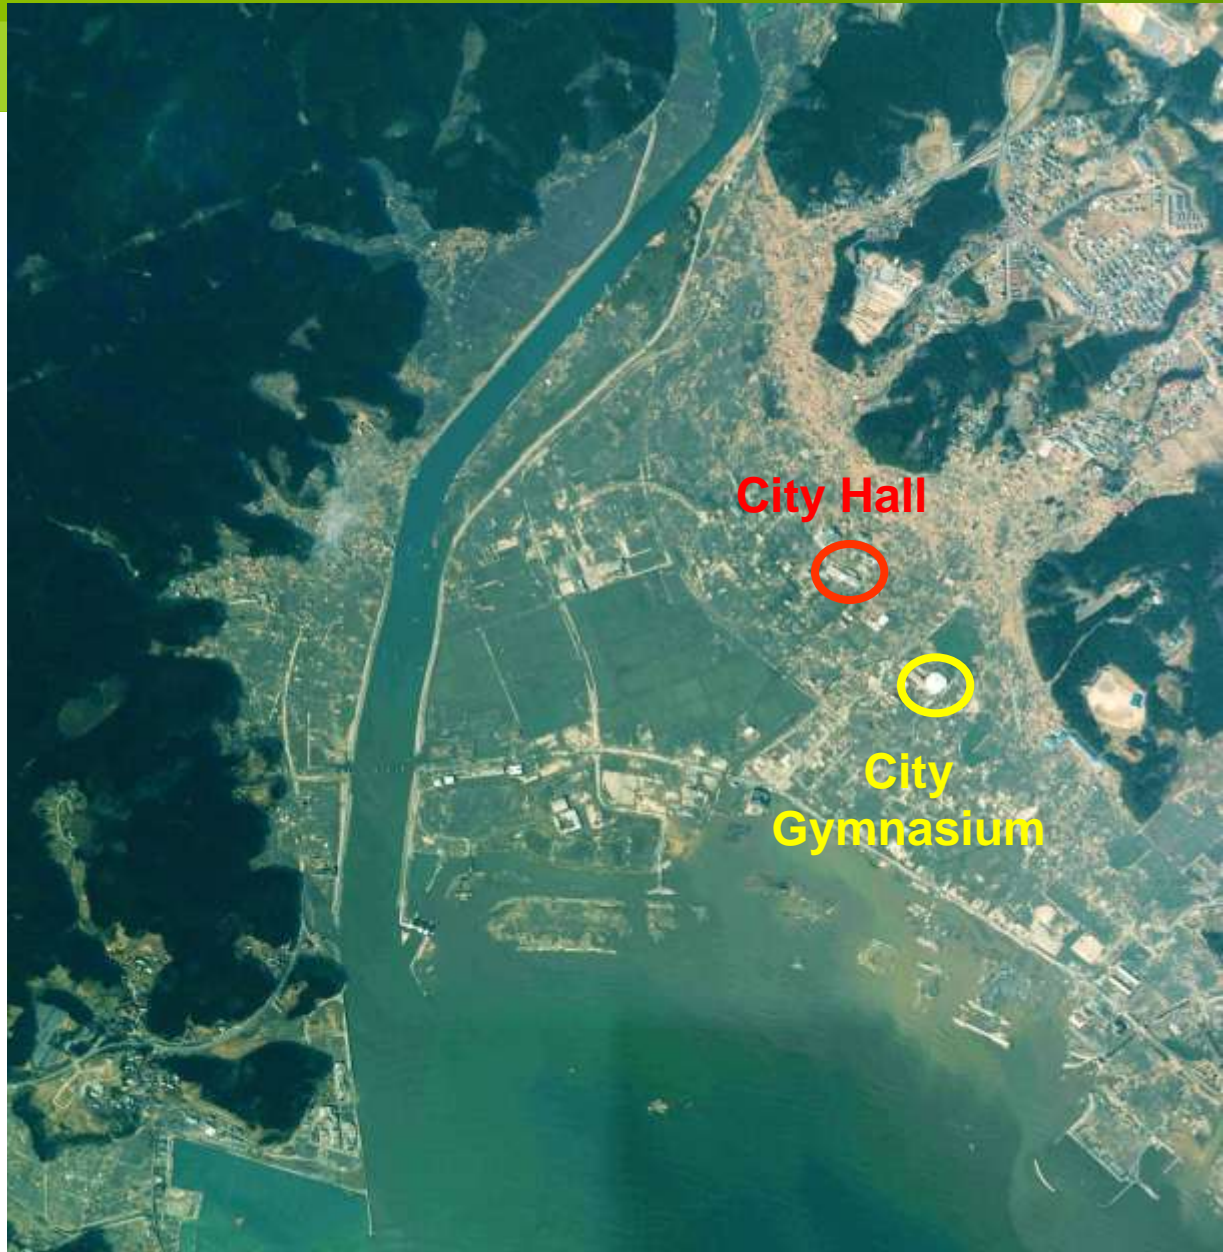
Rikuzentakata, Iwate

Dead and Missing: 1,771 person
Rate Dead and Missing: 10.4%

The city area was completely destroyed.

Almost 30% of city employees were killed, and city hall was destroyed. The government also stopped functioning.

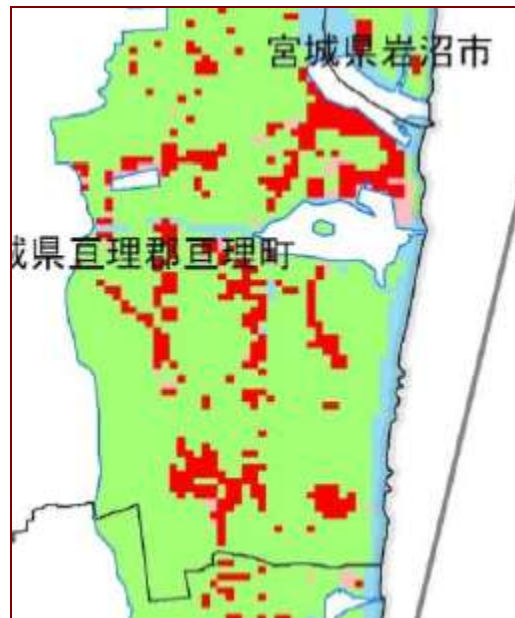
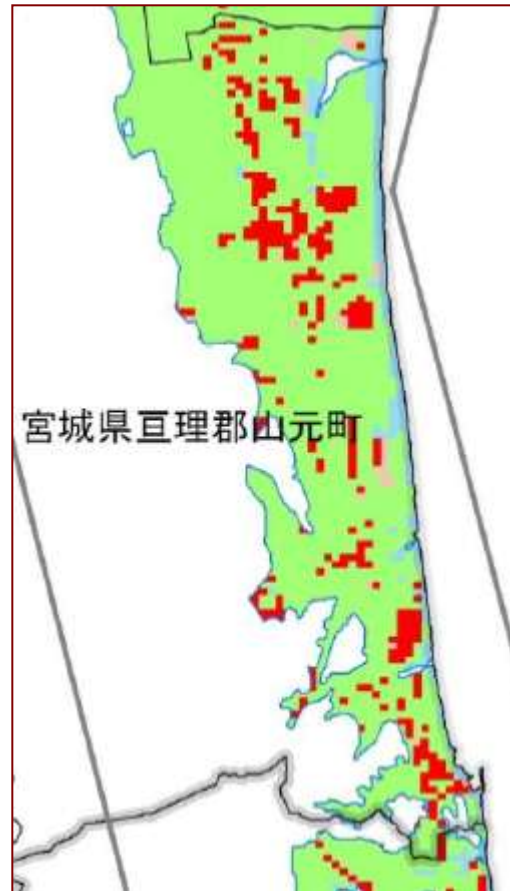
Flooded Maps in Sendai Bay Areas,

A large area of paddy fields (green) was flooded.

Agricultural settlements (red) suffered devastating damage.

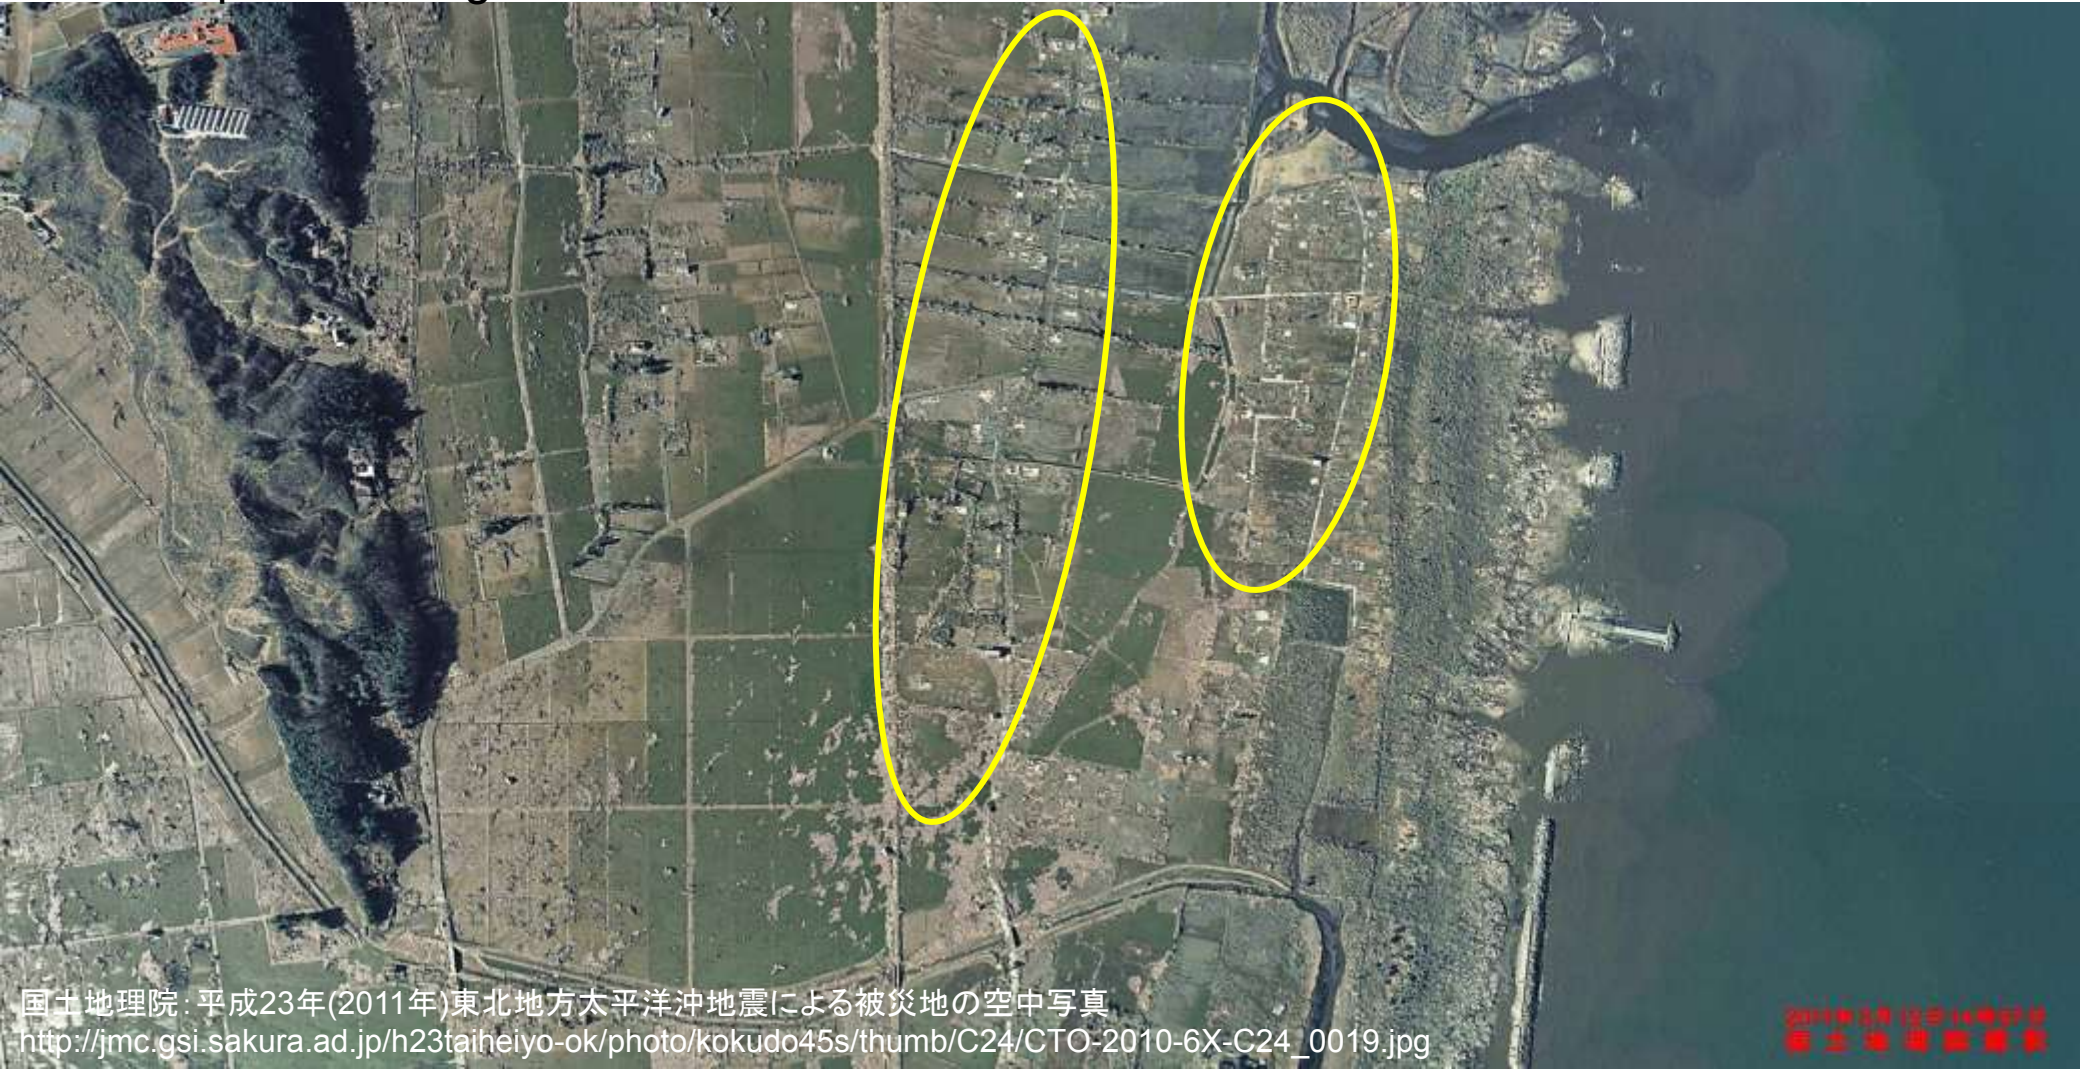
Shinhama Village of Yamamoto town, Miyagi Prefecture

Communities and paddy fields on the coast were damaged, and a large area was flooded.

Inland public facilities were safe, but city hall sustained earthquake damage.

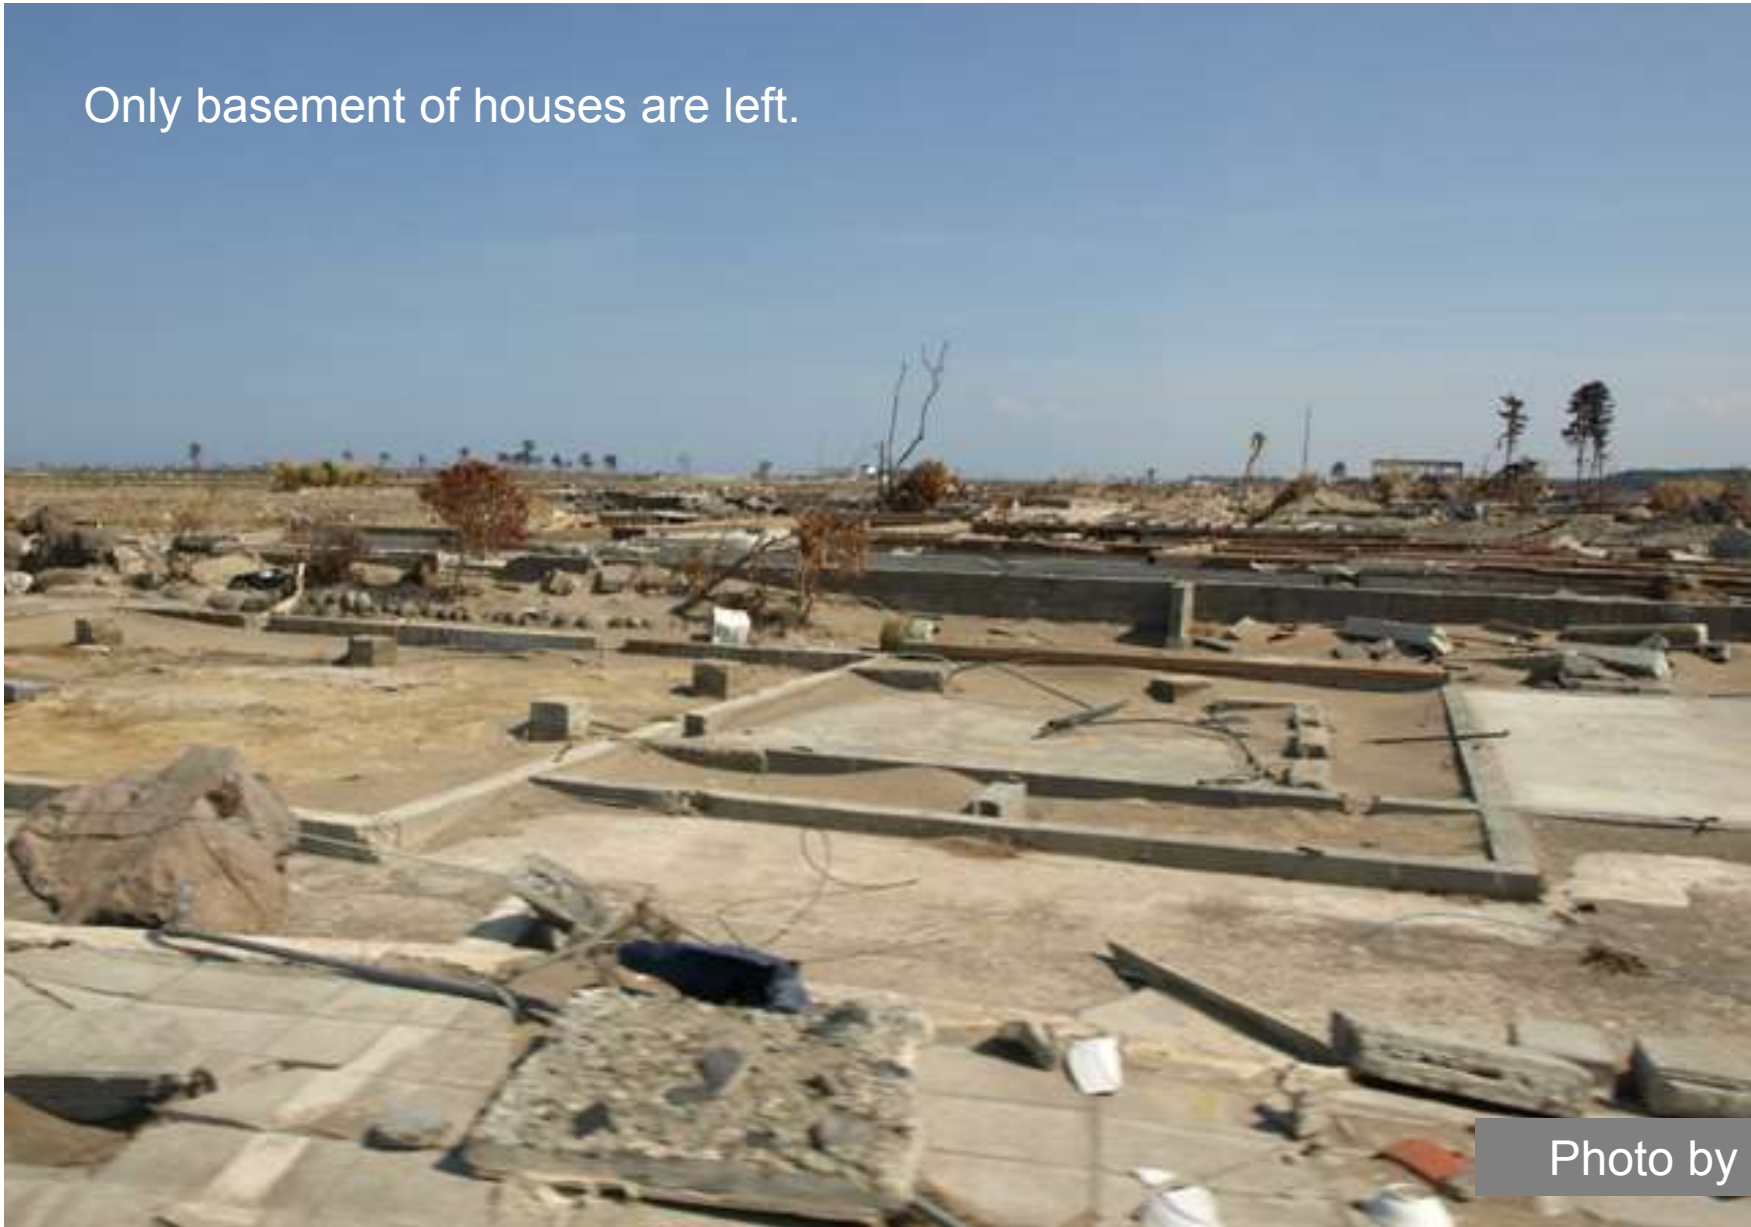
Shinhama Village in Yamamoto Town : May 25, 2011

Only basement of houses are left.

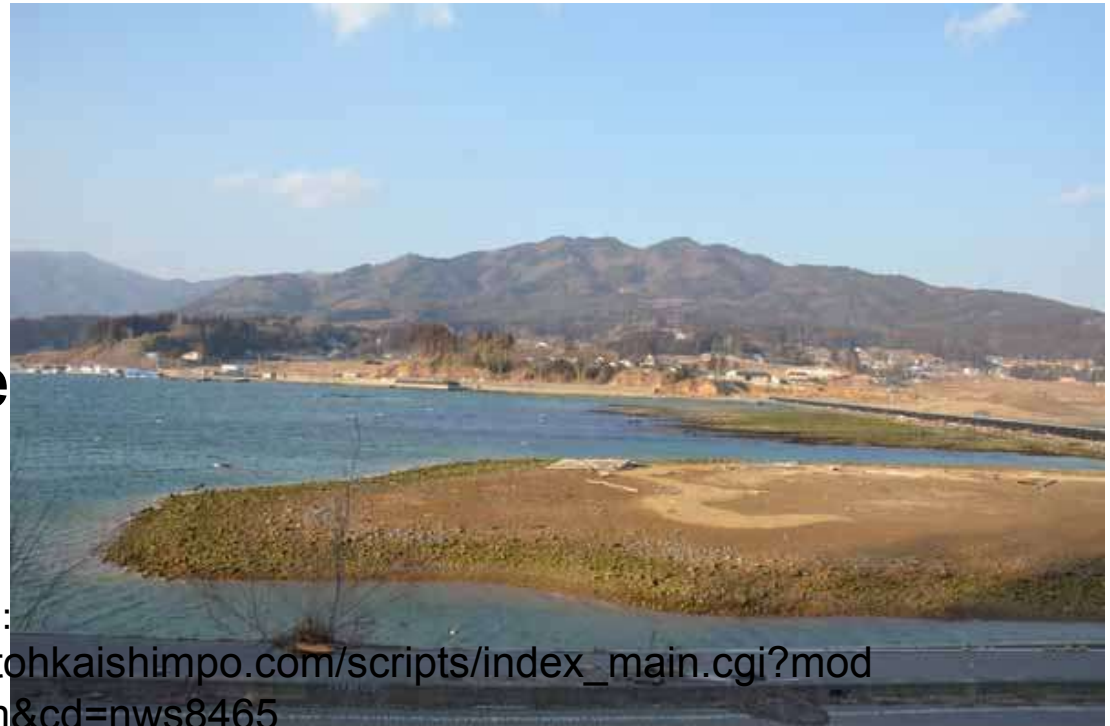
□ Restoration of Otomoura (Rikuzentakata)

- In 1968, tidelands were made into paddy fields.
- The paddy fields were destroyed in 2011 tsunami.
- It was decided to restore tidelands.
- Before 1968, tideland was paradise for clamming, etc.
