Disaster Countermeasures for Johkasou

**Ministry of the Environment
Government of Japan**

Basic Structure and Characteristics of Johkasou

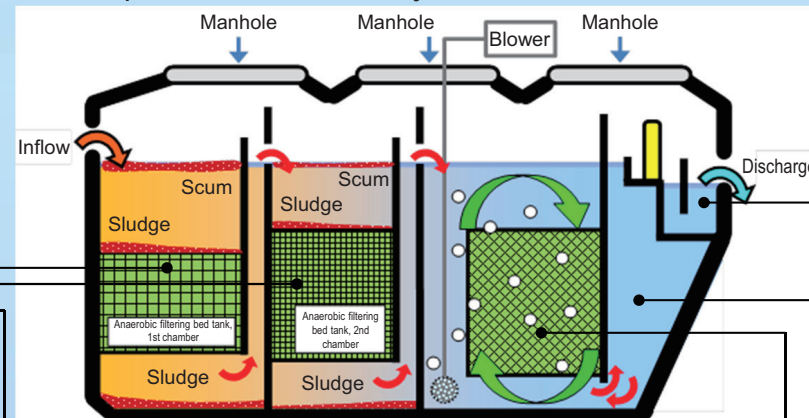
Example of the structure of johkasou

Treatment processes of johkasou is different from decentralized household wastewater treatment facilities overseas. The red frames to the right show the treatment processes not possessed by septic tanks.

Disinfection tank

Treated water is disinfected by chlorine before discharge.

Sedimentation tank

Suspended solids in treated water settle and the clean layer is fed to the disinfection tank.

Biological contact aeration equipment

- Aerobic microorganisms degrade organic contaminants.
- Ammonia is oxidized.

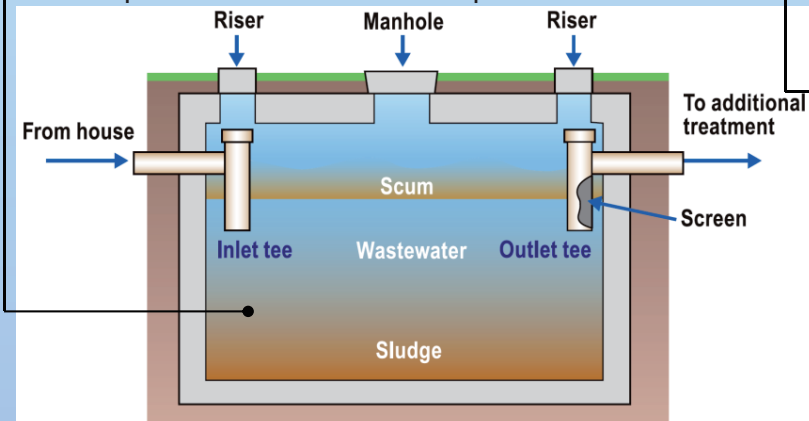
Example of the structure of a septic tank

- Solid waste in wastewater is separated and sludge is stored.
- Organic contaminants are degraded by anaerobic microorganisms.

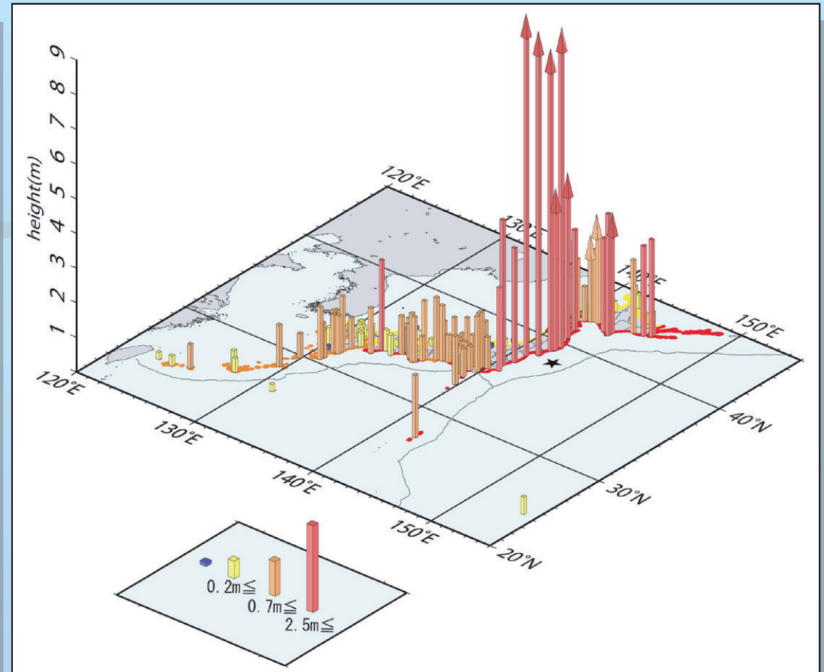
■ Height of tsunamis observed at tsunami observation centers

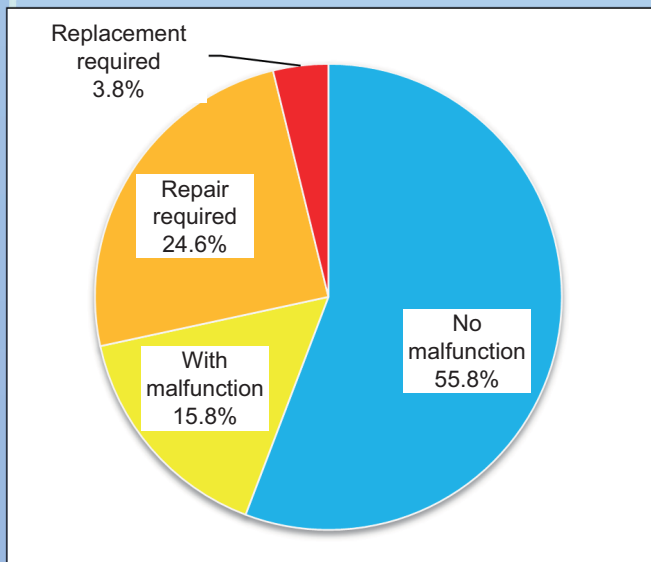
The Ministry of the Environment, Government of Japan surveyed damage to roughly 1,000 units of johkasou caused by the Great East Japan Earthquake. The earthquake was responsible for the largest scale of human and material destruction in Japan's postwar period, and many units of johkasou throughout the region were damaged. However, rate of Johkasou which required replacement is only 3.8%.

■ Status of johkasou damage caused by the Great East Japan Earthquake

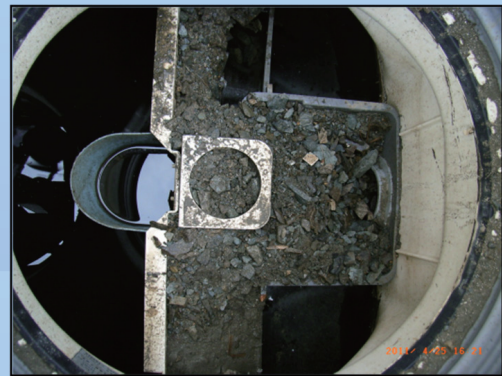
■ Inflow of sand and mud caused by a tsunami

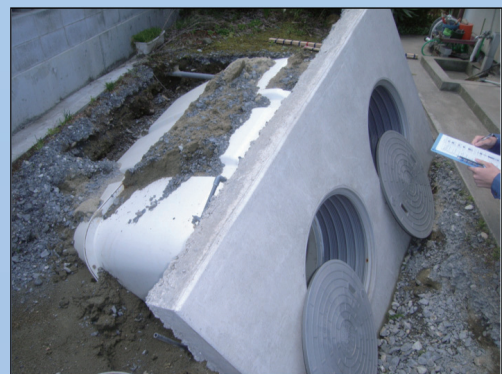
■ Tank pushed up to the surface by liquefaction

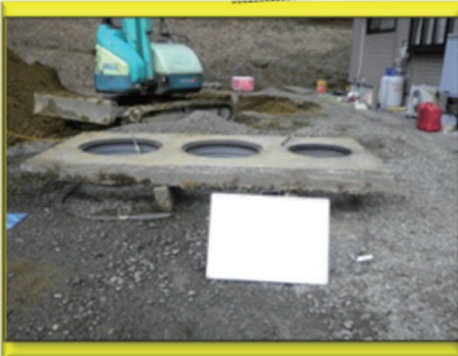
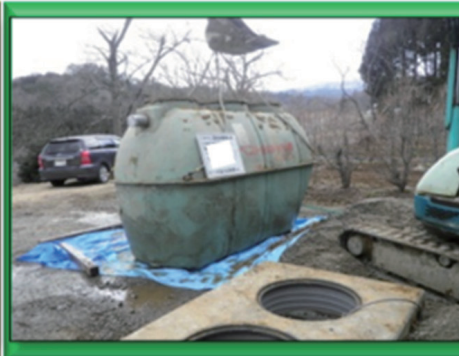
Example of other temporary measures

A hose is connected to the damaged air pipe.

A temporary manhole lid is installed to replace the lid that was swept away.

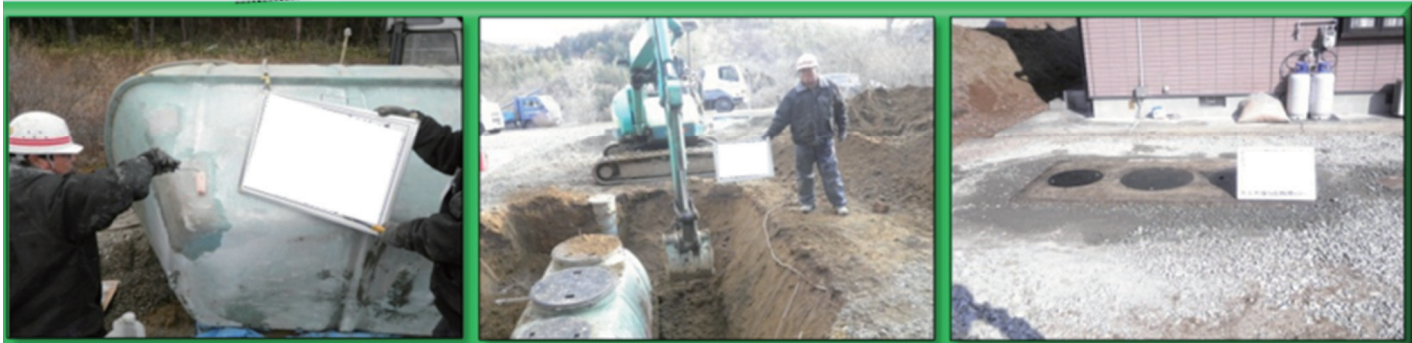
A temporary pipe is installed in place of the damaged pipe.

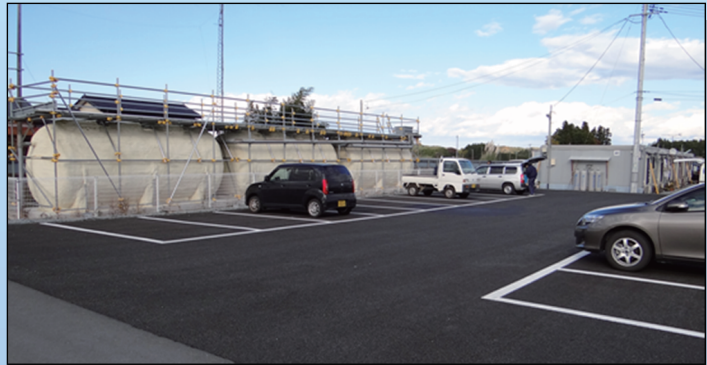
■ Johkasou installed at temporary housing after the Great East Japan Earthquake

- Ratio of johkasou installed 50.5% (= 26,278 houses / 52,028 houses)
- Number of johkasou installed 1,748 units (Johkasou for 21~50 people was the mainstay)

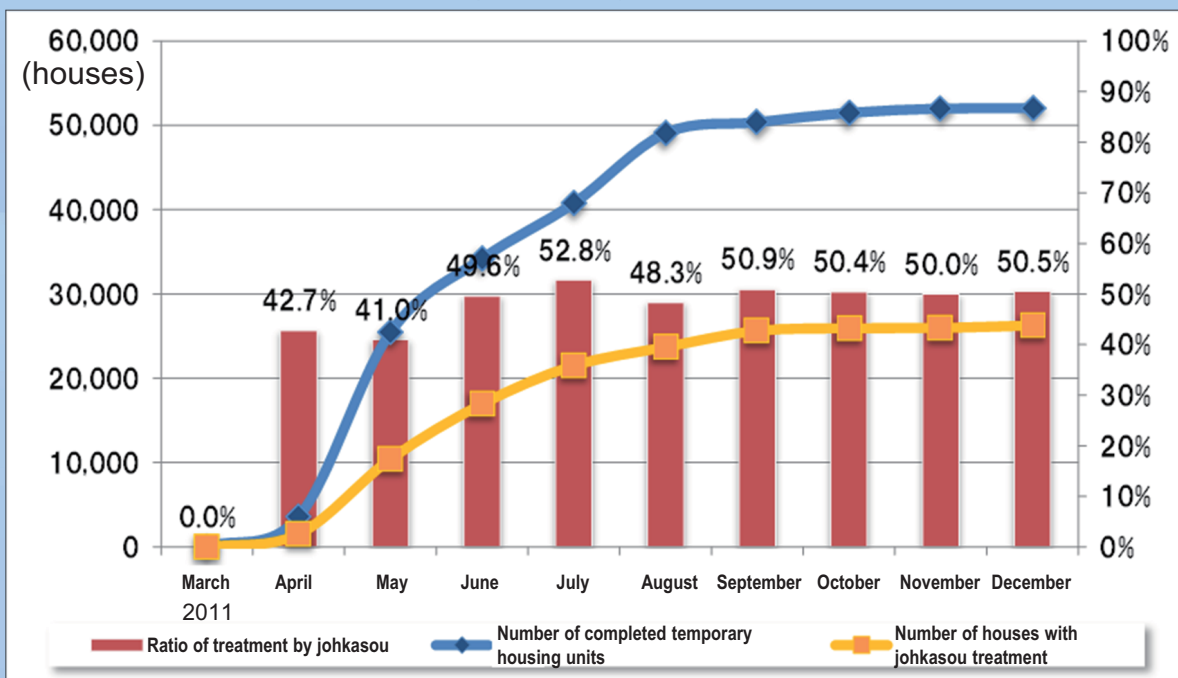
■ Number of constructed temporary housing units/number of supplied johkasou after the Great East Japan Earthquake (cumulative)
