Outline of the Accident

Ambient Dose Rates during Two Months after the Accident
(Within and around of the premises of the Tokyo Electric Power Company (TEPCO)'s Fukushima Daiichi Nuclear Power Station (NPS))

Ambient Dose Rates during Two Weeks after the Accident

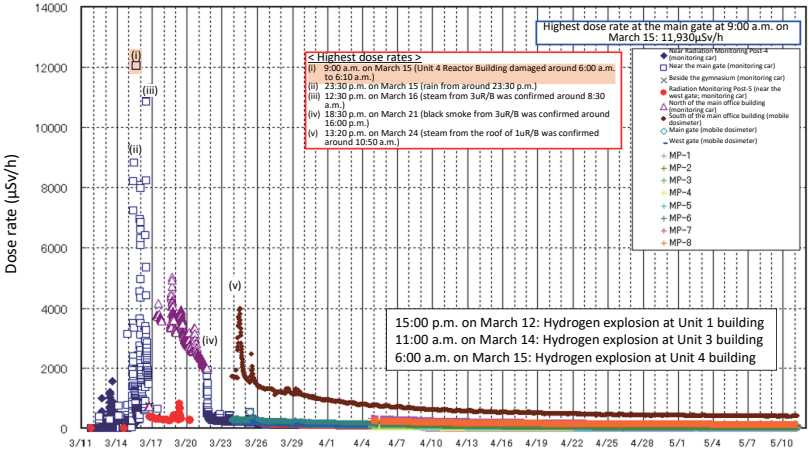
Hydrogen explosions occurred at buildings, etc. at Unit 1 to Unit 4 and the highest dose rates were measured in the morning of March 15.

In the early morning of March 12, 2011, monitoring cars measured higher ambient dose rates within the premises of TEPCO's Fukushima Daiichi NPS and the release of radioactive materials was first confirmed after the earthquake. At Unit 1, after an abnormal pressure rise in the containment vessel was observed, the pressure declined slightly. Therefore, it is considered that radioactive materials leaked from the containment vessel at Unit 1 and were discharged into the air. Thereafter, temporary rises of ambient dose rates were observed several times after the vent operations and explosions at the buildings. The highest ambient dose rate was measured at 9:00 a.m. on March 15. A monitoring car near the main gate measured the highest rate of approx. 12 mSv/h.

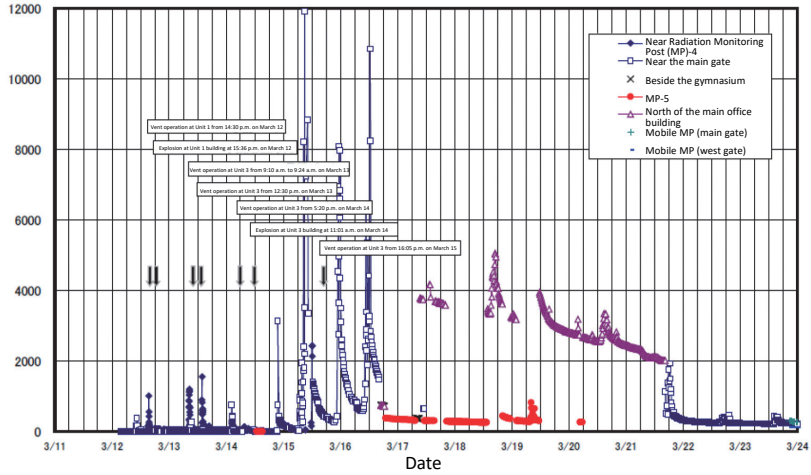
● **Changes in ambient dose rates measured by monitoring cars within and around the NPS**

In accordance with the progress of events, radioactive materials were released into the air due to containment vessel vent operations and explosions at reactor buildings. Vent operation at Unit 1 was considered to be successful as the pressure in the containment vessel declined at 14:30 p.m. on March 12. Due to the radioactive plume discharged at that time, an ambient dose rate of approx. 1 mSv/h was detected. On March 13, the following day, the ambient dose rate clearly increased again. This is considered to have been caused by vent operation at Unit 3 conducted after the water level in the reactor declined and the fuel was exposed from cooling water. At 9:00 a.m. on March 15, the highest rate of approx. 12 mSv/h was observed. Early in the morning at around 6:00 a.m. of that day, the pressure of the pressure suppression chamber declined at Unit 2 with the sound of an explosion. Therefore, the high dose rate on March 15 is considered to have been caused by the release of radioactive materials from Unit 2.

Ambient dose rate increases were also measured at 23:00 p.m. on March 15 and at 12:00 p.m. on March 16. Pressure decline in the containment vessel was observed in Unit 3 and Unit 2, respectively, and these ambient dose rate increases are considered to have been caused by the release of radioactive materials from Unit 3 and Unit 2.
