7.2

In the soil survey conducted by the national government in June 2011, three months after the accident, analysis of I-131 was conducted for soil samples collected within the 100-km zone of Tokyo Electric Power Company (TEPCO)'s Fukushima Daiichi NPS.

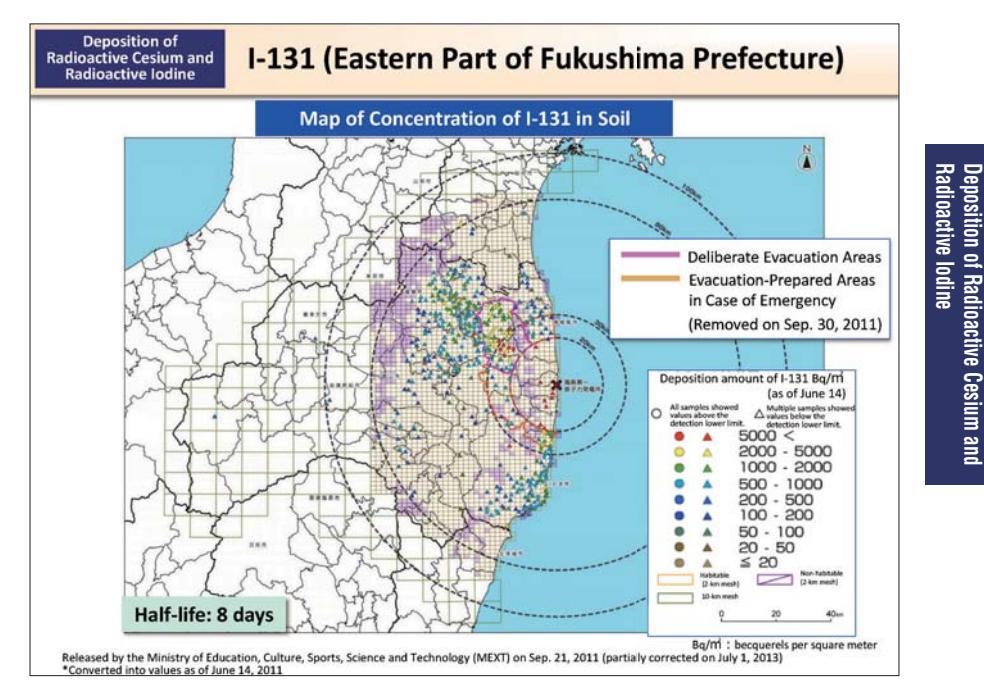
Areas showing high deposition amounts of iodine extended to the northwest of the NPS, in the same manner as in the case of cesium, and there are areas where the ratio of iodine against cesium is large in the southern areas of the NPS. I-131 and Cs-137 were thus deposited at different ratios in different areas probably because the ratio between I-131 and Cs-137 in radioactive plumes differed depending on the time when they were discharged. There is also the possibility that the ratio of I-131 against Cs-137 was relatively larger in plumes that flowed down to the south or that deposition was not even and a larger amount of Cs-137 was deposited in the north due to rainfall, resulting in increased concentrations of Cs-137 in soil in the north.^{*1}
