O Overview	The copyright of this verification experiment report is owned by the Ministry of the Environment.					
Technology intended for verification/ verification applicants		Home non-excrement waste water treatment equipment, which uses charcoal (The new purifying facility for non-excrement waste water, type SG-500)/Seiwa Denko Co., Ltd.				
Demonstration institution		Saitama-prefectural Environmental Analysis & Research Association				
Period of the experiment for verification		August 10, 2012 ~ January 28, 2013				
Purepose of this technology		This technology is designed to clean domestic wastewater (domestic non-fecal wastewater) containing no human excrement by solid-liquid separation based on physical sedimentation and physicochemical cleaning such as adsorption by charcoal.

1. Outline of the technology intended for verification

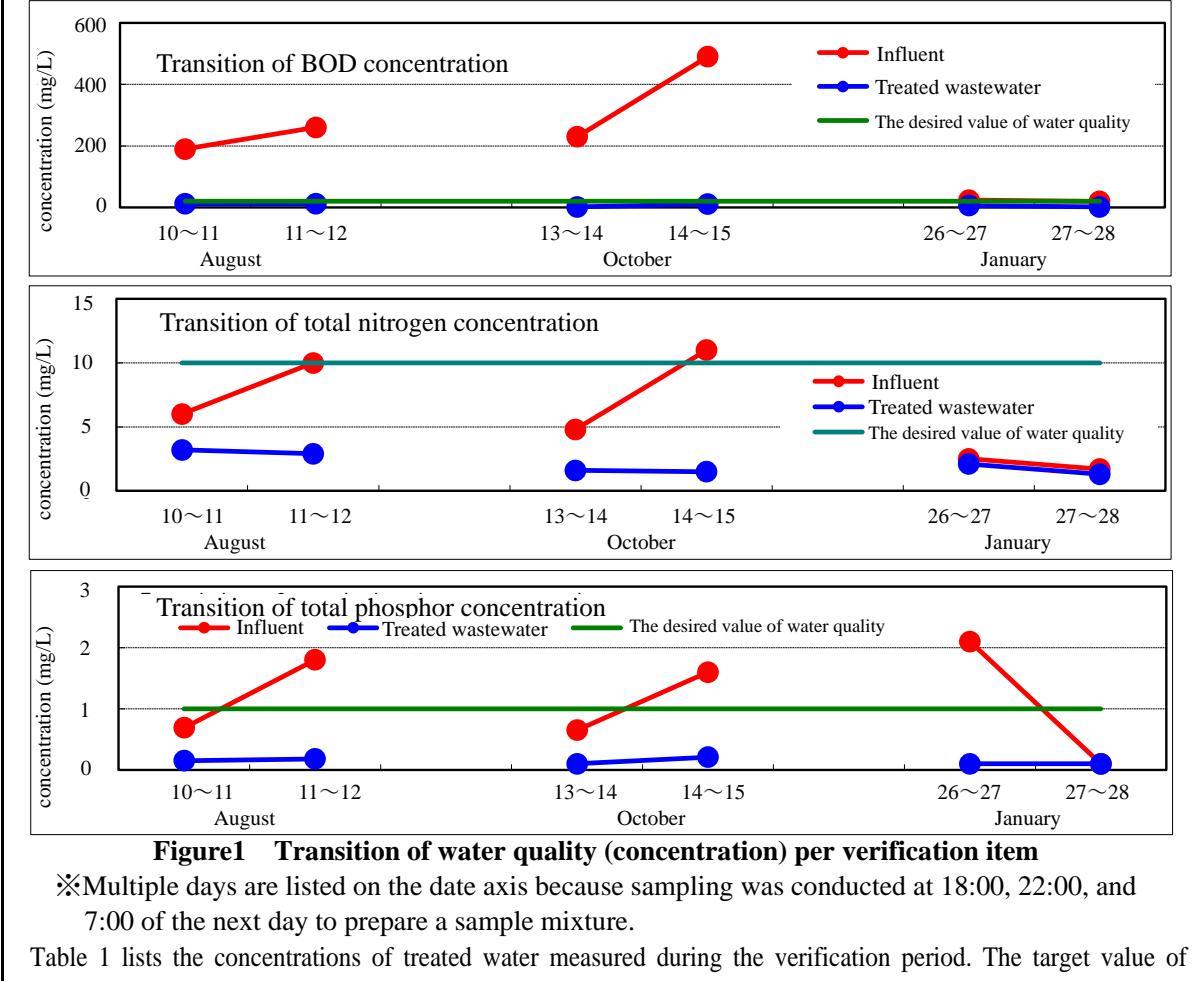
Verification experiments were conducted three times, in August, December, and January. Figure 1 shows the transition of water quality (concentration). Water was sampled three times a day, and the three samples were mixed to prepare a specimen. The concentrations were found to increase on the second day of each month because the usage increased (the number of residents increased on weekends).

treated water was achieved, the average BOD being 7.4 mg/L. Total nitrogen was 2.1 mg/L, achieving the target value, but the average inflow concentration was lower than the intended concentration. The total phosphor was 0.14 mg/L, achieving the target value, but the average inflow concentration was approximately the same as the intended concentration. The removal efficiency expressed as pollution load was as follows: BOD: 94.9%, total nitrogen: 55.2%, total phosphor: 84.2%.
