I-131 (Eastern Part of Fukushima Prefecture)

Map of Concentration of I-131 in Soil

Released by the Ministry of Education, Culture, Sports, Science and Technology (MEXT) on Sep. 21, 2011 (partially corrected on July 1, 2013)
*Converted into values as of June 14, 2011

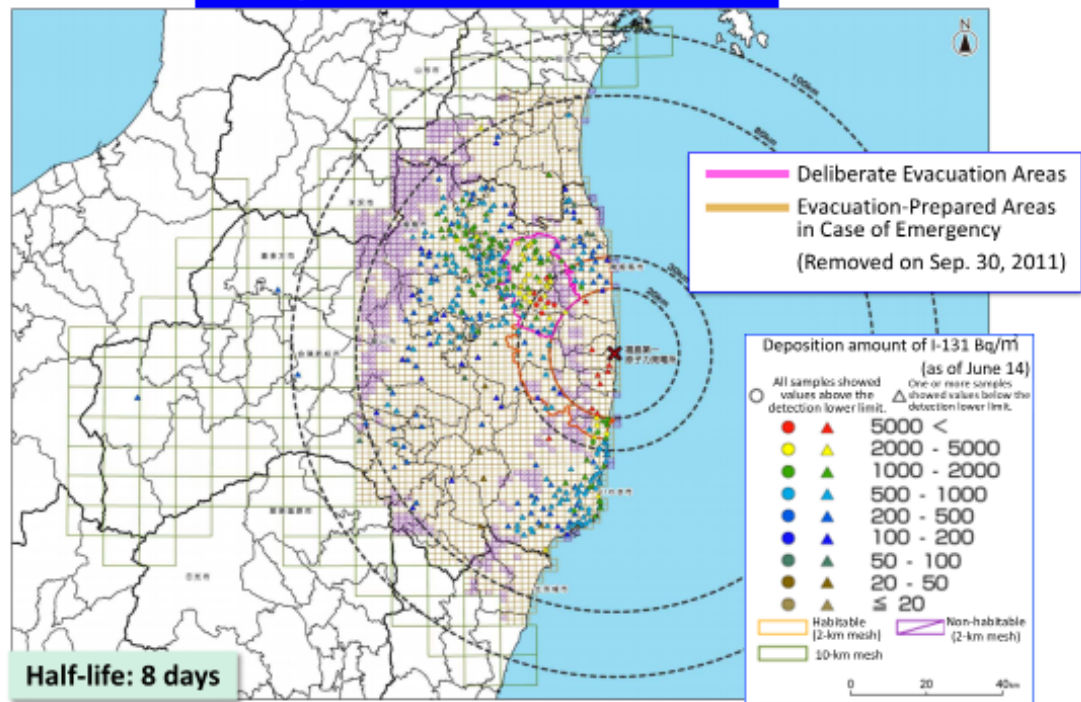
In the soil survey conducted by the national government in June 2011, three months after the accident, analysis of I-131 was conducted for soil samples collected within the 100-km zone of Tokyo Electric Power Company (TEPCO)'s Fukushima Daiichi NPS.

Areas showing high deposition amounts of iodine extended to the northwest of the NPS, in the same manner as in the case of cesium, and there are areas where the ratio of iodine against cesium is large in the southern areas of the NPS. I-131 and Cs-137 were thus deposited at different ratios in different areas probably because the ratio between I-131 and Cs-137 in radioactive plumes differed depending on the time when they were discharged. There is also the possibility that the ratio of I-131 against Cs-137 was relatively larger in plumes that flowed down to the south or that deposition was not even and a larger amount of Cs-137 was deposited in the north due to rainfall, resulting in increased concentrations of Cs-137 in soil in the north.¹
