Spatiotemporal
Distribution of
Ambient Dose Rates

Comprehensive Radiation Monitoring Plan and Information Disclosure

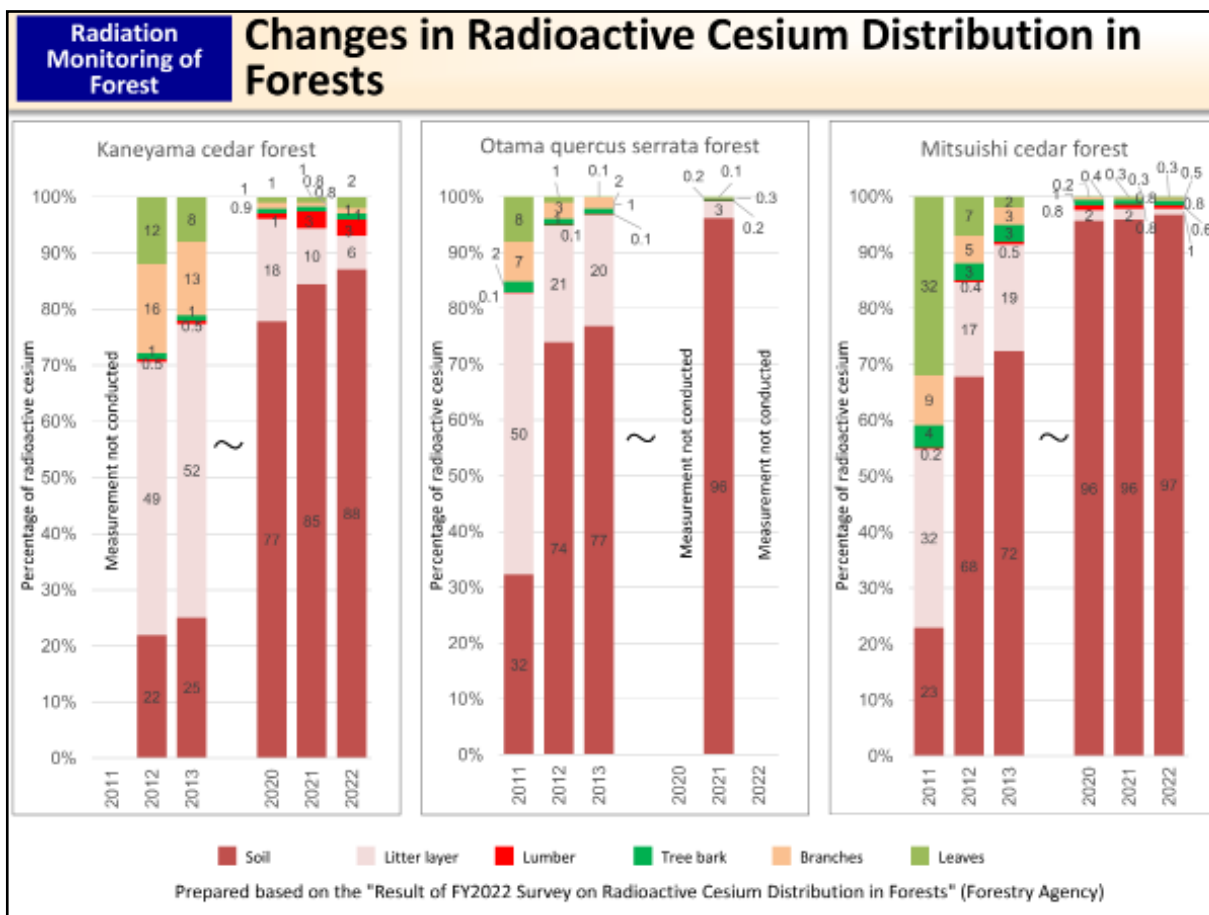
Regarding radioactive cesium in the surveyed forests, in the first one year after the accident from 2011 to 2012, the percentage of radioactive cesium found in leaves, branches and litter layers decreased significantly, while that found in soil increased significantly. This is considered to be because radioactive cesium deposited on leaves and branches, etc. of trees gradually transferred to the litter layer on the ground due to rain or leaf fall and then transferred to soil due to the decomposition of the litter layer. The percentage of radioactive cesium in soil is continuously increasing, and over 90% of the radioactive cesium in forests is found in soil or the litter layer as of 2022, mostly found in the soil surface layer at a depth between 0 cm and 5 cm.

The percentage of radioactive cesium found in the litter layer is high in the Kaneyama cedar forest and is low in other forests. Each forest thus shows different tendencies. The survey will be continued into the future.

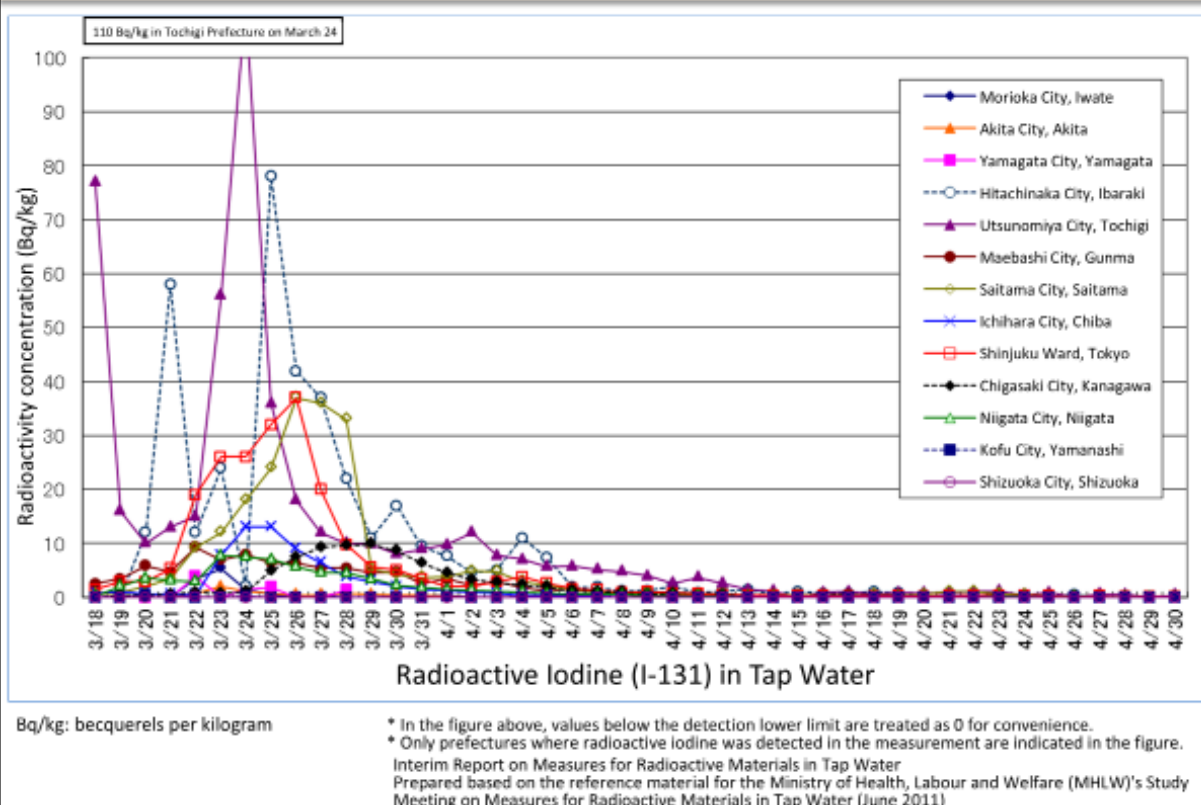
Radioactive Iodine (I-131) (the Tokyo Metropolis and 12 Prefectures)

As a result of the inspection of radioactive materials in tap water conducted by the Ministry of Education, Culture, Sports, Science and Technology (MEXT), radioactive iodine was detected in the Tokyo Metropolis and 12 prefectures out of 47 prefectures nationwide. Highest concentrations were detected at the respective locations from March 18 to 29, 2011, but I-131 concentrations turned to decrease in many locations in the latter half of March 2011. In and after April 2011, only small amounts of I-131 were detected at some of these locations.

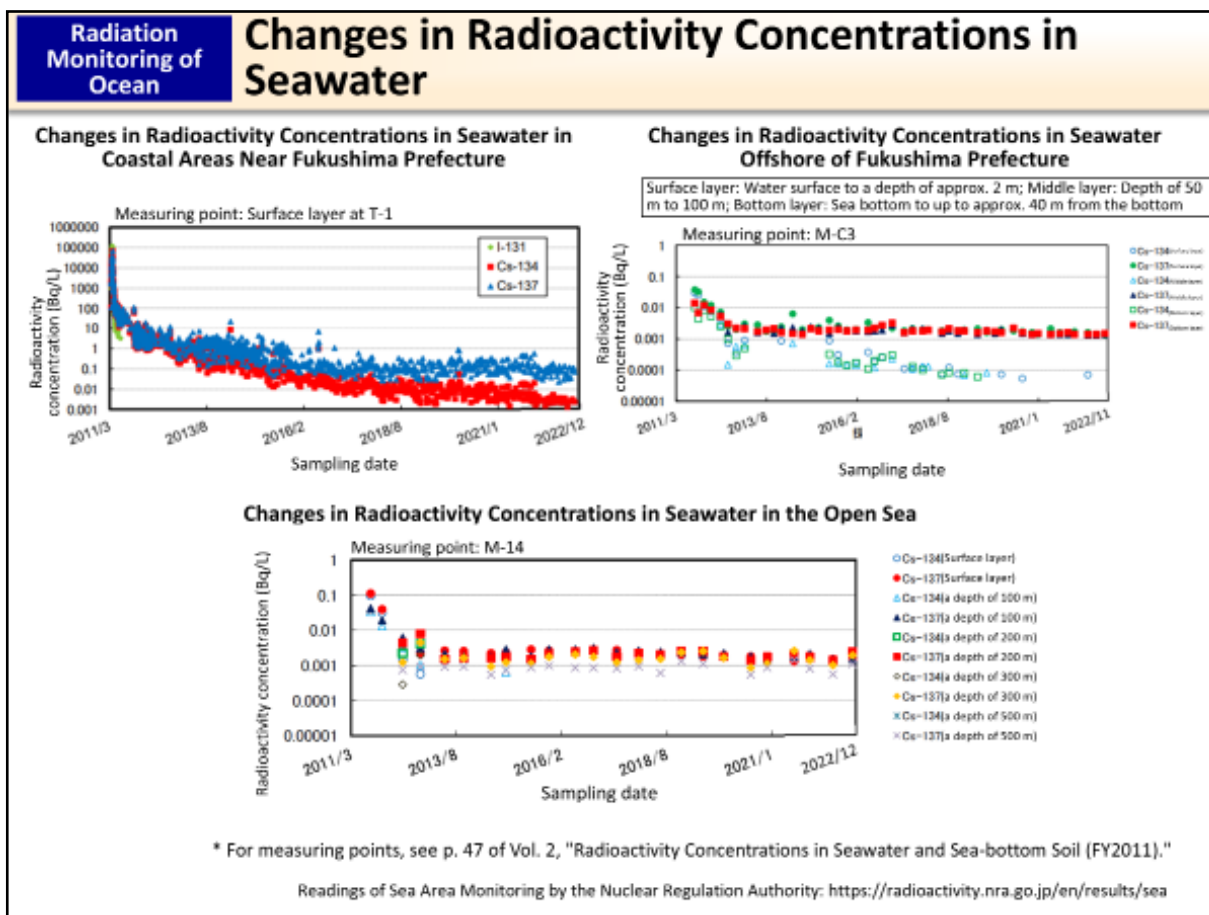
Changes in Radioactivity Concentrations in Seawater

Soil with radioactive cesium is transported to coastal areas via rivers.

Radioactivity concentrations in seawater samples collected near Tokyo Electric Power Company (TEPCO)'s Fukushima Daiichi NPS rose to 100,000 Bq/L immediately after the accident, but dropped to one-thousandth (100 Bq/L) in one and a half months as a result of dilution and dispersion. The concentrations further decreased to 10 Bq/L in one and a half years and are 1 Bq/L or less at present.
