**Radiation Dose Map**

Spatiotemporal  
Distribution of  
Ambient Dose Rates

**Distribution of Ambient Dose Rates within the 80-km Zone of  
TEPCO's Fukushima Daiichi NPS**

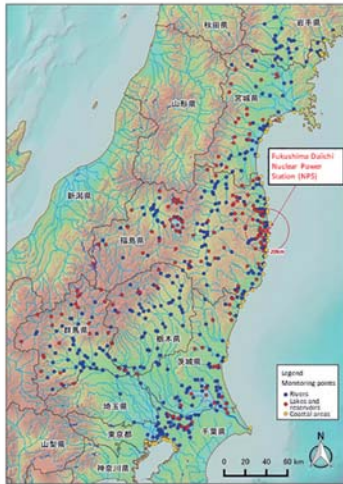
## Radioactive Material Monitoring in and around Fukushima Prefecture (Public Water Areas)

**[Coverage]**  
Whole Area of Fukushima, Miyagi, Ibaraki, Tochigi and Gunma Prefectures, and part of Iwate and Chiba Prefectures, etc.

**[Monitoring points]**  
602 locations

**[Radionuclide analyses]**  
• Samples  
Water, sediments and Surrounding environment (soil)

• Analyzed radionuclides  
Radioactive cesium  
Radioactive strontium (only for some water and sediment samples)

**[Frequencies]**  
Twice to 10 times a year depending on the contamination status, etc.

Radioactive material monitoring was conducted at rivers, lakes and coastal areas in locations centered on Fukushima Prefecture, such as Miyagi and Ibaraki Prefectures, where contamination with radioactive materials was suspected.

In FY2020, monitoring covered 602 locations and analysis was conducted for radioactive cesium and strontium in water, etc.

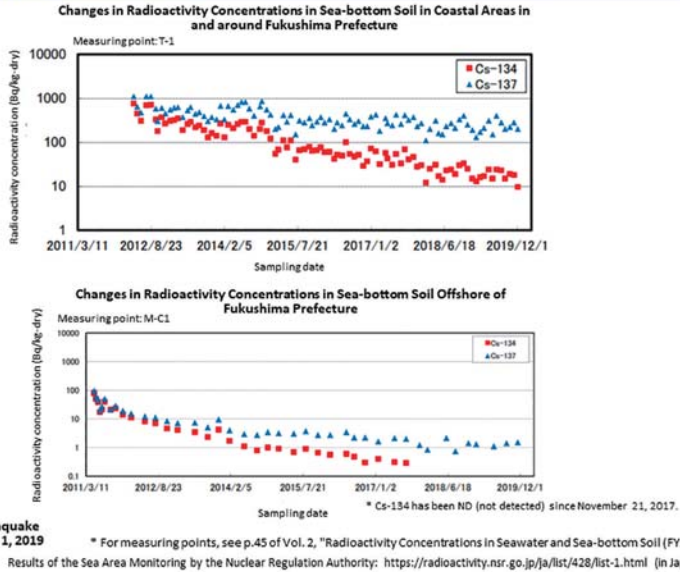
## Changes in Radioactivity Concentrations in Sea-bottom Soil

As a result of measuring dried sea-bottom soil samples collected in the coastal areas near Tokyo Electric Power Company (TEPCO)'s Fukushima Daiichi NPS, the concentrations of Cs-134 and Cs-137 were initially 1,000 Bq/kg but decreased in two years after the accident to 200 Bq/kg (down by 80%) and 500 Bq/kg (down by 50%), respectively. (Measuring Point T-1)

Radioactivity concentrations detected from sea-bottom soil samples collected 40 km offshore (Measuring Point M-C1) rose to 100 Bq/kg immediately after the accident but decreased to 10 Bq/kg a year later. (Related to p.185 of Vol. 1, "Distribution of Radioactive Cesium in the Ocean")

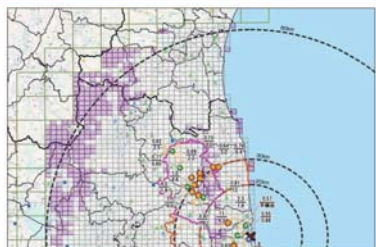
Deposition Amount of Pu-238 and Pu-239+240 (as of June 14, 2011)

**Half-life:**  
**Pu-238=87.7 years**  
**Pu-239=24,000 years**  
**Pu-240=6,564 years**

The amounts of deposited Pu-238 and Pu-239+240 detected in the surveys were found to be within their ranges in past measurements conducted from FY1999 to FY2009, before the accident, covering the whole nation. It means that the amounts were within the fluctuations due to past nuclear bomb tests in the atmosphere, except for the amount of Pu-238 detected in a sample collected at one location (p.182 of Vol. 1, "Effects of Nuclear Test Fallout (Japan)").
